**MILLER PACIFIC
ENGINEERING GROUP**

**FAULT TRENCH INVESTIGATION
PROCTOR TERRACE ELEMENTARY SCHOOL
1711 BRYDEN LANE
SANTA ROSA, CALIFORNIA**

September 11, 2025

Project 1079.121

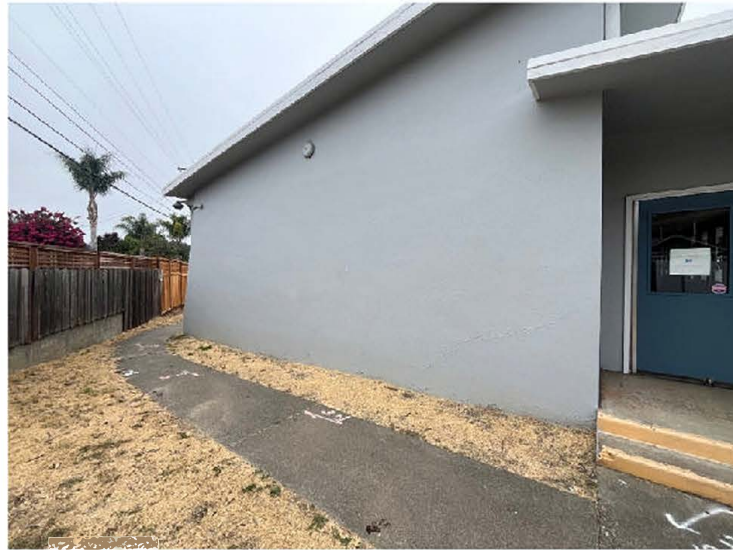
We did not observe any apparent damage to the building itself at this location during our 2018 visit, at which time the building had apparently been repainted in the recent past. During our most recent reconnaissance, we noted that the building's exterior wall shows significant cracking in the stucco façade and apparent foundation settlement at the scarp location.

Location 1 - View to northeast of low northeast-facing scarp at northern corner of main building, approximately coincident with fault trace mapped by Hecker (2016, 2018) and CGS (2024). Note approximate 1-foot rise in ground surface against block wall and prominent cracks in stucco facade.

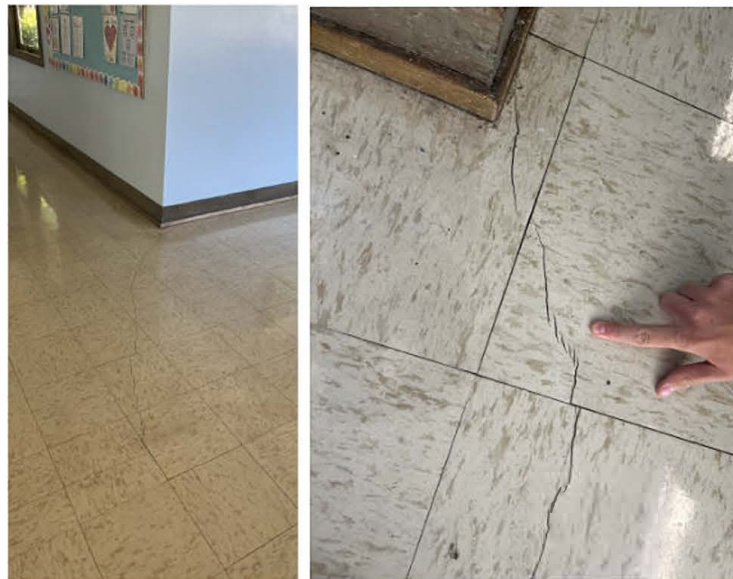
- In the central part of the main building, at the intersection of the western wing's hallway and the main hall connecting the other 2 wings, we observed that the linoleum floor is damaged, with visible cracks extending from the northern and southern corners of the hallway intersection. The cracks in the floor exhibit patterns typically associated with shear failure, including en-echelon cracks and apparent pull-apart zones. See Location 2 on Figure 5.

Location 2 - Cracked linoleum floor in main building hallway exhibiting an echelon fractures. Cracks extend across entire hallway along northwest trend.

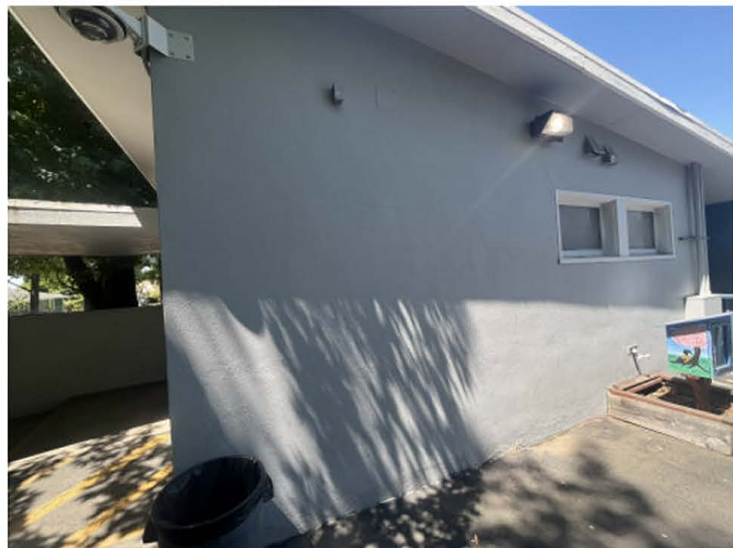
- At the southern corner of the main building's west wing, we observed similar damage to the exterior stucco as noted at the northern corner, as shown on Figure 5 (Location 3). Aside from the aforementioned locations, no similar distress was noted in either the interior or exterior of the campus structures.

Location 3 - View to north of damaged stucco at south corner of main building at location of deformation zone observed in Trench T-4 and approximately on strike with mapped fault and locations 1 and 2.

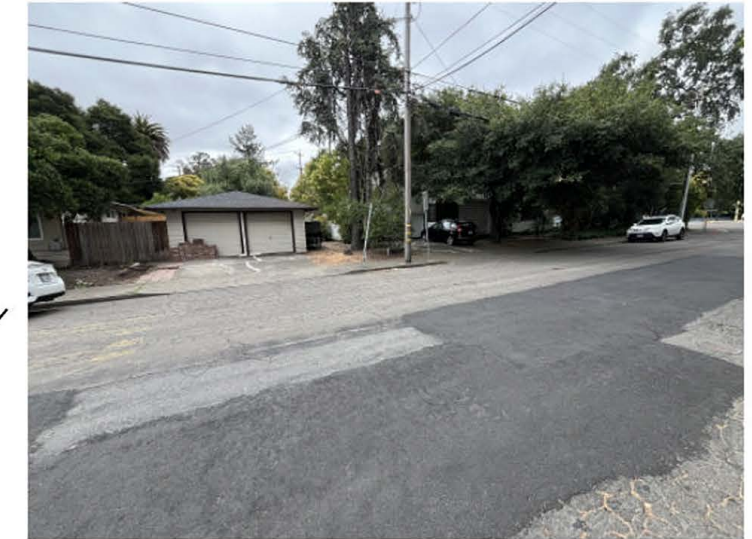
- Along the southeast side of Grosse Avenue, the three concrete driveways closest to Bryen Lane exhibit conspicuous and extensive cracking. See Location 4 on Figure 5. Although this may also be the result of older improvements, poor subgrade conditions, and/or root intrusion from mature trees, we did note that all other driveways and residential flatwork on the southeast side of Gross Avenue appear to be of similar age but in much better condition.

Location 4 - View to south of severely damaged concrete driveways. Most of the concrete flatwork in the surrounding area is older, but in reasonably good condition without similarly prominent or extensive damage.

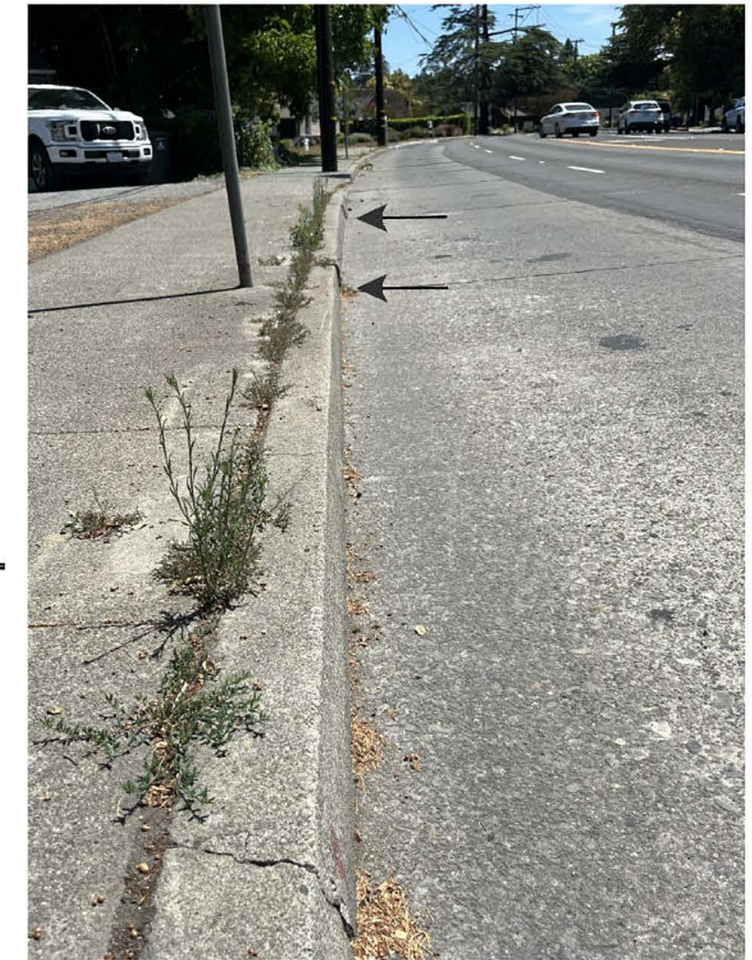
- Farther southeast, sidewalks along the north side of Fourth Street show several apparent right-lateral offsets at the curb/sidewalk control joints. We noted a four locations at which offsets are between about ½ and 1-inch as shown on Figure 5 (Location 5). Cumulatively, we measured a total of about 2 ¾ inches of right-lateral offset across an approximately 70-foot wide zone. The eastern two locations appear to coincide with the projection of the fault from the south as mapped by McLaughlin (2008).

Photo 5 - View to northeast of right-lateral offsets between sidewalk panels along Fourth Street. Total of 4 locations noted with apparent cumulative offset just under 3 inches.

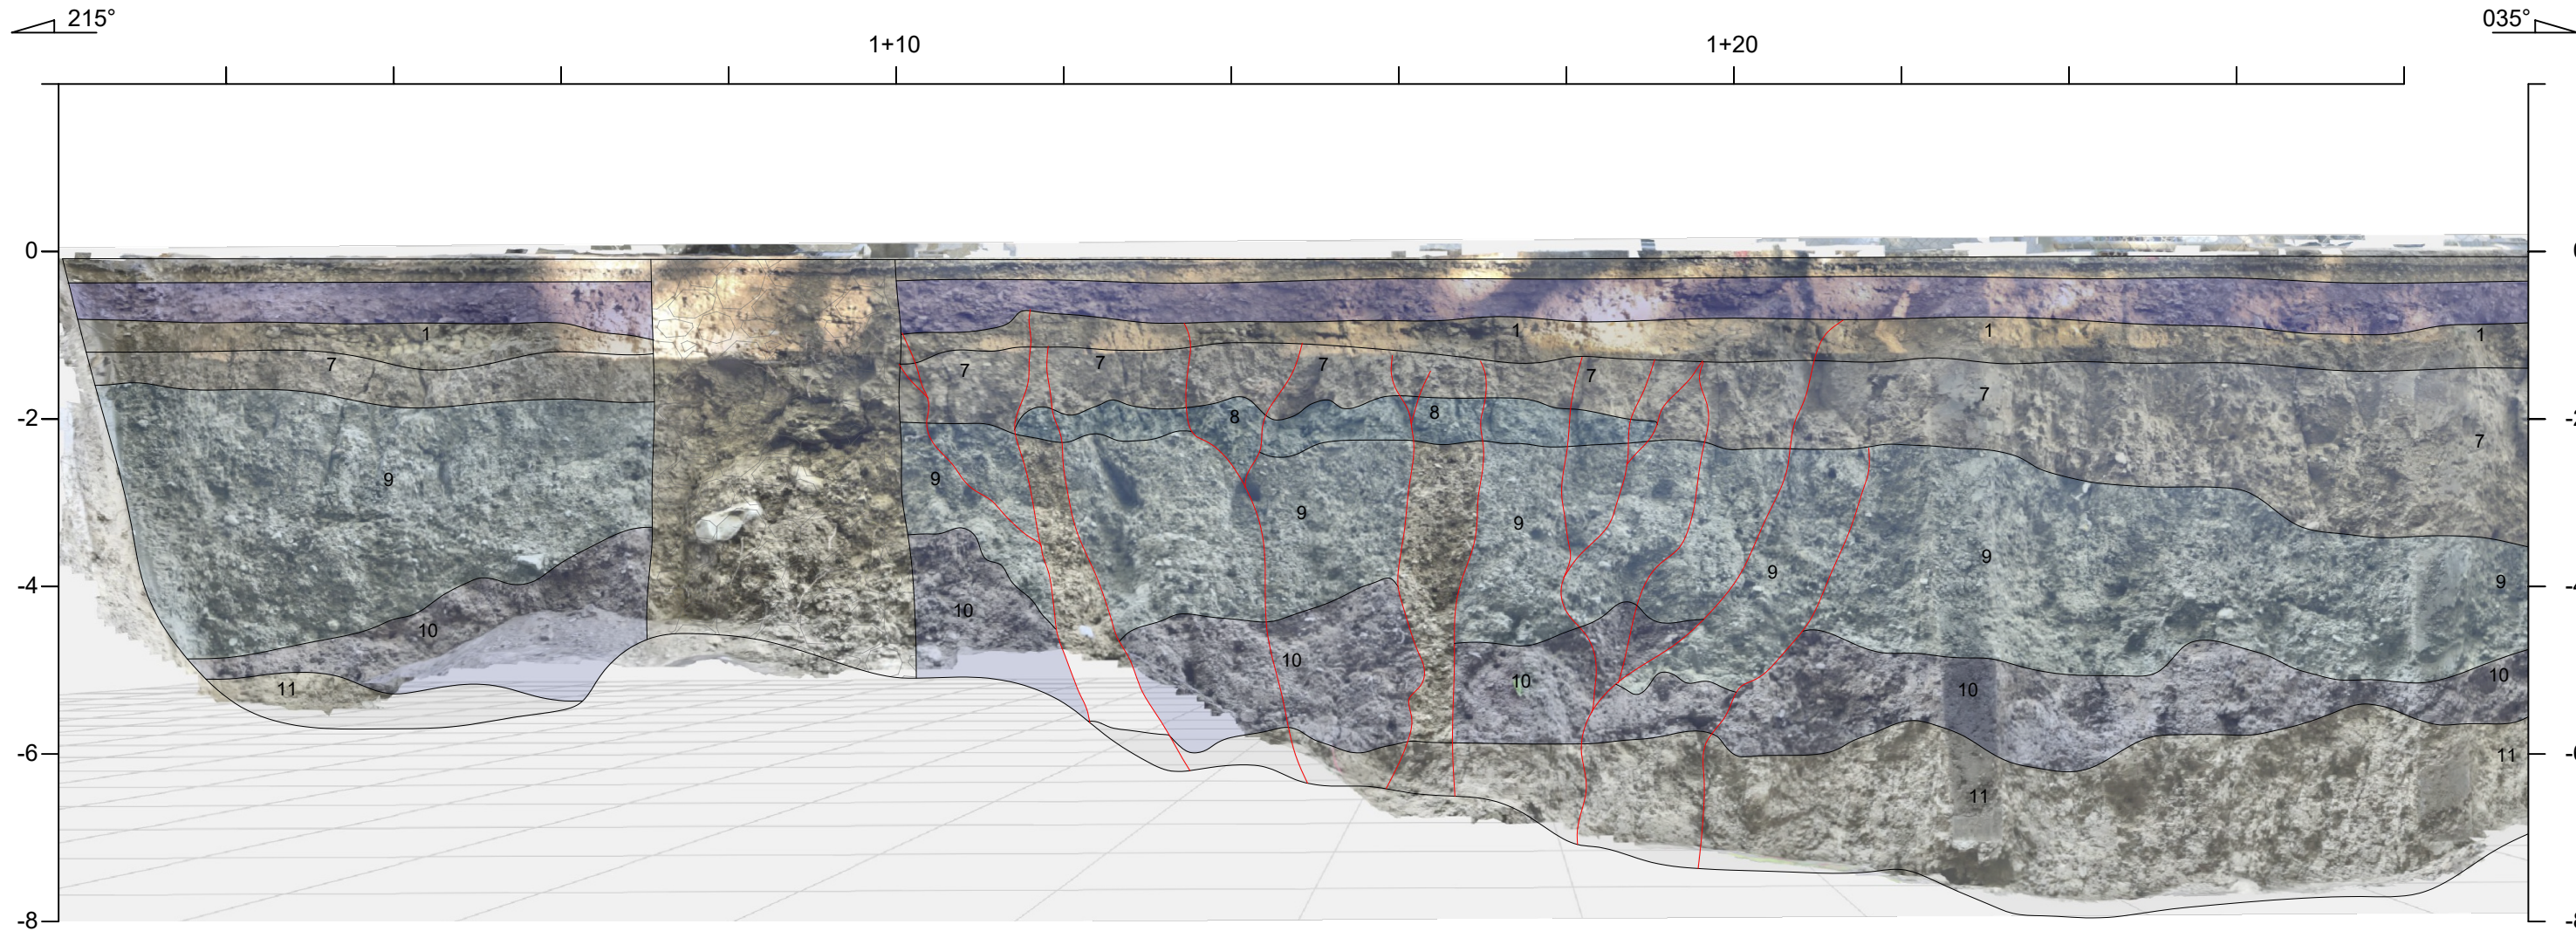
C-9

A zone of deformed soil between Stations 0+0 and 0+36 is characterized by abrupt thickening/thinning and truncation of soil layers. No deformation was observed at Station 0+50, suggesting the edge of the deformation zone is somewhere between Stations 0+36 and 0+50, which was not excavated due to utility conflicts. A detailed log of the deformation zone is shown on Figure C-8. We also collected a 3-D scan of the deformation zone using the “3D Scanner” app available through the Apple store, and using the internal camera on an iPad Pro 13. A high-resolution color photomosaic derived from our scan is shown overlaid with the trench log on Figure C-9, and the unaltered image is shown on C-10.

Between Stations 0+10 and 0+22, several contacts between soil horizons are offset by a series of subvertical discontinuities expressed as seams of coarse rounded sand and gravelly sand. Some of these seams offset contacts in the base of the trench between the basal clayey soils (unit 11) and overlying silty to gravelly sands (units 9 and 10). Others project downward into open vertical cracks in the clayey soils, some filled with occasional rounded sands and pebbles, but do not appear to exhibit any vertical offset. We did not observe any consistent preferred gravel clast orientation along most of the seams that would provide better evidence of shear.

Most of the discontinuities are traceable to the base of the clayey surface soils, within about 2 or 3 feet of the ground surface and typically project to prominent open vertical cracks in those soils. Typically, vertical cracks in plastic clayey soils would be attributed to shrink/swell behavior in response to changing moisture content. However, the near-surface clayey soils within the deformation zone are laterally extensive across the entire site, and although all of the trenches were left open for several weeks (allowing ample opportunity for desiccation and cracking to occur), prominent cracks were only observed within the deformation zone in association with the vertical sandy seams in the deeper, coarser horizons.
