# **LAUREL RIDGE ELEMENTARY SCHOOL**

## **RENOVATION**

### **DEKALB COUNTY SCHOOL DISTRICT PRELIMINARY REPORT**

**OCTOBER 29, 2021**

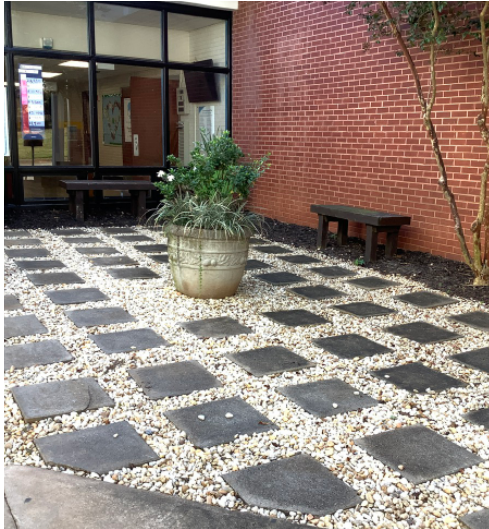
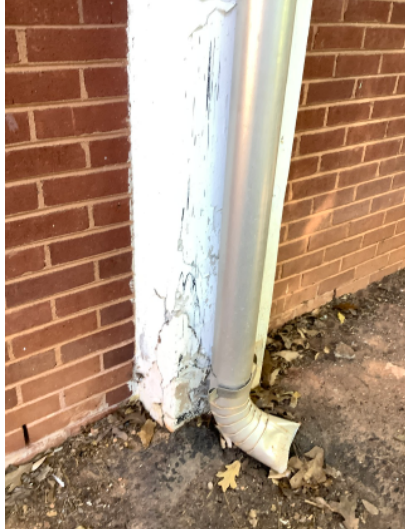
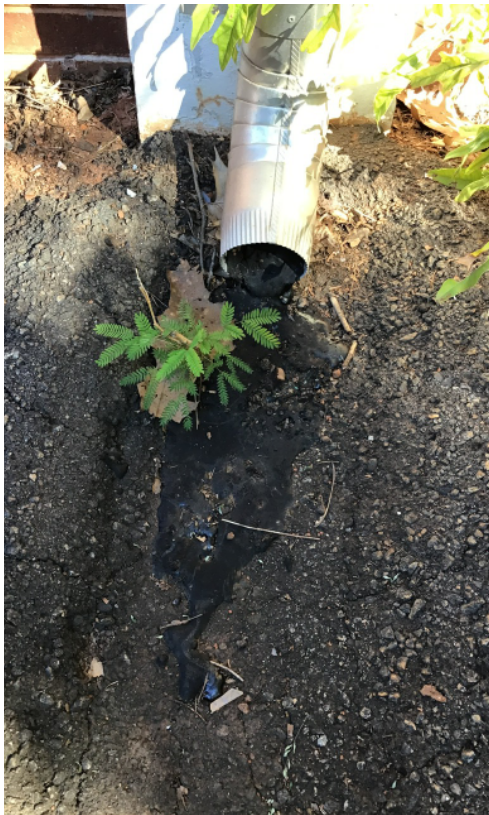
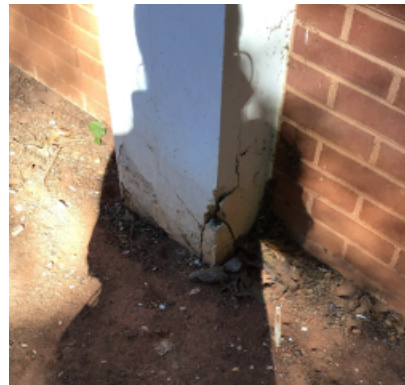
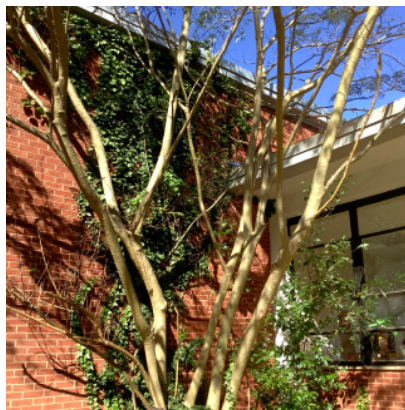
- Exterior brick has some defects typical of a building of its age. There are multiple locations where brick has been patched with excess mortar.
  - Multiple exterior columns have experienced damage over time, exposing rebar
  - Exposed wood in multiple locations where fascia is unfinished.
- 
- Proposed Repairs:
    - Consult with a structural engineer to repair columns.
    - Replace damaged portion of wall, patch cracks in brick masonry with matching brick.

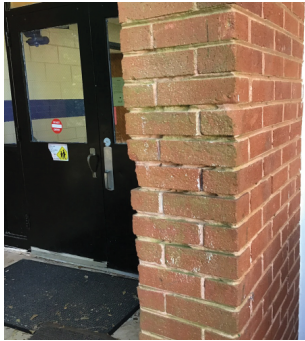
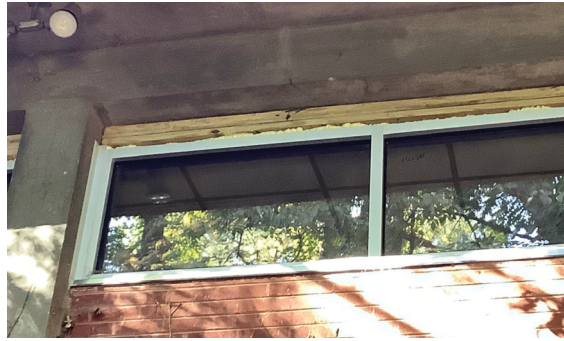
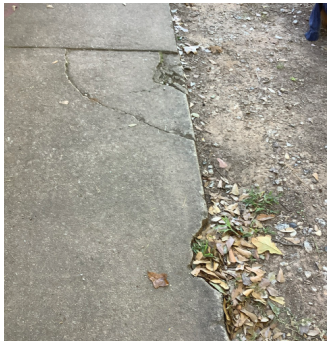
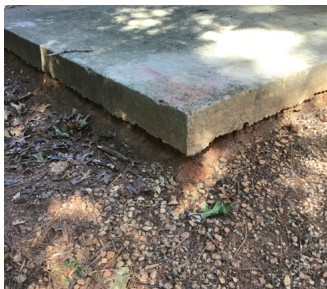
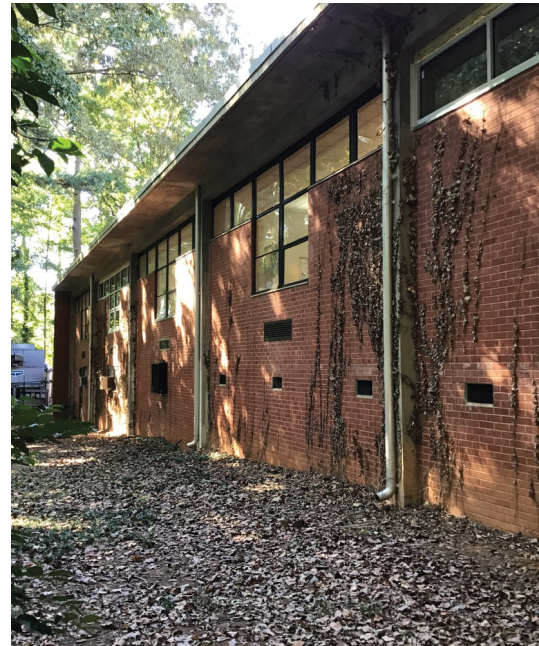
- Paint is peeling off columns and fascia.
- Proposed Repairs:
  - Prepare surfaces and repaint where paint is peeling

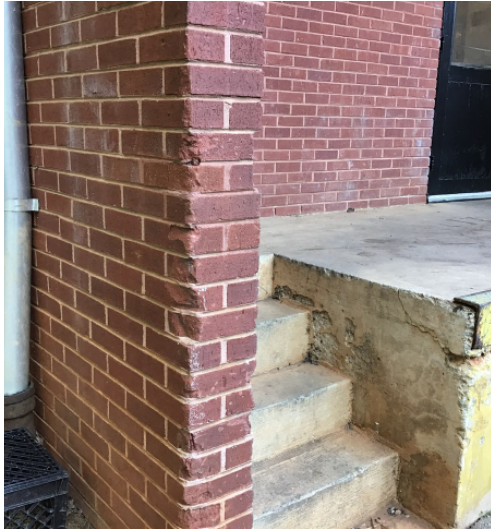
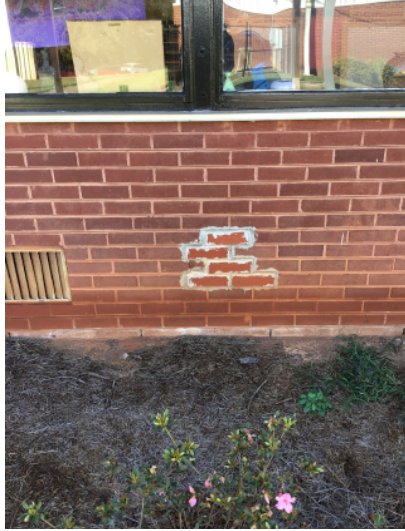
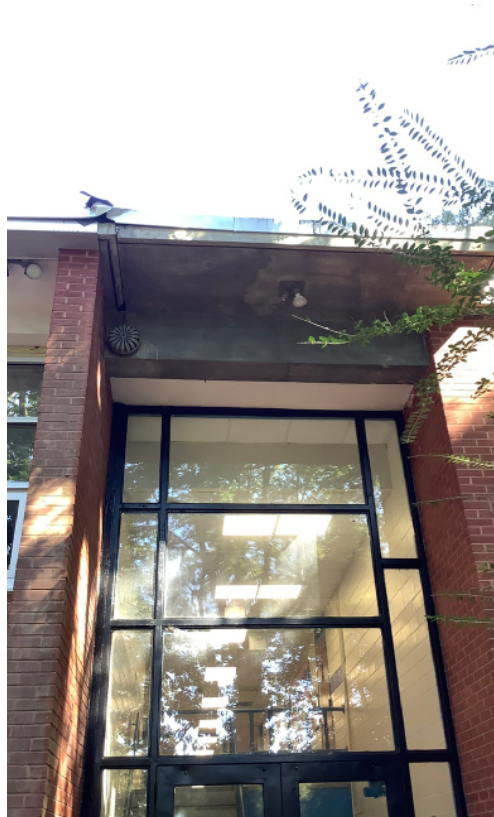
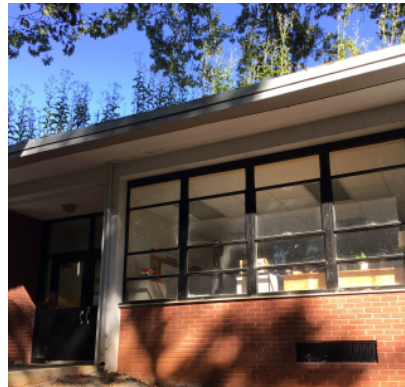
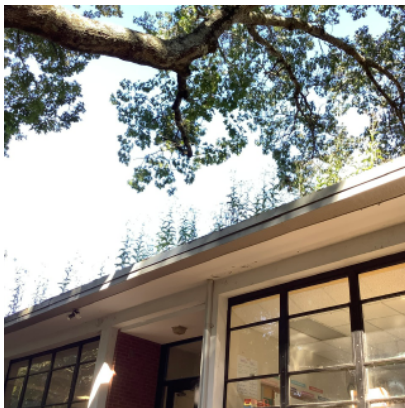
- Exterior brick has some defects typical of a building of its age. There are multiple locations where brick has been patched with excess mortar.
- Multiple exterior columns have experienced damage over time, exposing rebar
- Exposed wood in multiple locations where fascia is unfinished.
- Proposed Repairs:
  - Consult with a structural engineer to repair columns.
  - Replace damaged portion of wall, patch cracks in brick masonry with matching brick.

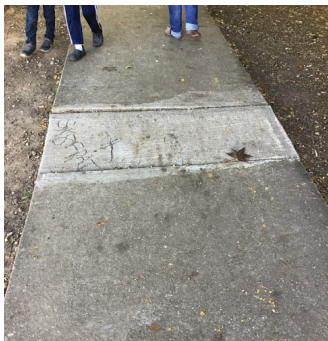
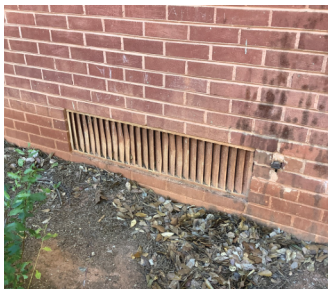
- Paint is peeling off columns and fascia.
- Proposed Repairs:
  - Prepare surfaces and repaint where paint is peeling

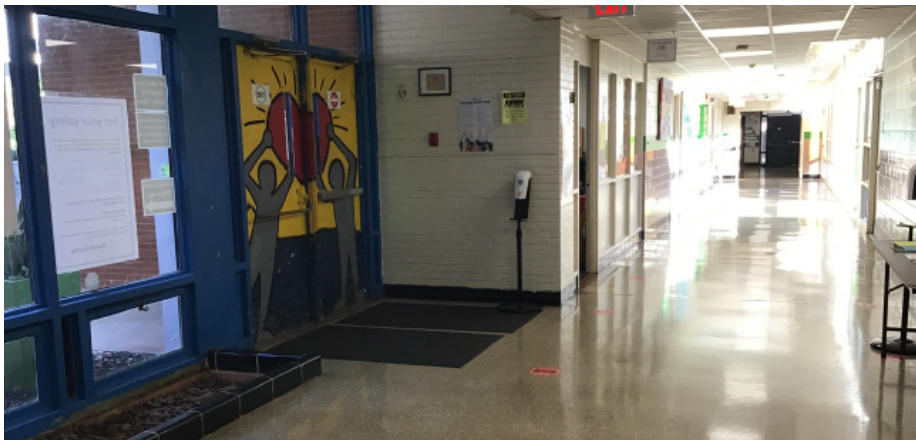
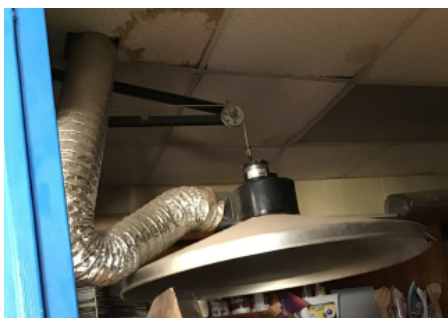
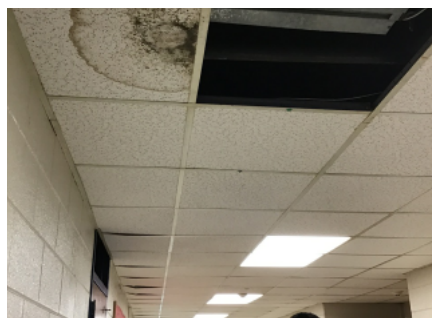
- Existing door hardware should be replaced to meet ADA requirements
- Water damage on ceiling tiles throughout building
- Flooring is terrazo, VCT, and quarry tile throughout. Floor finishes appear to be in fair condition.
- Light fixtures vary between fluorescent pendants and lay in fluorescent fixtures.

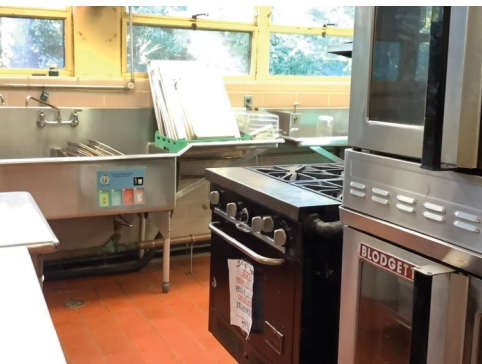
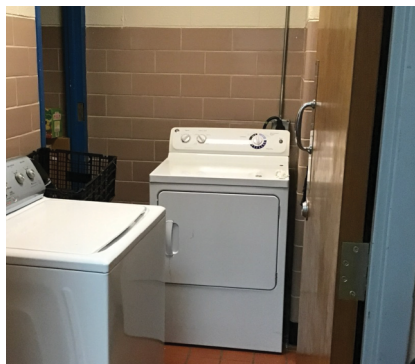
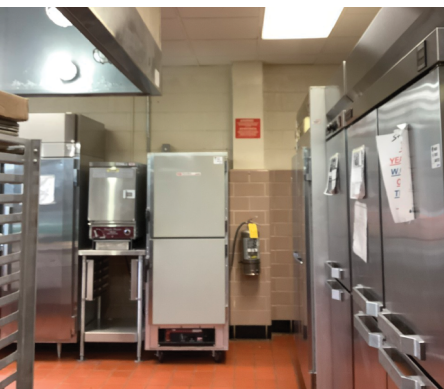
- The existing kitchen is in fair condition. According to the kitchen manager, all equipment is in working order. The kitchen contains equipment that is no longer used. This could result in a resizing of the vent hood.
- Proposed Repairs:
  - Reference mechanical assessment

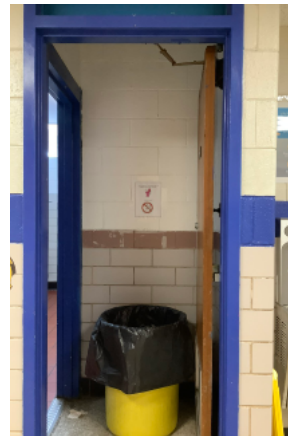
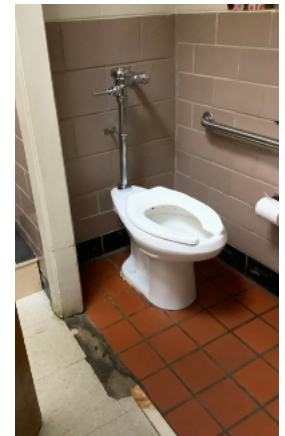
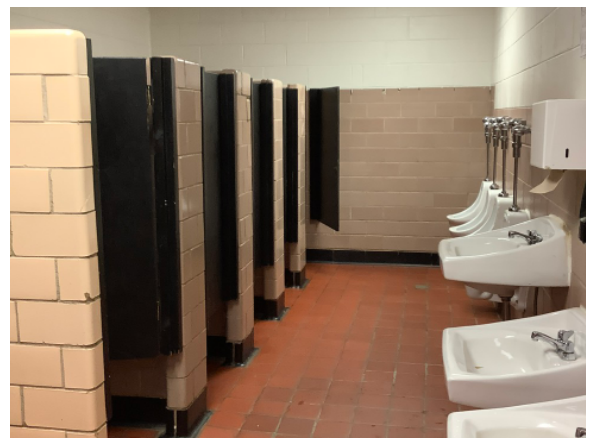
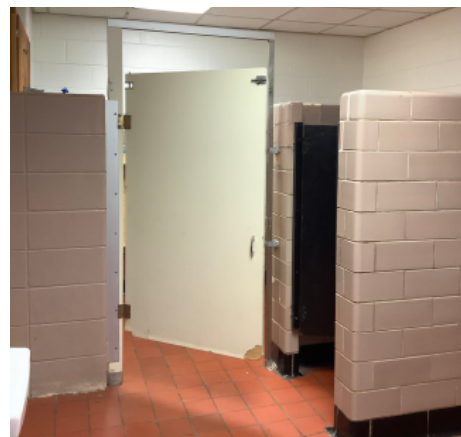
- Existing water coolers appear to be in proper condition.

- Recommend bringing water coolers up to ADA Standard heights and clearances

- Toilet fixtures appear to be in proper operating condition.

- Restroom partitions and doors appear to be in fair condition

- Individual and gang restrooms have ADA concerns related to door swings and stall clearances.

- Floor finish for the restrooms is quarry tile throughout. Flooring is damaged in some locations.

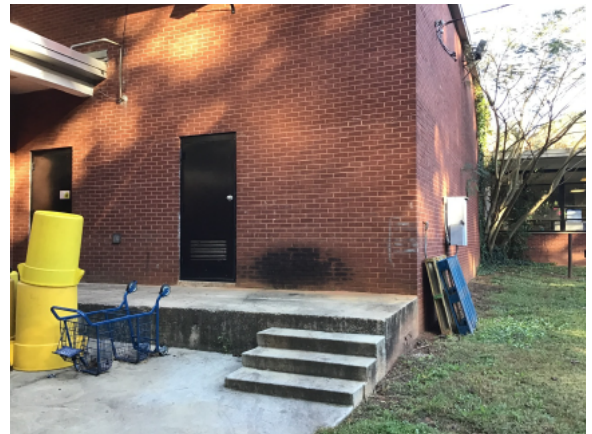
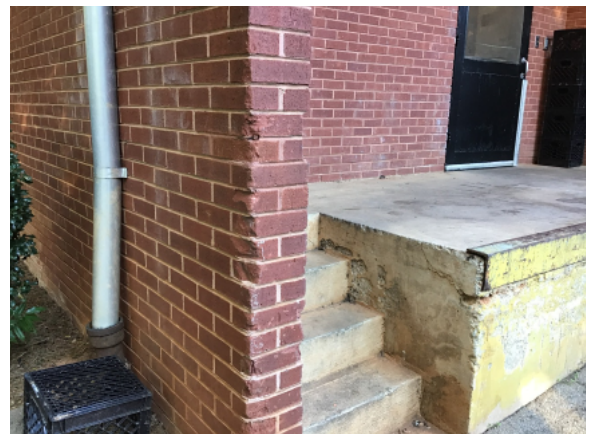
- There is currently no access to the roof. Recommend adding either an interior or exterior access point.
- 
- Door hardware does not meet ADA requirements in multiple locations. Round door knobs should be switched out for levers.
- Door clearances do not meet ADA requirements in multiple locations.
- Exterior concrete ramps may need handrails depending on slope of ramp.
- Light switches are currently mounted too high to meet accessibility requirements.
- Kitchen loading dock contains multiple life safety concerns; Handrails, guardrails, etc.

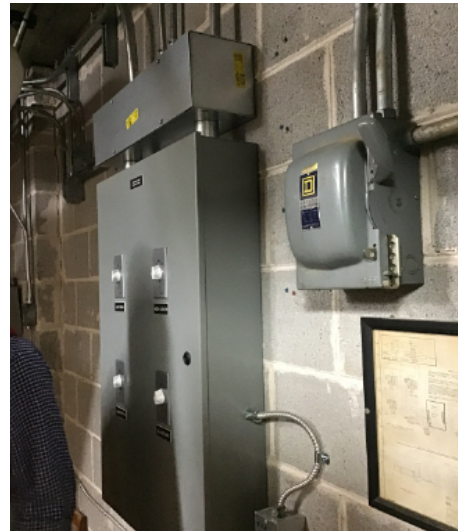
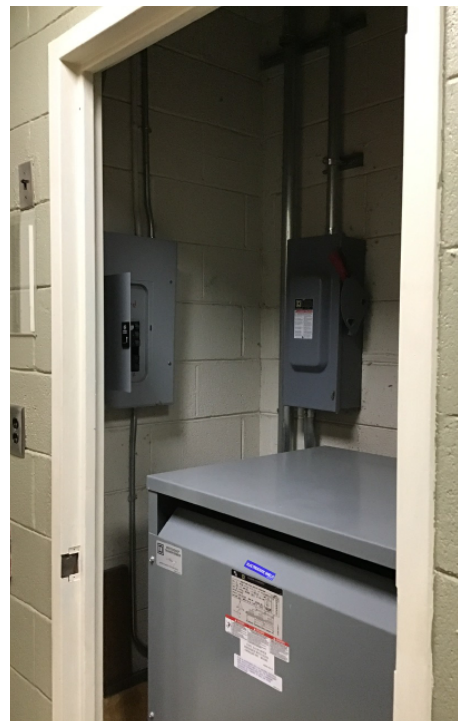
- Power Distribution Systems
  - Existing electrical service is original to building and is in poor condition. Existing main panel labeling is unreadable, but estimated service is rated for 800-1000 Amps at 277/480 Volts, 3-Phase, 4-Wire.
  - Panelboards and transformers throughout building are original to building and in need of replacement.
  - Emergency generator does not exist for this school.
  - Emergency lighting is currently tapped ahead of main and is a code violation.
- Lighting
  - Existing lighting in corridors, media center, cafeteria and administration are older LED retrofit.
  - Existing lighting in all other areas is existing fluorescent.
- Fire Alarm
  - Fire alarm system does not meet current life safety codes and is in need of replacement.

- Power Distribution
  - Upgrade electrical service and provide new panels and circuiting for HVAC system replacement.
  - Provide new emergency generator and separate life safety and non-life safety systems.
- Lighting
  - Provide new LED lighting and controls throughout building to meet IECC. This includes new LED lighting in Gymnasium.
