# CHESTNUT ELEMENTARY SCHOOL

## RENOVATION

### DEKALB COUNTY SCHOOL DISTRICT PRELIMINARY REPORT

OCTOBER 29, 2021

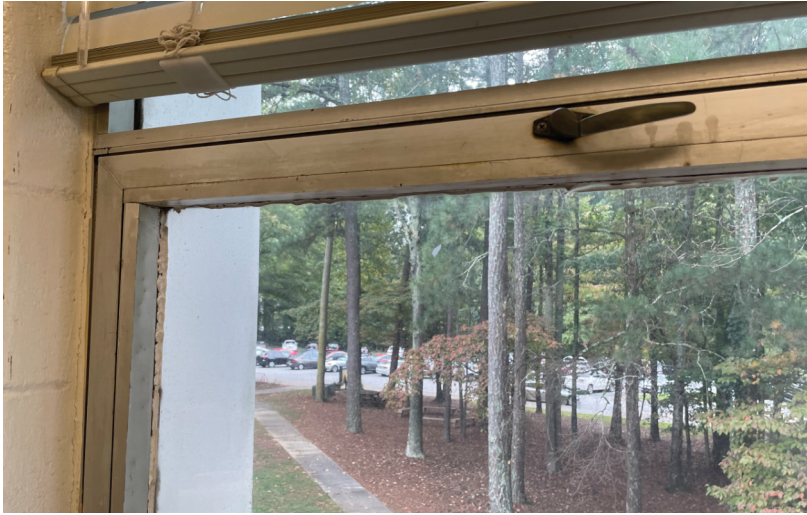
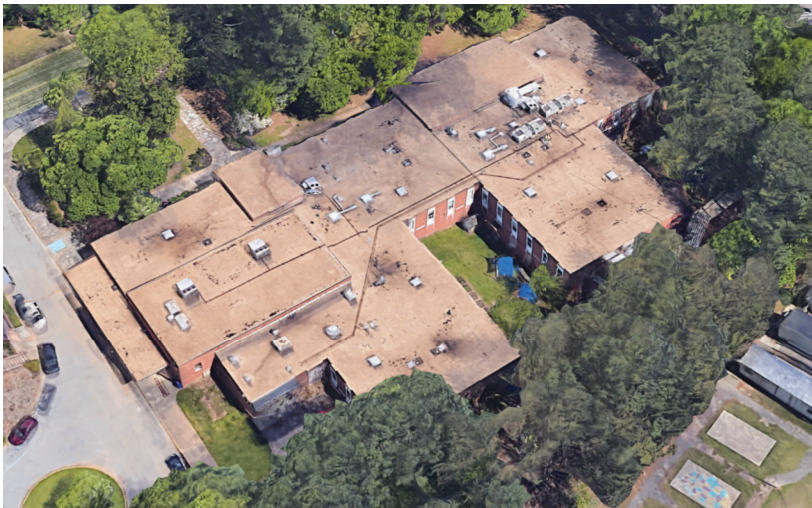
The existing building exterior is in fair condition.

- It is recommended to replace all existing single pane windows on the school.
- There is currently no roof access to the roof. A roof hatch or exterior ladder should be added to provide safe access to the roof. Aerial images show water pooling around roof drains. Signs of water damage along roof drain lines and condensation from mechanical units. Water infiltration through existing skylights is also causing damage to interior spaces.

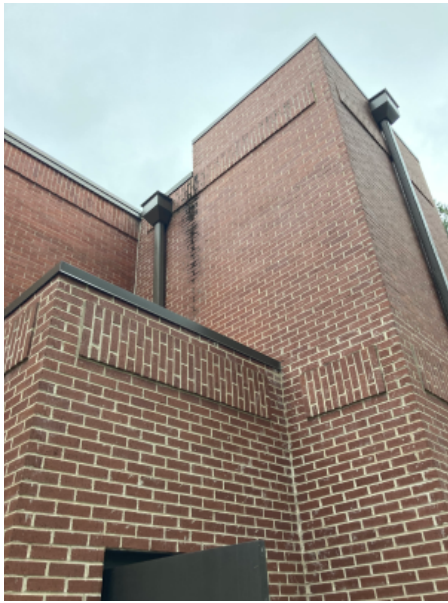
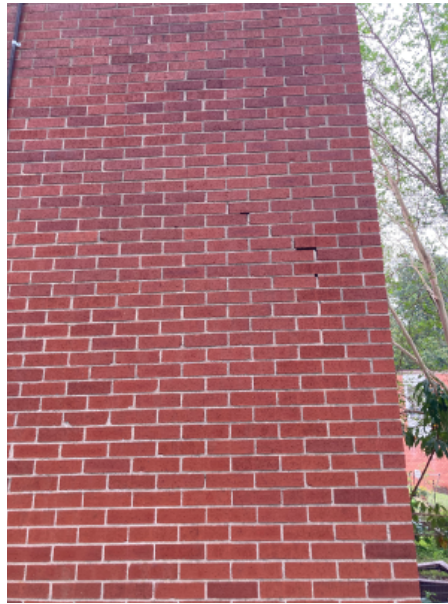
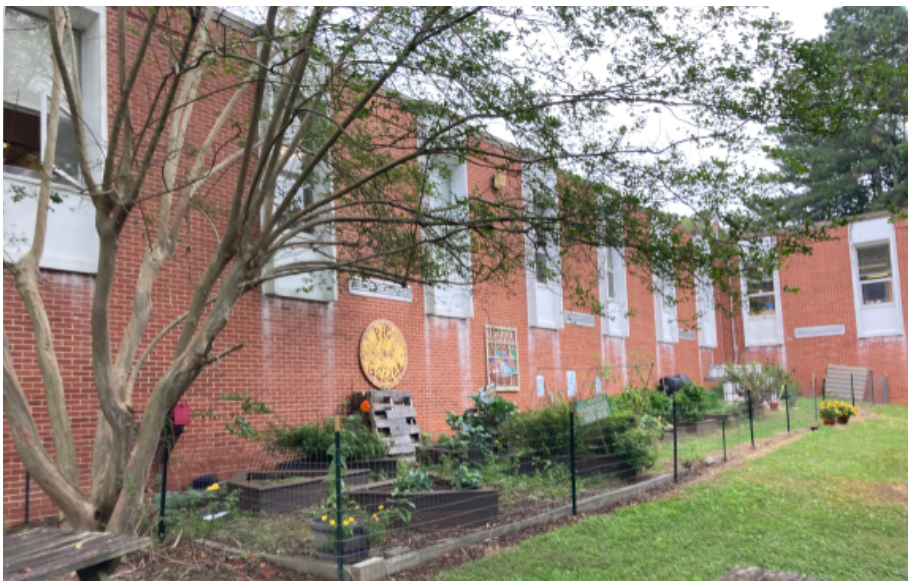
## i. Exterior Walls

- Exterior brick has some defects typical of a building of its age. Mortar has been washed away by weathering or pressure washing. White paint on the concrete is staining the underside of most windows
- Existing school does not have roof access
- Proposed Repairs:
  - Repoint brick at areas of mortar damage.
  - Clean areas under windows and repaint concrete
  - Provide roof access via ladder with cage

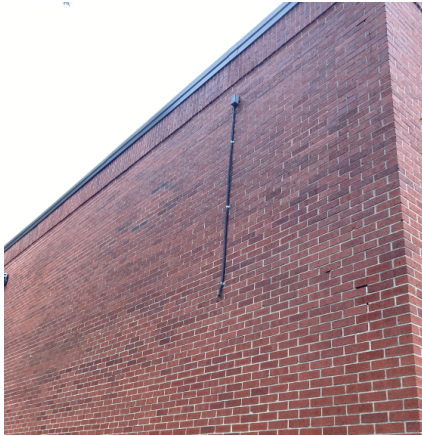
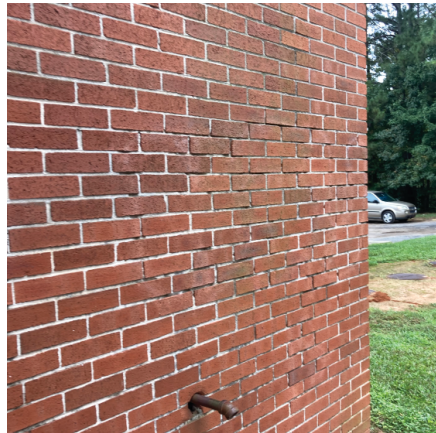
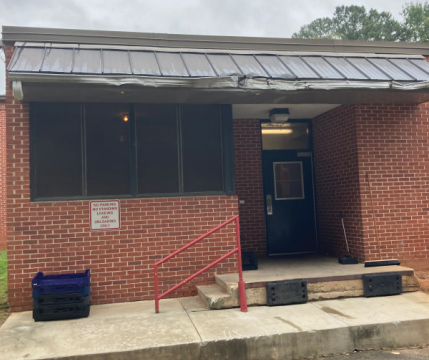
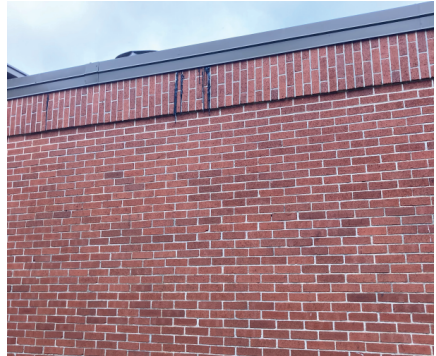
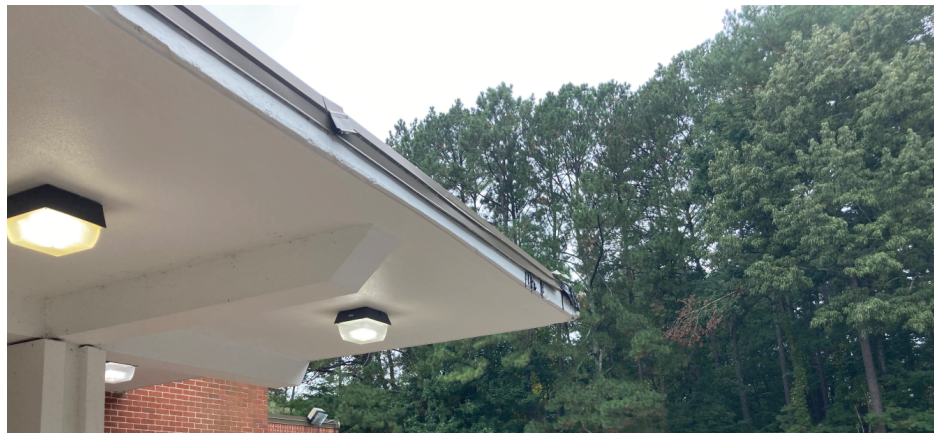
## i. Exterior Walls (continued)

- Gutters and canopy are damaged near the kitchen loading dock. Gutters have been struck by trucks causing heavy damage and preventing proper drainage from the canopy
- There are miscellaneous pipes and conduit around the exterior of the building
- Proposed Repairs:
  - Replace existing gutters.
  - Remove unused utilities.
  - Provide bollards or wheel stops to limit trucks from hitting gutters

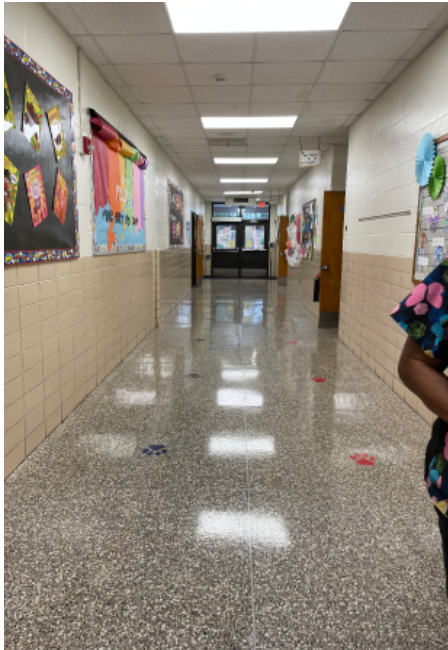
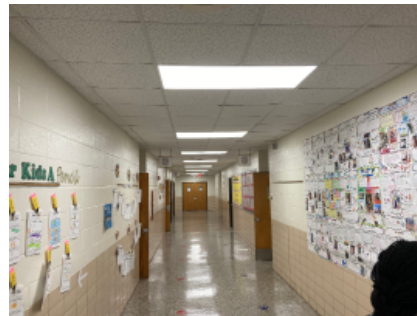
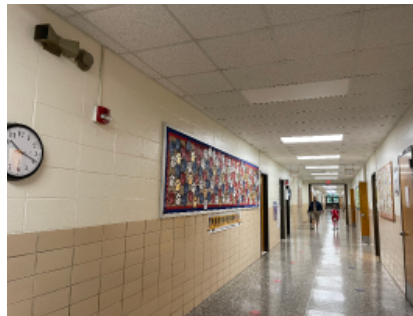
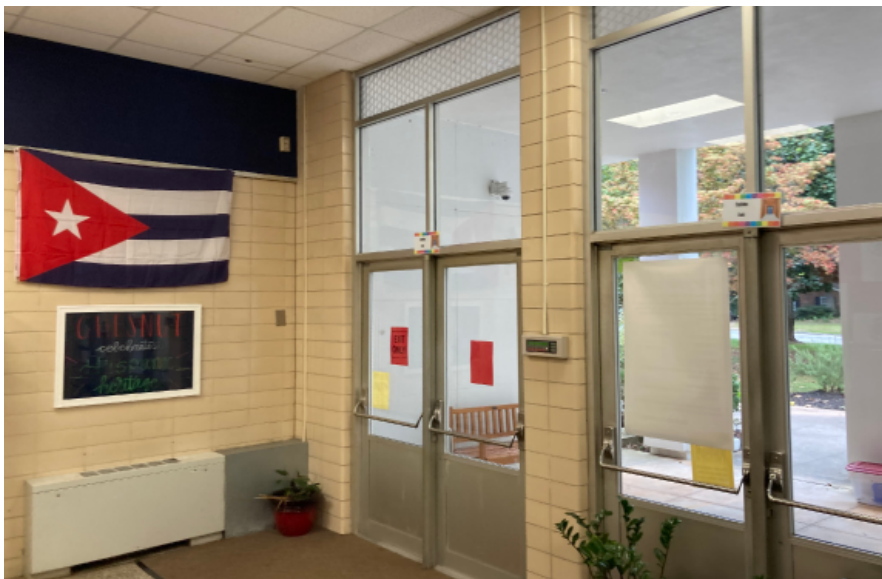
## ii. Interior

- We propose a secure vestibule to be added to the main entry. This would require the relocation of the existing trophy case and the addition of some storefront to enclose the entry. Security systems will include but may not be limited to surveillance cameras, electric strikes with buzzers, and bulletproof glass.
- Corridor, cafetorium, and media center lights have been replaced with LED fixtures within the last 15 Years. All other classrooms contain fluorescent fixtures. The architect proposes that these all be replaced along with the acoustical ceilings throughout.

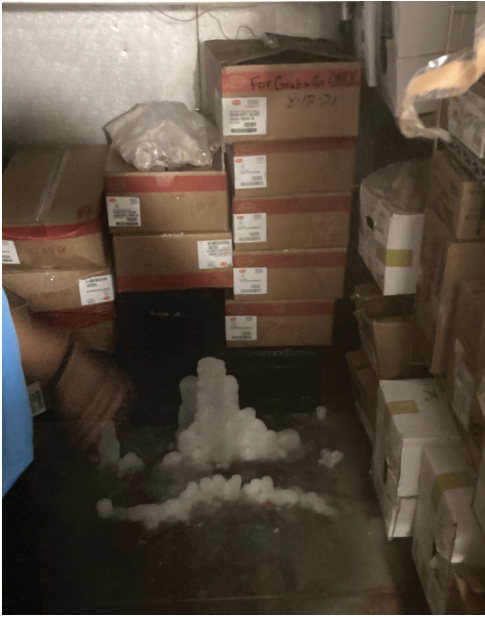
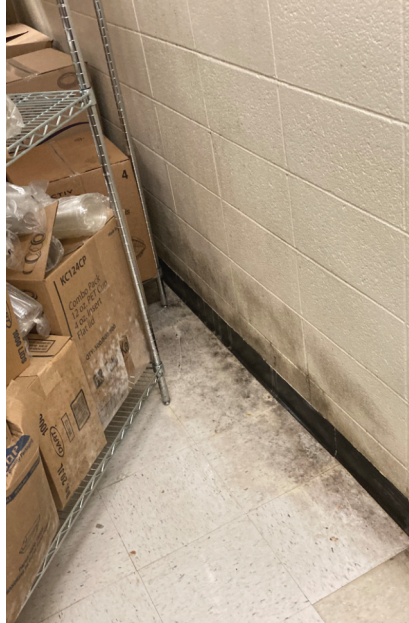
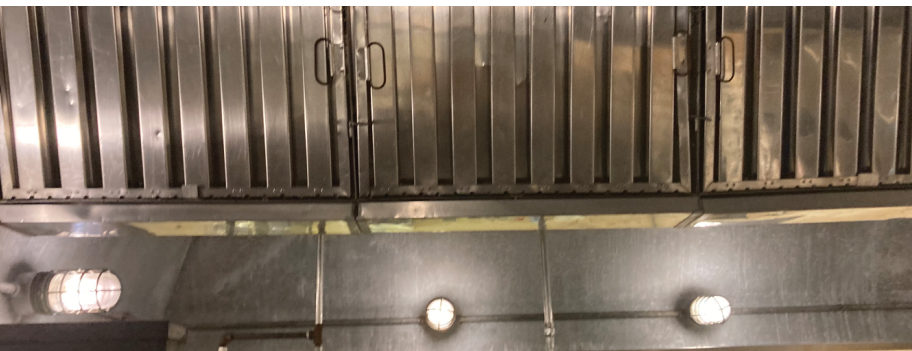
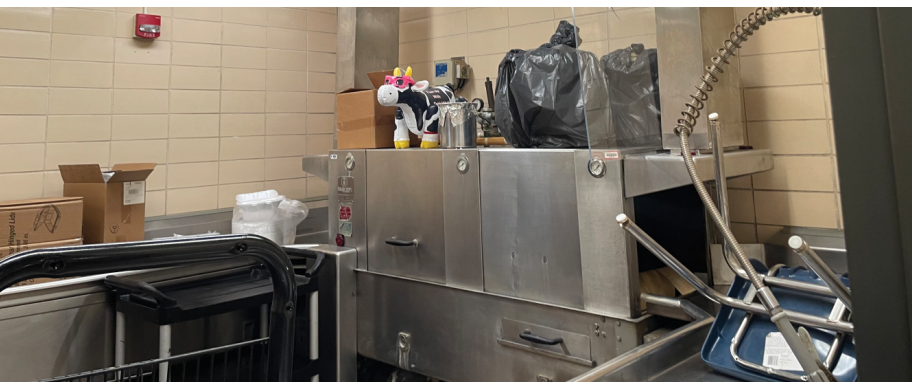
### iii. Kitchen Equipment

- The existing kitchen contains equipment that either is not used or is not operating properly. Leaking is occurring above the walk-in freezer, causing a build up of ice inside. The plenum space above walk-in refrigerator and freezer is unconditioned, leading to condensation and what appears to be mold build-up.
- Vent hood filters fall out sporadically. Vent hood can be resized based on unused equipment that can be removed.
- Condensate pipe above pantry is leaking, causing mold and mildew to form in the dry food storage area.
- Proposed Repairs: Investigate source of leaks, remove unused kitchen equipment, replace broken kitchen equipment.
- Environmental consultant to evaluate what appears to be mold and provide remediation

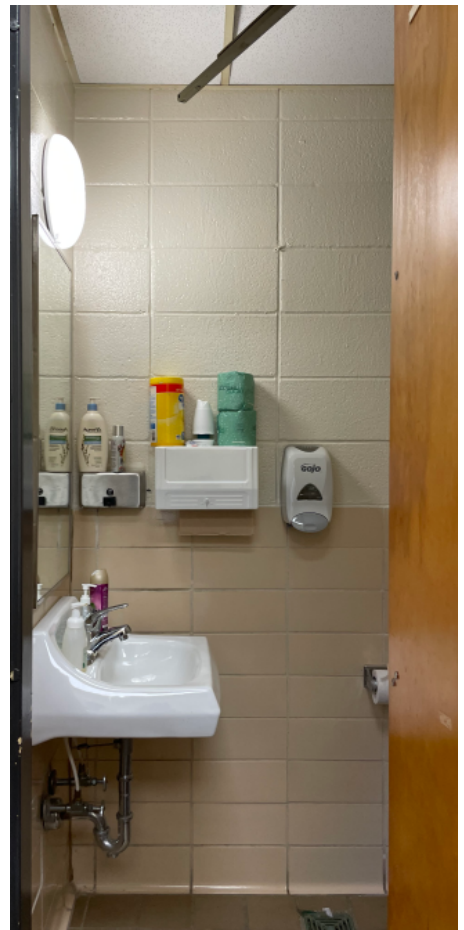
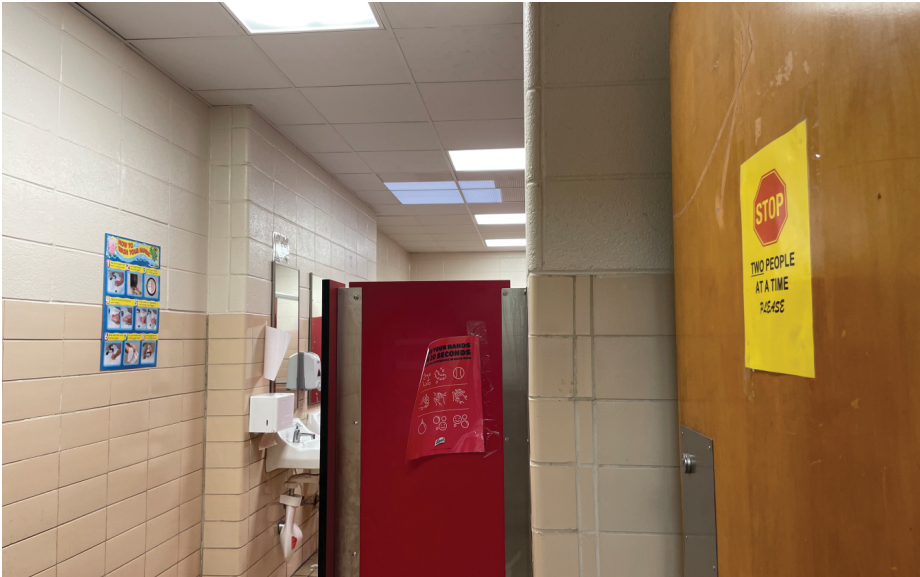
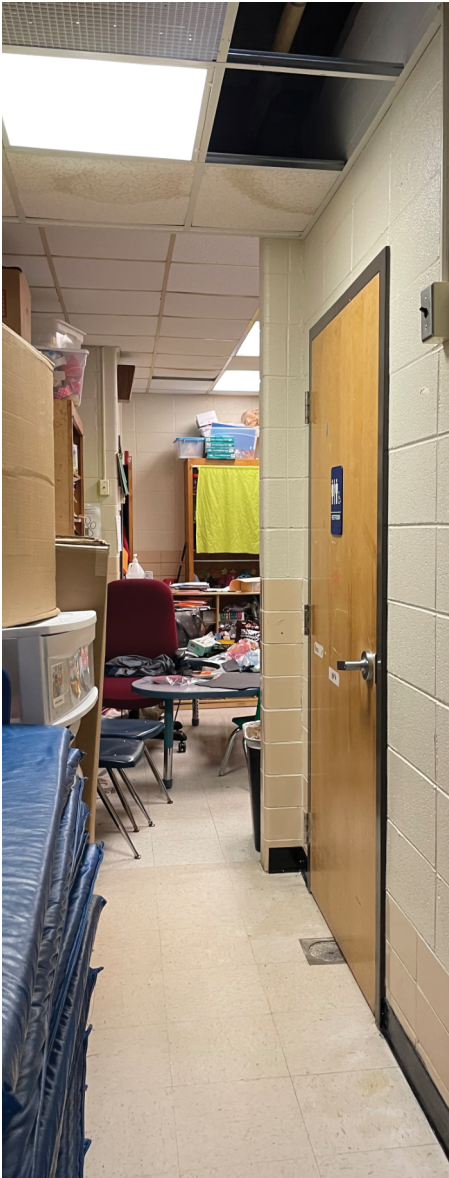
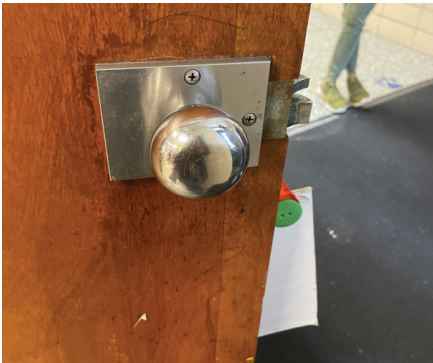
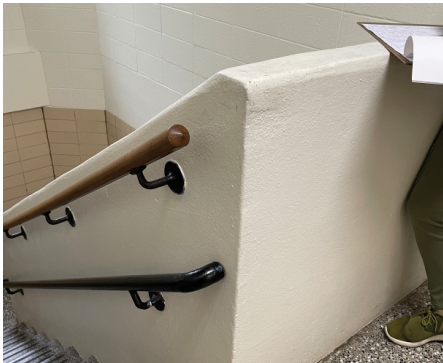
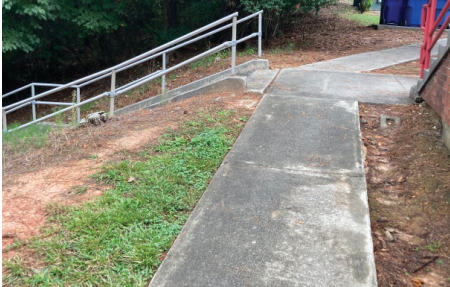
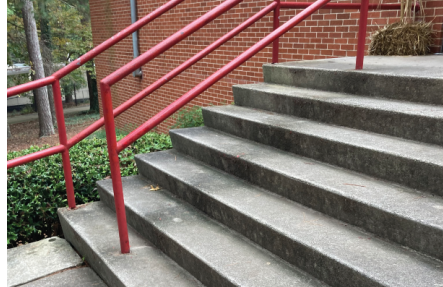
## v. ADA Compliance & Building Accessibility

- Interior and exterior handrails do not currently meet the standards for egress. Many handrails do not extend the proper distances at the top or bottom of staircases. There are multiple cases where the handrails are not continuous where required.
- Door hardware does not meet ADA requirements in multiple locations. Round door knobs should be switched out for levers.
- Door clearances do not meet ADA requirements in multiple locations.
- Exterior concrete ramps may need handrails depending on slope of ramp.
- Light switches are currently mounted too high to meet accessibility requirements.
- There is no ADA access to the stage in the cafetorium.
- Restrooms have multiple ADA concerns including turning radius and door clearances.

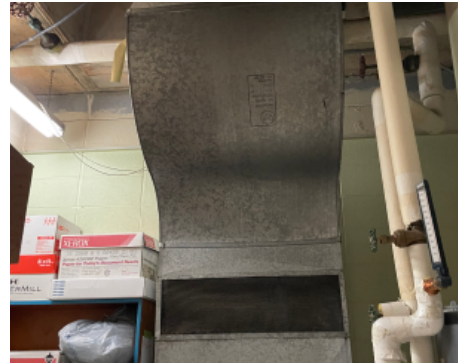
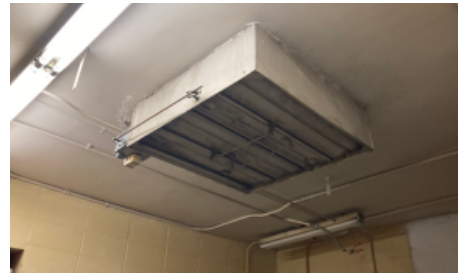
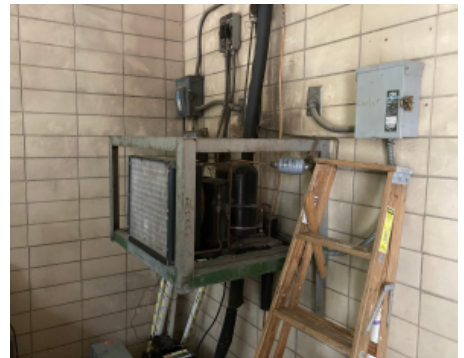
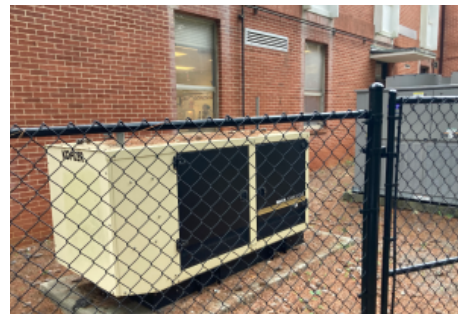
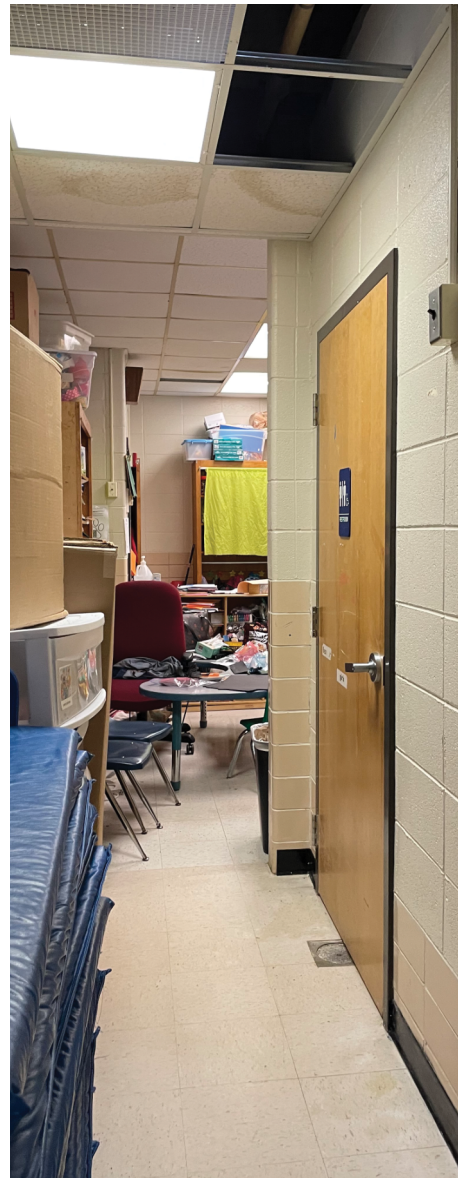
## vi. Mechanical Engineering Assessment

- HVAC:
  - The school is conditioned using an air-cooled chiller and boiler combination, which circulates chilled water/hot water to perimeter unit ventilators in most classrooms, ceiling mounted air handling units in several other spaces, and corridor air handling units. Kitchen ventilation and makeup is achieved using the cooking equipment exhaust hood along with a conditioned air makeup system.
- Fire Suppression:
  - Currently, the school has limited fire protection service, isolated to the stage of the cafeteria. The remainder of the school is not served by a fire protection system. A hydrant is located opposite the school on N. Peachtree Road directly in front of the front façade of the school.
- Security Entry:
  - Currently, the school lacks a security vestibule to meter persons entering the school.

a) Replacement of HVAC components throughout the building. This includes classroom unit ventilators, corridor fan coil units, kitchen ventilation and makeup air equipment, boiler(s) and pumps, air distribution. Exhaust systems for toilet rooms will need to be redesigned. Any redesign would include means for stopping moisture generation, namely insulation replacement on cold water hydronic systems above ceilings.

e) A thorough review of the kitchen envelope and humidity conditions may reveal the need for additional space conditioning and/or moisture barrier design. The dry storage area has been affected by local moisture producing occurrences, including the access to a crawl space high in the wall.

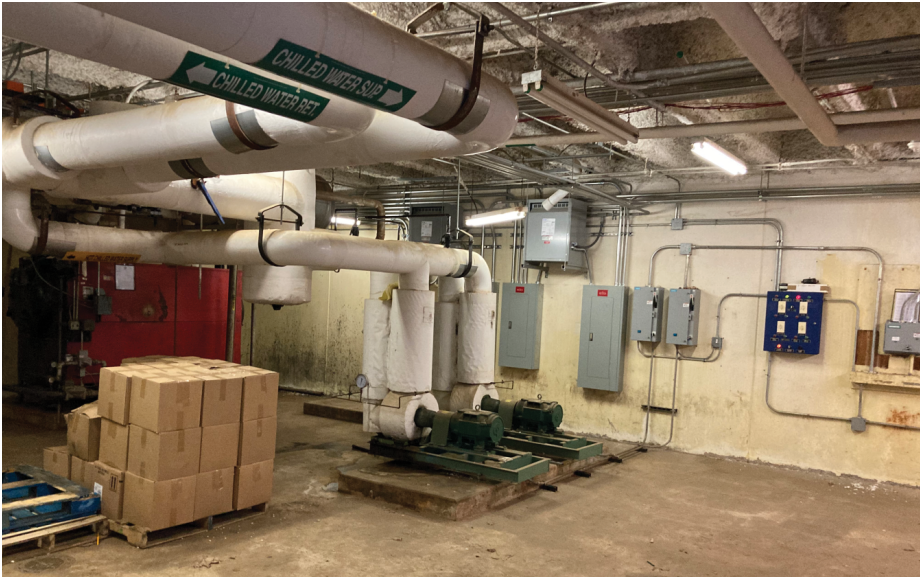
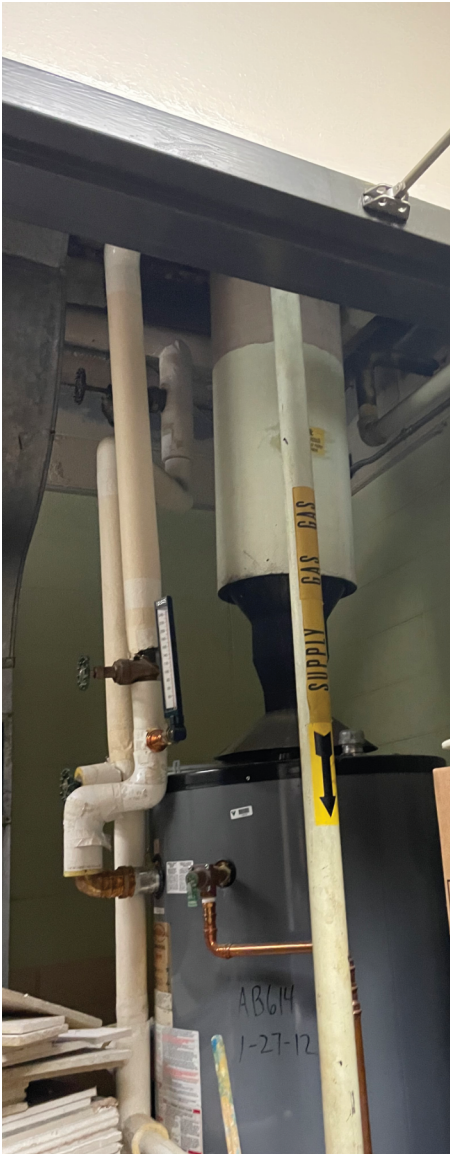
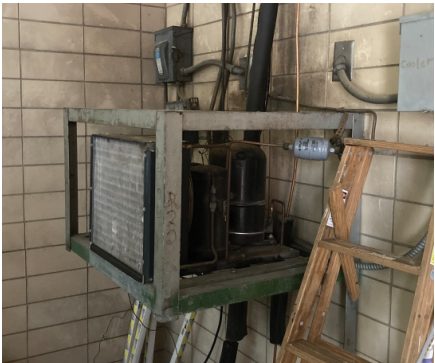
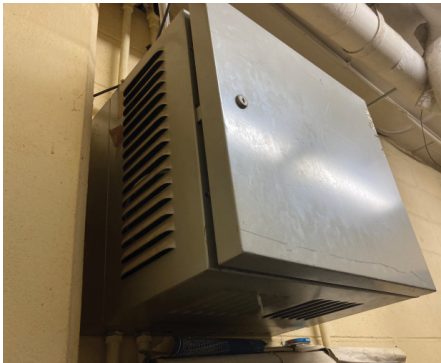
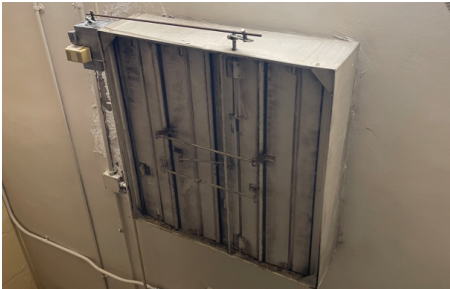
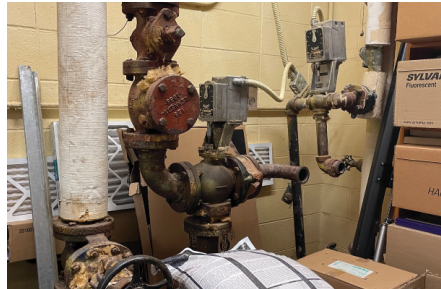
## vii. Electrical Engineering Assessment

- Power Distribution Systems
  - Existing electrical service is original to building and is in poor condition. Service is rated for 1000 Amps at 277/480 Volts, 3-Phase, 4-Wire.
  - Panelboards and transformers throughout building are original to building and in need of replacement.
  - Emergency generator was installed in 2013 and is in good condition.
- Lighting
  - Existing lighting in corridors, media center, cafeteria and administration are older LED retrofit.
  - Existing lighting in all other areas is existing fluorescent.
- Fire Alarm
  - Fire alarm system does not meet current life safety codes and is in need of replacement.

- Power Distribution
  - Upgrade electrical service and provide new panels and circuiting for HVAC system replacement.
- Lighting
  - Provide new LED lighting and controls throughout building to meet IECC. This includes new LED lighting in Gymnasium.
- Fire Alarm System
  - Provide new fire alarm system throughout building per DeKalb County design guidelines.
