MIDVALE ELEMENTARY SCHOOL

DeKalb County School District

Facility Assessment Report

JUNE 9, 2021

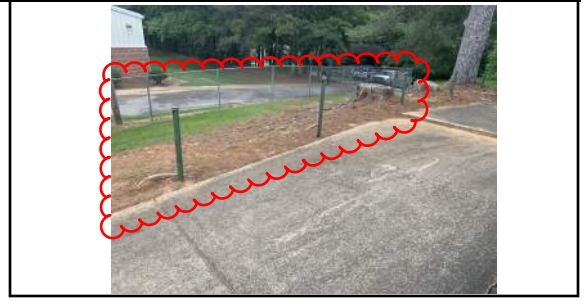
C01

North of service area, east side of building
-

Missing fencing/railing. Lack of ADA access to lower level of building/playfields/gym.
-

Provide switch back ADA ramp with landings and handrails not to exceed 1:12.

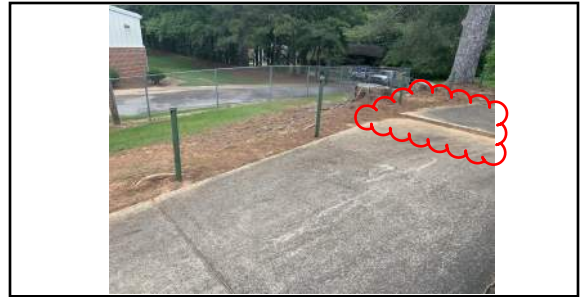
C02

North of service area, east side of building
-

Sidewalk settling, not ADA compliant
-

Replace section of sidewalk to be ADA compliant.

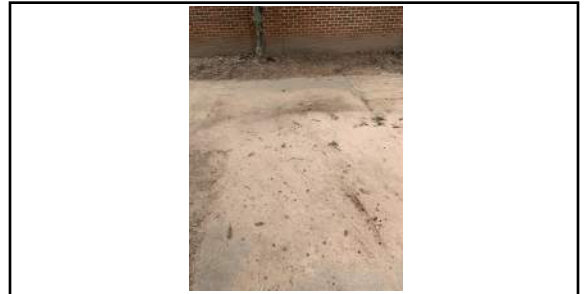
C04

Northeast of school, facing east wall of building
-

Drainage issue
-

Remove and replace sidewalk sections with positive slope away from sidewalk and buildings.

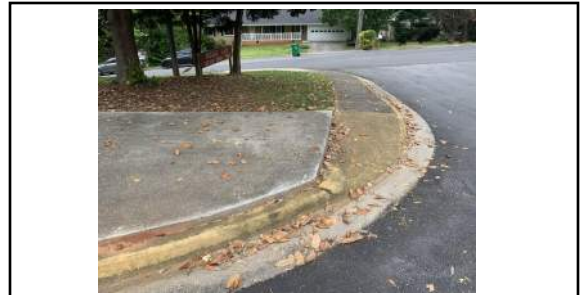
C05

East island of service area, facing Gleneagles Drive
-

Sidewalk and curb and gutter settling, not ADA compliant
-

Replace section of sidewalk and curb and gutter to be ADA compliant.

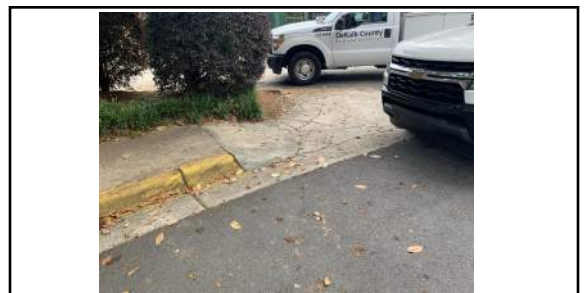
C06

South of service area
-

Cracked/broken concrete paving
-

Replace section of concrete paving

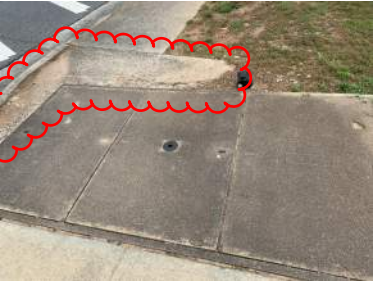
C09

South of building, west of entry drive off Midvale Road
-

Sidewalk and water vault top differential settling
-

Replace section of sidewalk and/or adjust water vault top to be ADA compliant.

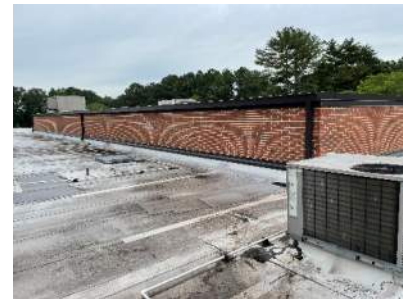
**S11**

Elevated Classroom Wall @ Roof
-

Minor settlement cracks in brick veneer
-

Monitor the previously made repair

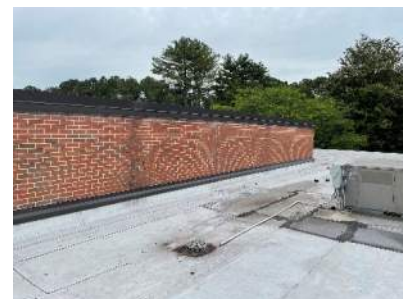
**S12**

Elevated Classroom Wall @ Roof
-

Minor settlement cracks in brick veneer
-

Monitor the previously made repair

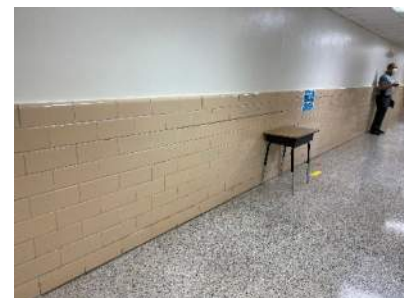
S18

Rear Classroom hallway at the concrete retaining wall

Mortar at bed joint has deteriorated

Clear the joint of loose mortar and replace the mortar in the joint

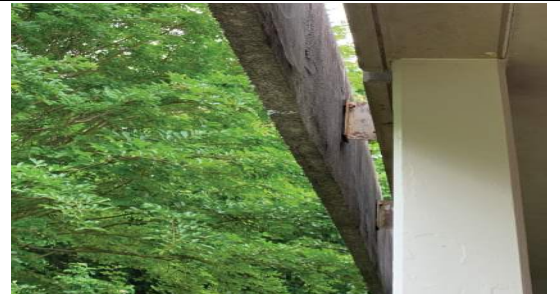
A01

*Front of school, signage.*
-

*Steel hanging system is rusted.*
-

*Recommend repairing and paint steel members.*

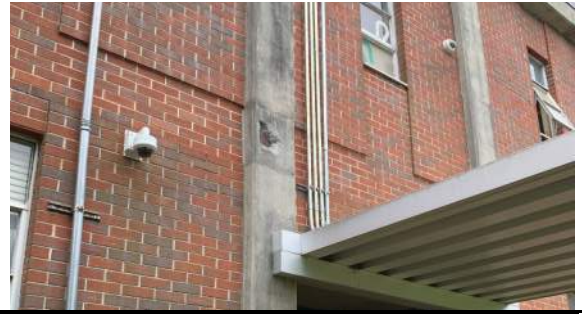
A02

*Building Exterior, sample photo.*
-

*Spalling concrete, damaged brick.*
-

*Repair concrete columns, pressure wash brick, point & re-tuck brick throughout building exterior.*

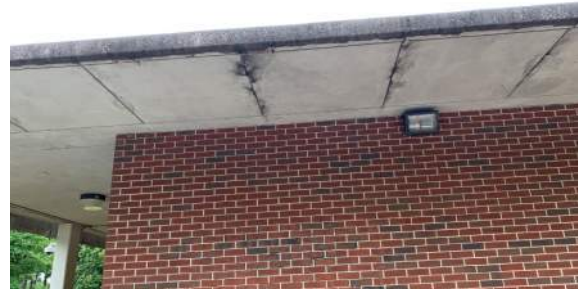
A03

*Building Exterior, Right of main Entry; roof overhang.*
-

*Water damaged soffit.*
-

*Recommend removing damaged stucco and re-applying a soffit finish and proper drip edge along roof overhang.*

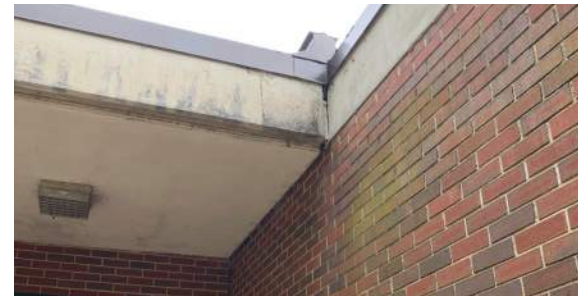
A04

*Building Exterior, Left of main Entry; roof overhang.*
-

*Water damaged soffit & brick.*
-

*Recommend removing damaged stucco and re-applying a soffit finish and proper drip edge along roof overhang.*

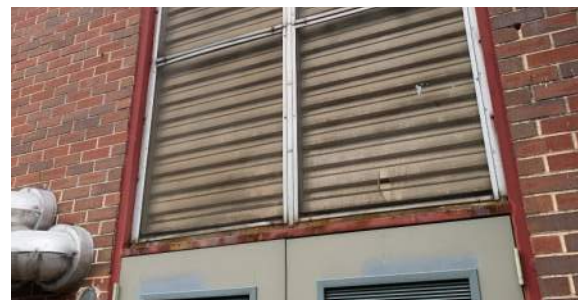
A05

*Exterior of main Mechanical Room.*
-

*Damaged brick and door frame.*
-

*Repoint brick; Replace Door & Louver frame.*

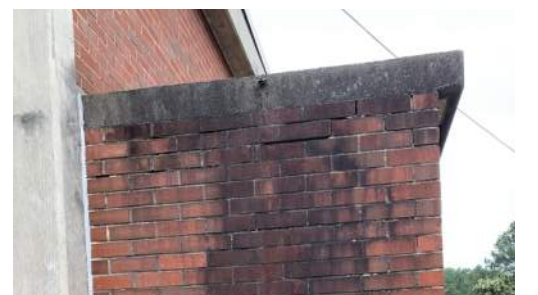
A06

*Exit to the right of main Mechanical Room.*
-

*Damage Brick.*
-

*Remove brick, repair roofing, replace brick or consider alternate exterior material.*

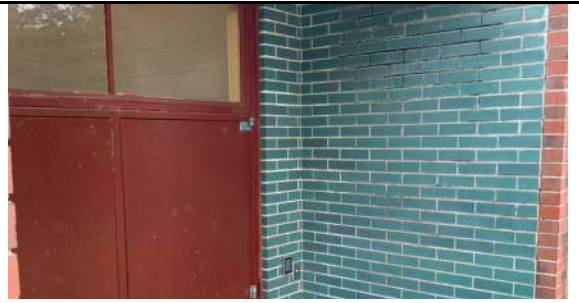
A07

Exit to the right of main Mechanical Room.

Damage Brick.

Remove brick, repair roofing, replace brick.

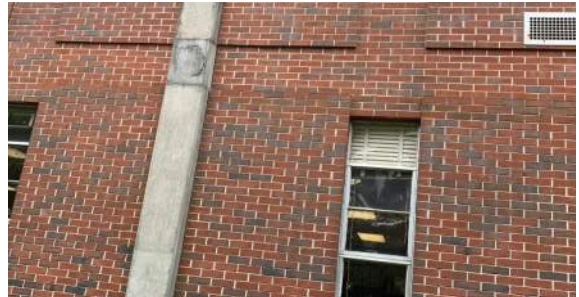
A08

Rear Exterior.

Damaged brick; spalling concrete columns.

Repair concrete columns, pressure wash brick, point & re-tuck brick throughout.

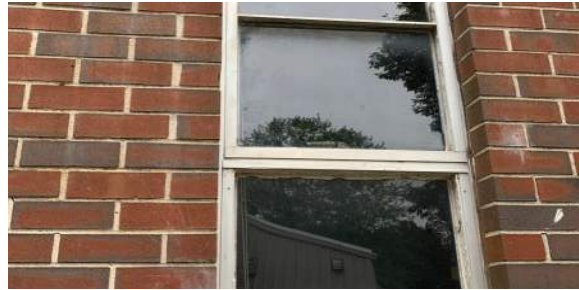
A09

Sample Exterior Window.

Single pane (non-energy efficient) & damaged windows.

Recommend replacing all windows w/ double-pane windows; replace flashing all around at opening, typical.

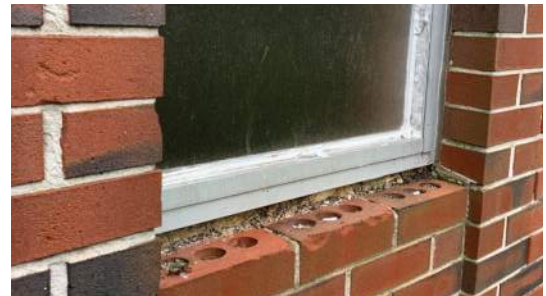
A10

Rear, Exterior.

Single pane (non-energy efficient) & damaged windows.

Replace sill; after window replacement.

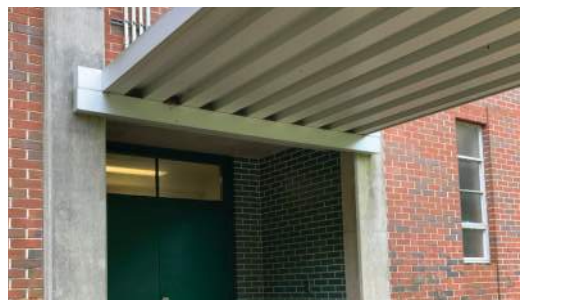
A11

Rear, Exterior Gym-level exit.

Spalling concrete, damaged brick. No ADA-compliant gym level access.

Repair concrete; clean brick; re-point all brick. Install new elevator and stair lobby.

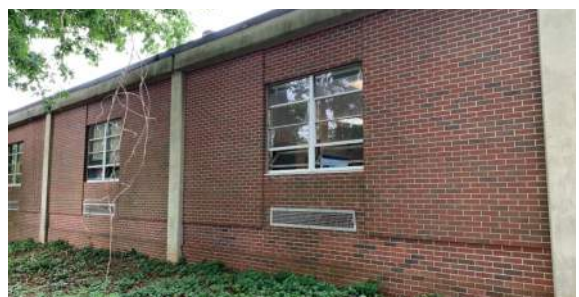
A12

Left of Main Entrance, Side, Exterior (Sample Location)

Single pane (non-energy efficient) & damaged windows. Damaged vent grilles.

Recommend replacing all windows w/ double-pane windows; replace flashing all around at opening, typical.

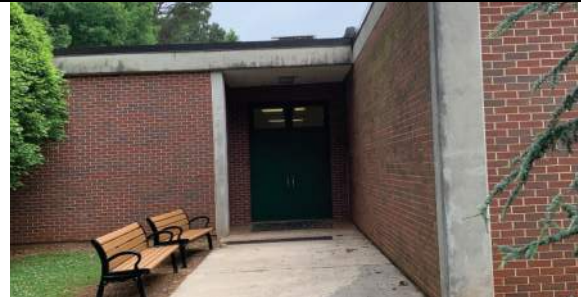
A13

*Building Exterior, Left of main Entry; roof overhang.*
-

*Water damaged roof overhang; missing guardrail at roof.*
-

*Clean & repair soffit; install code-compliant railing at roof.*

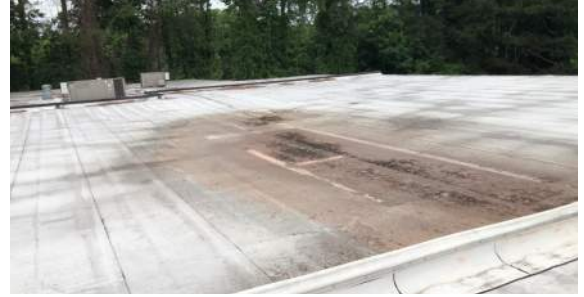
A14

*Roof, sample photo.*
-

*Evidence of water ponding after rain; poor roof drainage, non-sloped roofing areas & damaged roofing; no railings.*
-

*Recommend removing existing roof and re-roof to include proper tapered insulation; install guardrails at roof edges.*

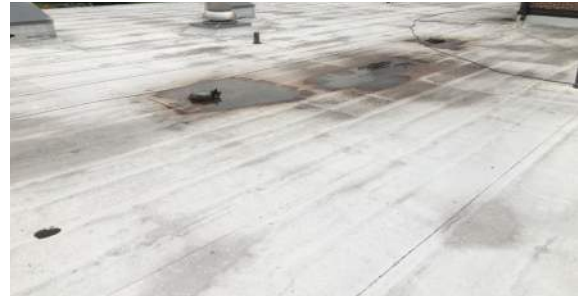
A15

*Roof, sample photo.*
-

*Water is ponding after rain; poor roof drainage, non-sloped roofing areas & damaged roofing.*
-

*Recommend removing existing roof and re-roof to include proper tapered insulation.*

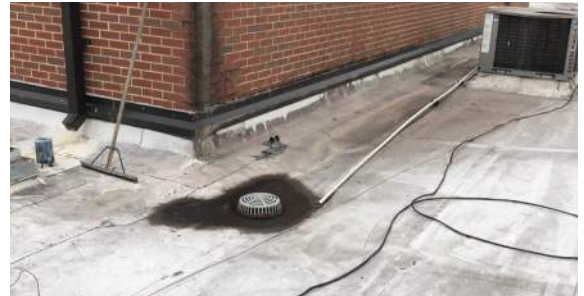
A16

*Roof, sample photo.*
-

*Water is ponding around roof drain; poor roof drainage, non-sloped roofing areas & damaged roofing.*
-

*Recommend removing existing roof and re-roof to include proper tapered insulation and new roof drains.*

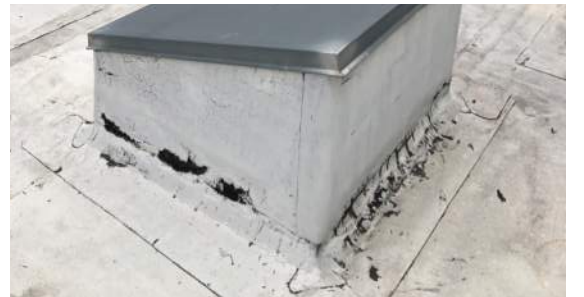
A17

*Roof, sample photo.*
-

*Damaged roofing, base flashing & sealant is deteriorated.*
-

*Remove existing roof and re-roof to include proper tapered insulation, new flashing (complete roof system).*

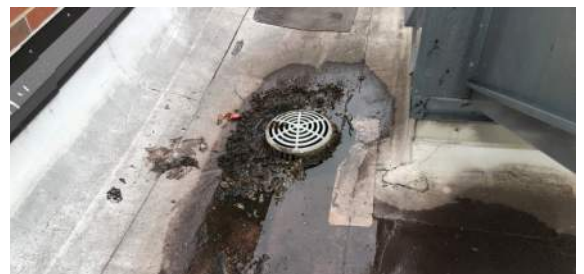
A18

*Roof, sample photo.*
-

*Water is ponding around roof drain; poor roof drainage, non-sloped roofing areas & damaged roofing.*
-

*Recommend removing existing roof and re-roof to include proper tapered insulation and new roof drains.*

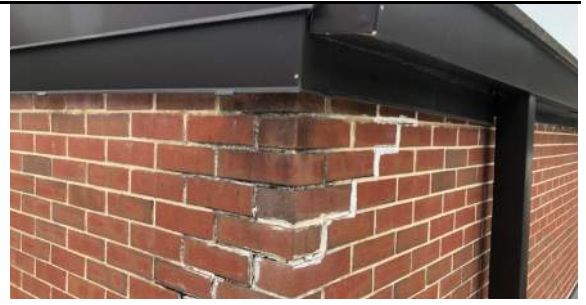
A19

*Roof, sample photo.*
-

*Water damaged brick & grout at coping / gutter.*
-

*Recommendation to pressure wash brick, point & re-tuck brick throughout; reflash parapets & replace coping.*

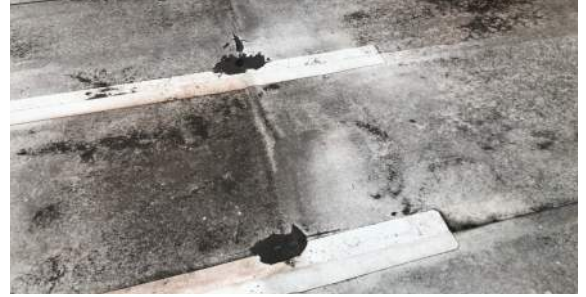
A20

*Roof, sample photo.*
-

*Dirty / damaged / non-sloping roof, ponding areas; deteriorating bonding adhesive.*
-

*Recommend removing existing roof and re-roof to include proper tapered insulation.*

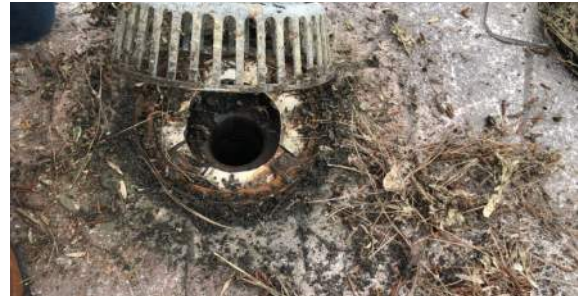
A21

*Roof, sample photo.*
-

*Roof drain is clogged, water is ponding.*
-

*Recommend removing existing roof and re-roof to include proper tapered insulation and new roof drains.*

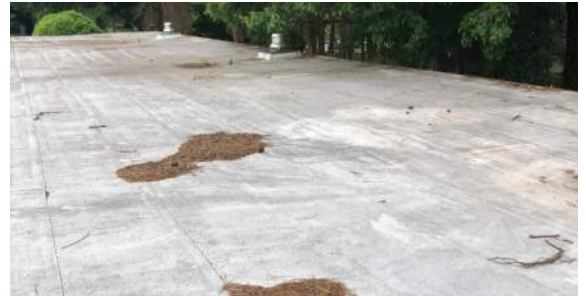
A22

*Roof, sample photo.*
-

*Overgrown trees, dirty / damaged / non-sloping roofing.*
-

*Recommend removing existing roof and re-roof to include proper tapered insulation. Trim adjacent tree limbs.*

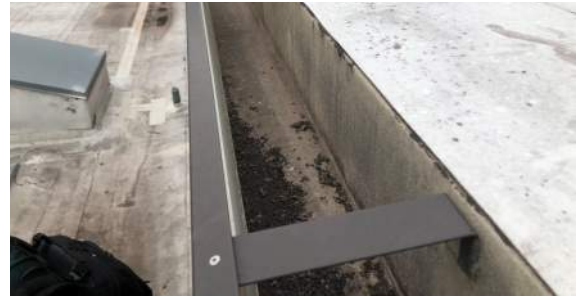
A23

*Roof gutter, sample photo.*
-

*Dirt collected in gutter, clogging downspouts.*
-

*Install gutter guards.*

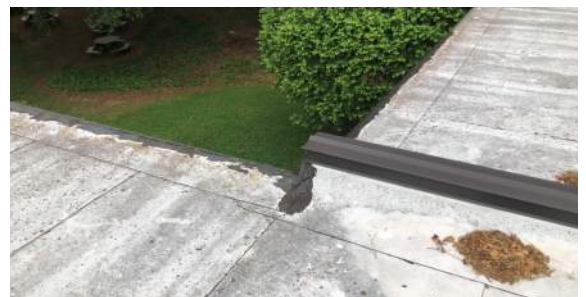
A24

*Roof area, west portion of building.*
-

*Damaged roofing; missing edge coping & fall protection.*
-

*Recommend removing existing roof and re-roof to include proper tapered insulation; install fall protection.*

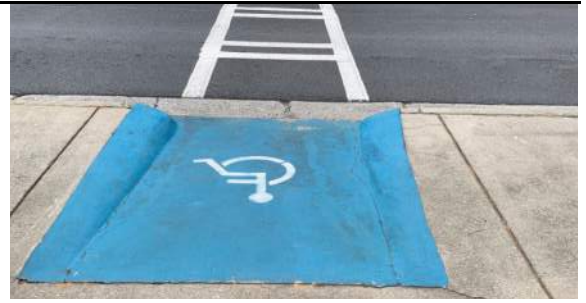
A25

Front of school.
-

ADA curb cut missing flared sides; curb transition is too abrupt.
-

Remove portion of sidewalk and install ADA-compliant flared sides.

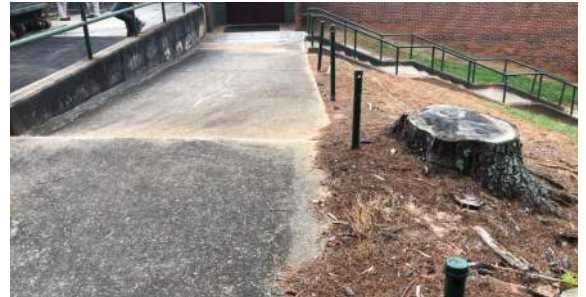
A26

East exterior, to the right of main Mech. Room.
-

Damaged sidewalk; no guardrail at elevation drop between sidewalk and utility yard.
-

Repair sidewalk and install guardrail at portions of wall exceeding 30" high.

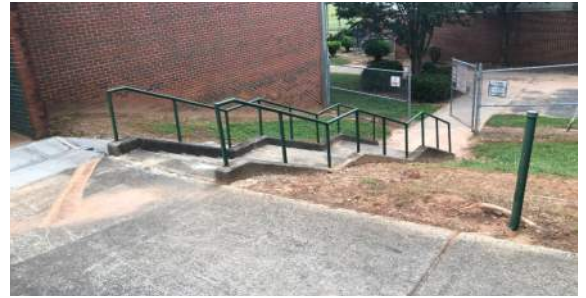
A27

East exterior, to the right of main Mech. Room.
-

Damaged sidewalk, no ADA-access to lower level.
-

Repair sidewalk, install new ADA-compliant ramp to connect all levels of the school.

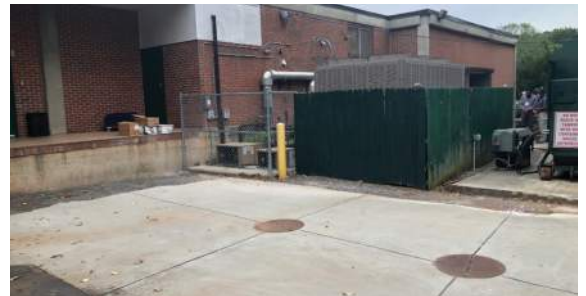
A28

East exterior, Loading area / Utility Yard.
-

Rusted / damaged fencing.
-

Recommend installing new aluminum, louvered fencing all around mechanical equipment.

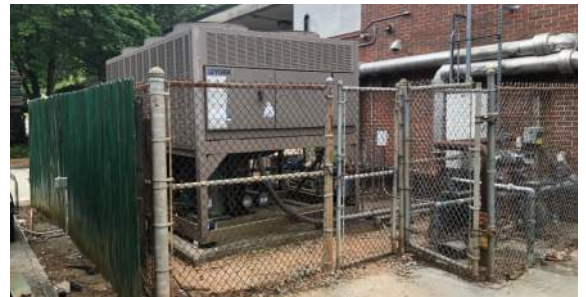
A29

East exterior, Loading area / Utility Yard.
-

Rusted / damaged fencing.
-

Recommend installing new aluminum, louvered fencing all around mechanical equipment.

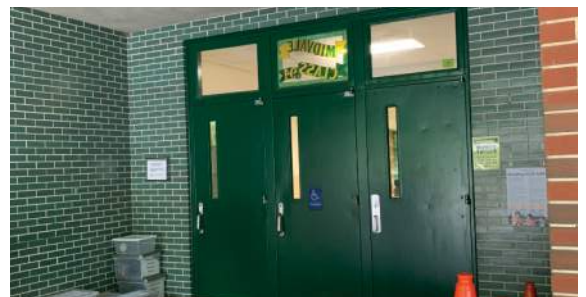
A30

Front - Main School Building Entrance.
-

Doors & openings are not ADA compliant.
-

Install set of power-assist double doors.

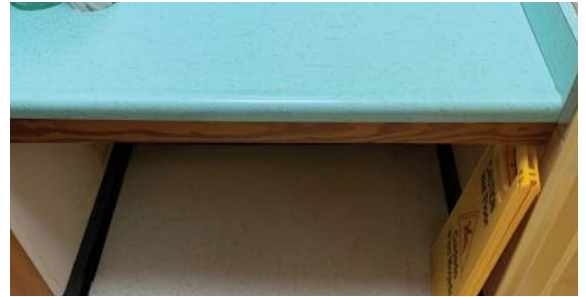
A32

Women's RR @ Workroom.
-

Vanity and Toilet room do not meet ADA req's.
-

Demolish interior walls & doors and reconfigure Restroom to meet ADA dimensions & clearances.

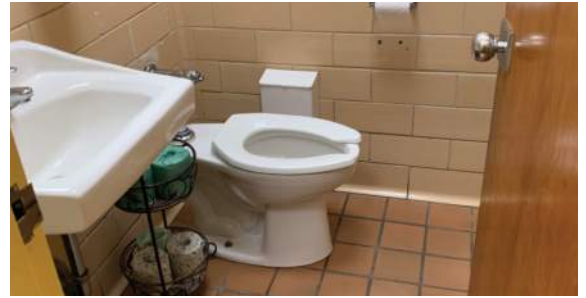
A33

Women's RR @ Workroom.
-

Vanity and Toilet room do not meet ADA req's.
-

Demolish interior walls & doors, reconfigure to meet ADA dimensions & clearances.

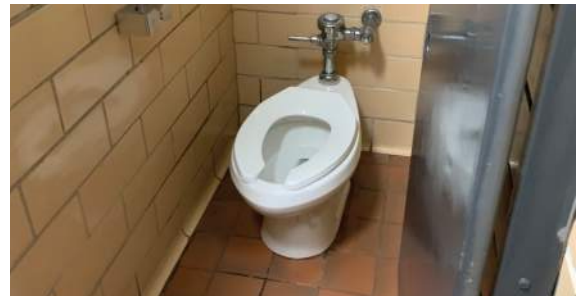
A34

Typical Special Education shared RR
-

Toilet rooms do not meet ADA req's; missing Lavatory.
-

Demolish interior walls & doors, reconfigure to meet ADA dimensions & clearances.

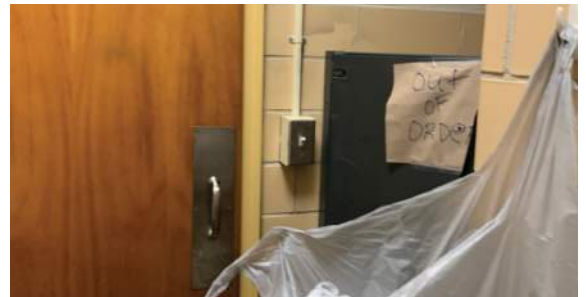
A35

Typical Special Education shared RR
-

Toilet rooms do not meet ADA req's; missing Lavatory.
-

Demolish interior walls & doors, reconfigure to meet ADA dimensions & clearances.

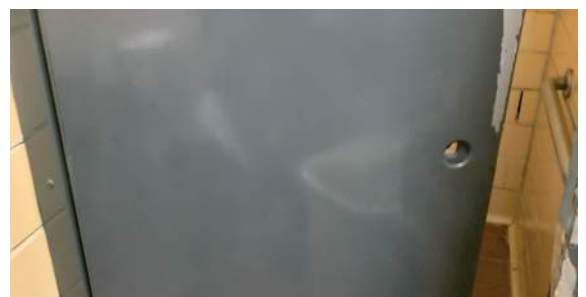
A36

Typical Special Education shared RR
-

Toilet rooms do not meet ADA req's; missing Lavatory.
-

Demolish interior walls & doors, reconfigure to meet ADA dimensions & clearances.

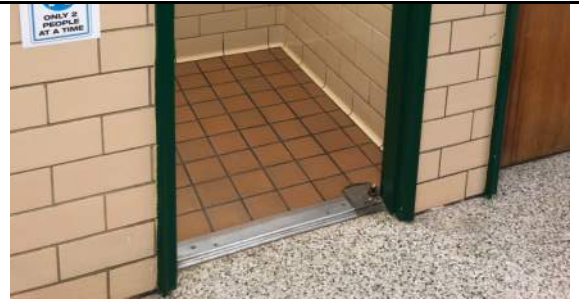
A37

Children's gang RR entrance, sample photo.
-

Non-ADA compliant threshold.
-

Remove threshold completely or install a shallower threshold to be ADA-compliant.

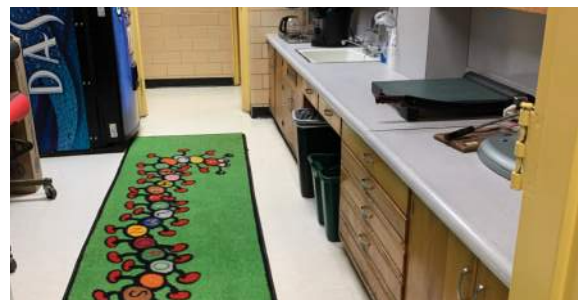
A41

Teach Workroom millwork.
-

Non ADA-compliant millwork; no knee clearance under sink & counter is too low.
-

Install new millwork with ADA-compliant knee clearance at sink.

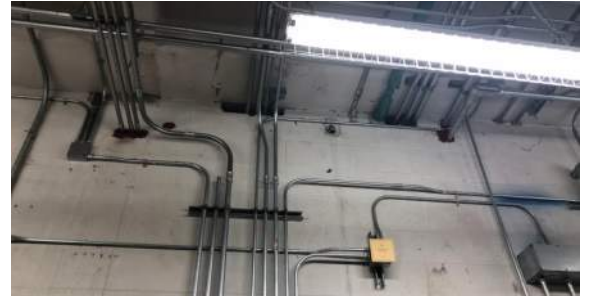
A50

Missing fire sealant in rated wall.
-

Install fire stopping around gaps at rated wall.

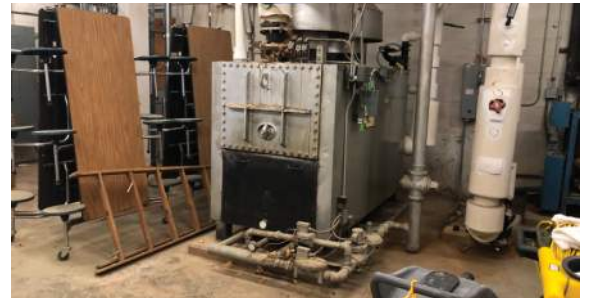
A51

Storage of loose items; fire hazard.
-

Remove miscellaneous loose items.

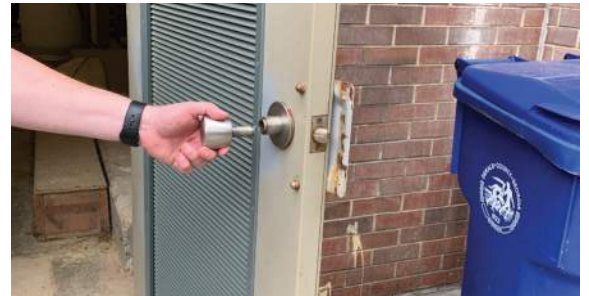
A52

Broken and non-ADA compliant door hardware.
-

Install new ADA-compliant door hardware.

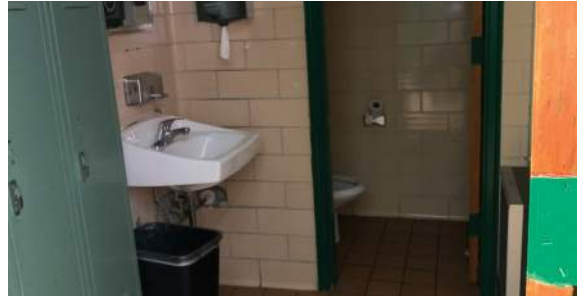
A56

Missing fire sealant in rated wall.
-

Install fire stopping around gaps at rated wall.

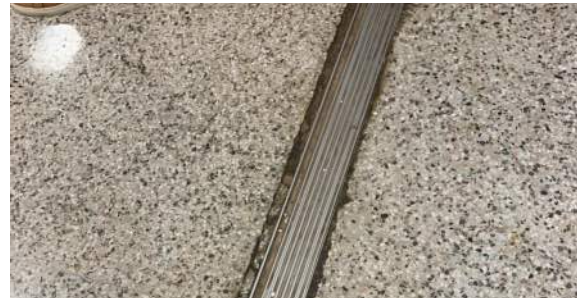
A58

Chipped / broken flooring and / or sealant joint.
-

Replace EJ cover.

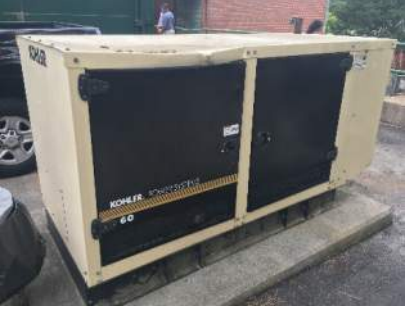
<p>E01</p> <ul style="list-style-type: none">

Top of generator is damaged.

Recommend replacing generator top.

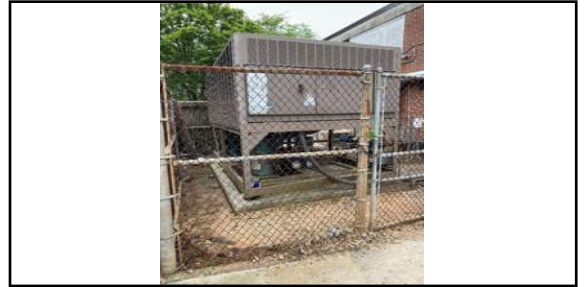
**M02**

Chiller – manufactured in 2014 – has refrigerant leaks.

Recommend replacement due to maintenance issues.
