PHASE I ENVIRONMENTAL SITE ASSESSMENT & RISK HAZARD ANALYSIS

CLAIRMONT PRESBYTERIAN PROPERTY

2020 CLAIRMONT ROAD
DECATUR, GEORGIA 30033

MARCH 27, 2023

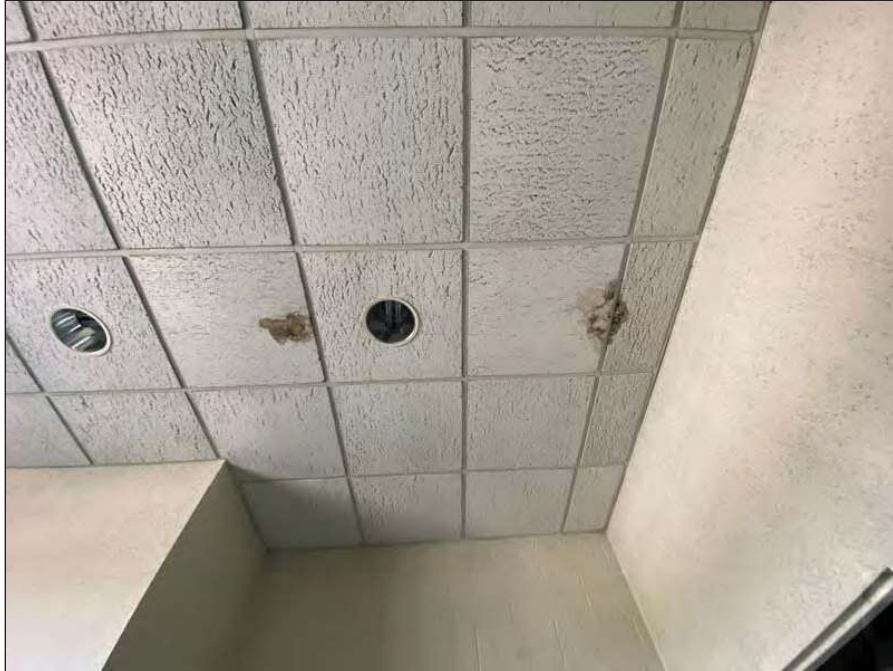
Staining and apparent mold associated with water damage was located on various ceiling tiles located throughout Mulligan Hall and the Family Life Center. Additional mold could be present in areas not observed.

25 - Potential mold and water damage on the first floor

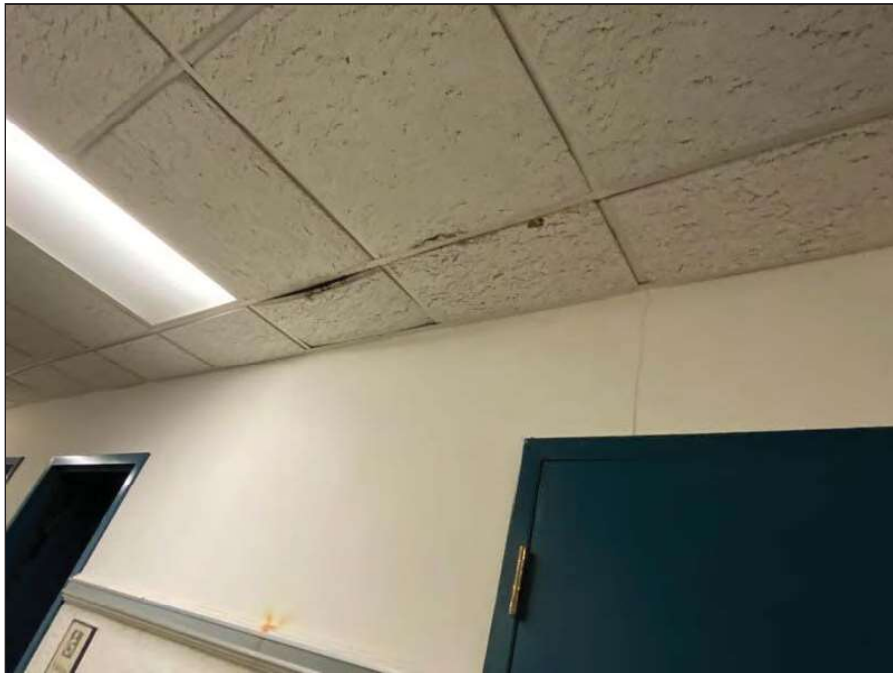
30 - Potential mold and water damage on the second floor

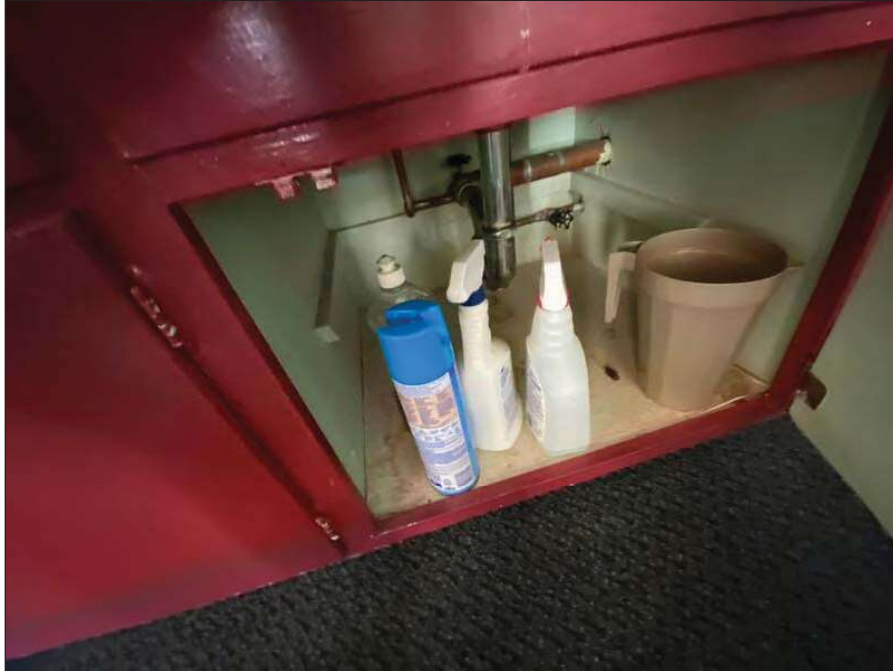
Containers of household cleaners and cans of paint were located throughout Mulligan Hall and the Family Life Center, in bathrooms, storage closets, janitors closets, and classrooms. Staining was not observed on the containers or cans and the surfaces in the vicinity of the containers and cans.

31 - Household cleaners in a classroom on the second floor

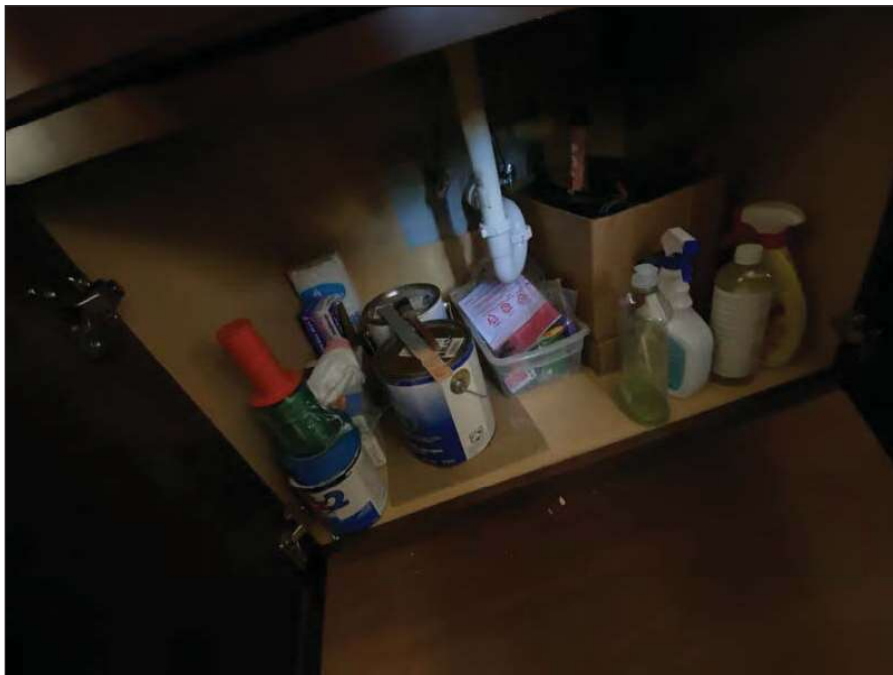
40 - Household cleaners and cans of pain in the bathroom

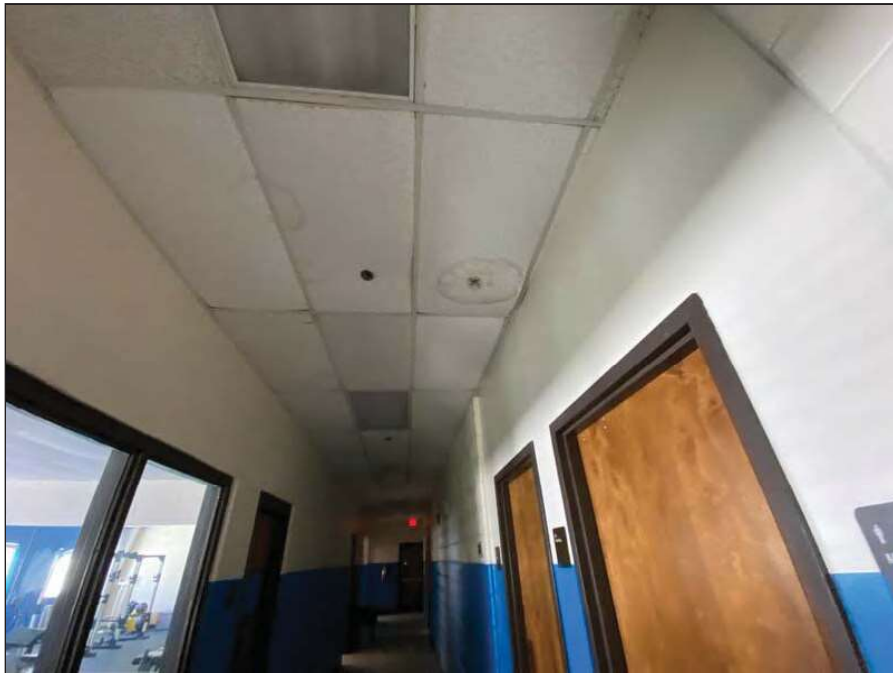
46 - Water damage on the first floor

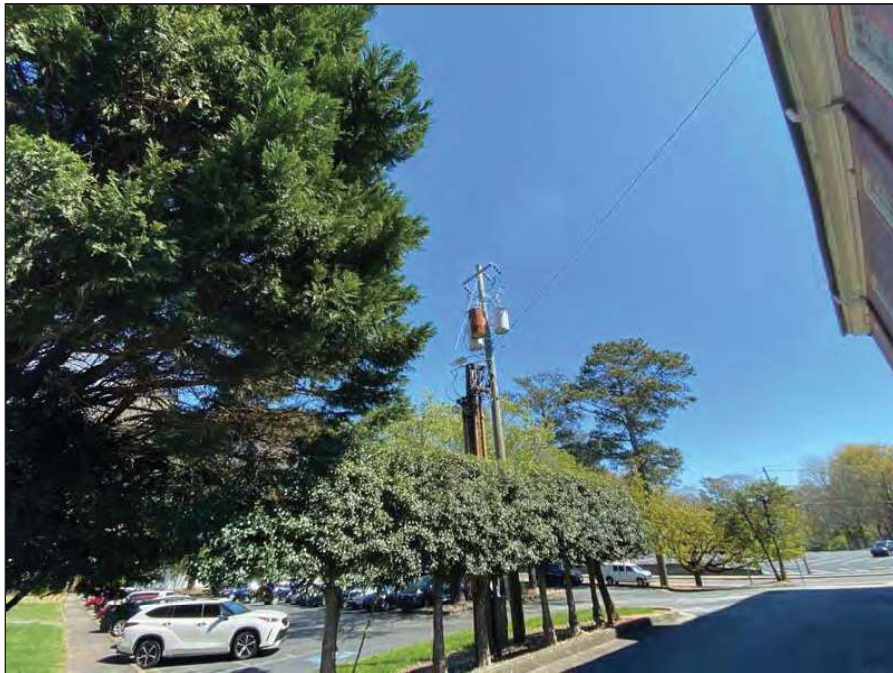
Asphalt parking areas, landscaped areas, and playgrounds are present on the exterior portions of the property. A detention pond is located on the northern portion and a gazebo is located on the northwestern portion. Two solid waste dumpsters were located on the southeastern portion. One is used for solid waste and the other is used for recycling. Three pole-mounted transformers were observed at the site. The transformers are owned and maintained by Georgia Power. ECS did not observe evidence of leakage or staining in the vicinity of the transformers.

56 - Pole-mounted transformers
