GRINNELL NEWBURG COMMUNITY SCHOOL DISTRICT

DAVIS ELEMENTARY SCHOOL - FAILING MASONRY STUDY REPORT

CMBA # 24216
NOVEMBER 07, 2024

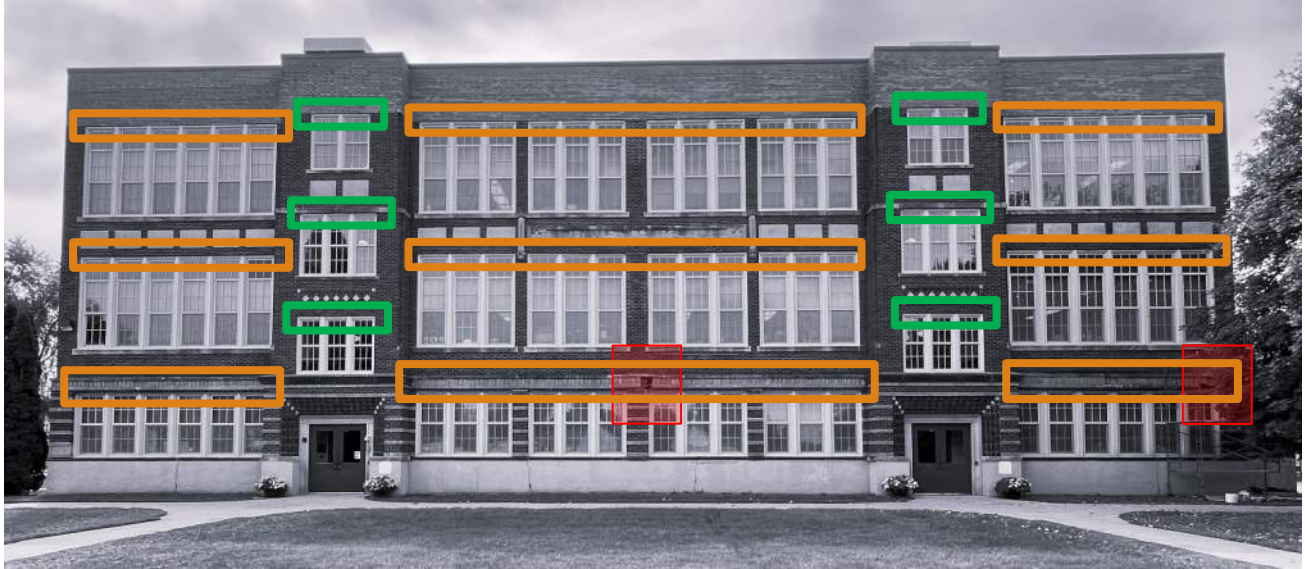
Each façade was evaluated for masonry failure. The most extensive failures are located on the north and east façades, at the window headers and lintels. The brick veneer appears to be crumbling at the top header course and beginning to protrude from the concrete beam due to years of continuous weather saturation (Figure 2 & 3). It was determined after brick removal that the existing steel angle lintels are intended to be anchored to the perimeter concrete beams. In most cases the angles are anchored to this beam, however, at one of the locations where brick was removed (Figure 2), the angles do not anchor into the concrete. All the steel angles are deteriorating to some degree, several are severely deteriorated. This deterioration is causing the brick veneer to sag and fail. Where the lintels are not attached to the beams this sagging and failure is even more apparent (Figure 5). Through-wall flashing was not found within system. This was typical in the era when the building was constructed and explains why water is penetrating the wall assembly.

Figure 1: North Façade – Masonry failure locations; Red highlights indicate areas of investigation

- Recommended large opening repairs: Remove existing exterior wythe of brick and associated steel angle lintels, replace lintels with hot-dipped galvanized angles and fasteners, install flashings to protect lintels, install sheet metal flashing above belt courses, sills and projected courses, reinstall / replace brick to match existing coursing and patterns.

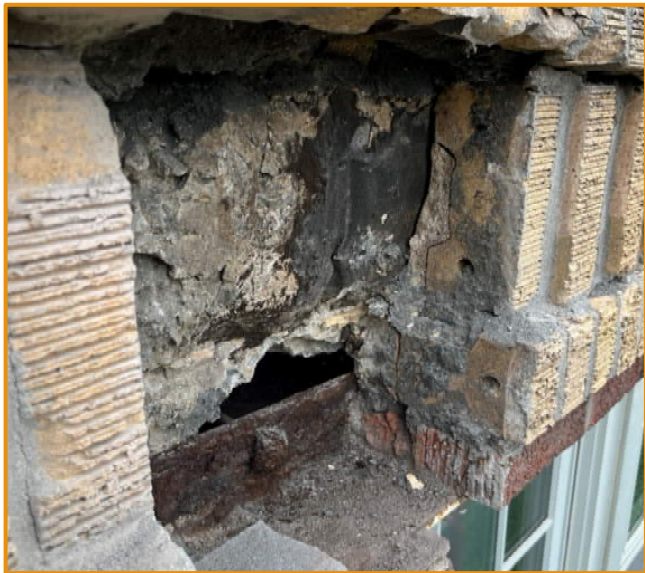
Figure 2: Masonry Failure – North center lintel at library / no concrete beam attachment

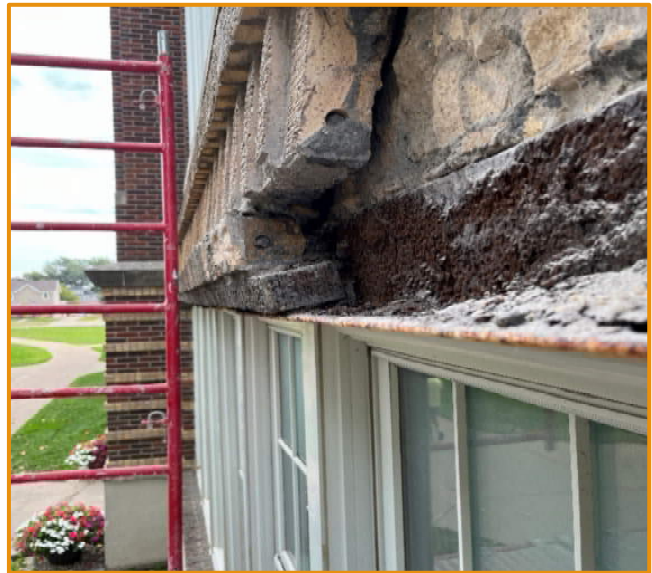
Figure 3: Masonry Failure – Northwest protruding brick; lintel deteriorating

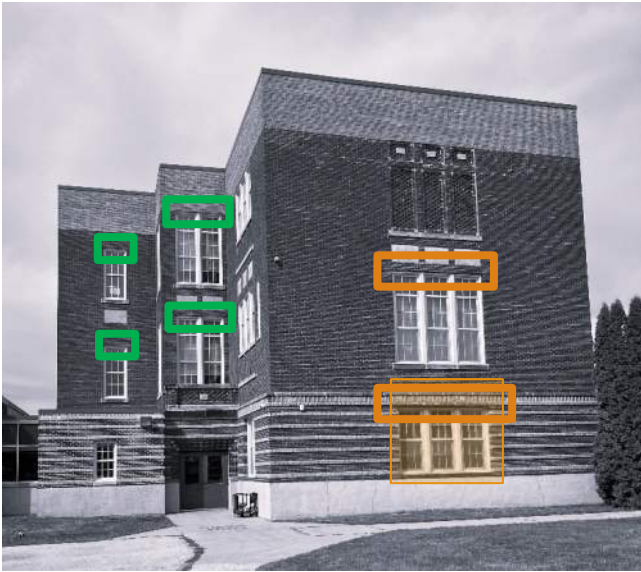
Figure 4: East Façade – Masonry failure locations
Orange highlights indicate areas of investigation

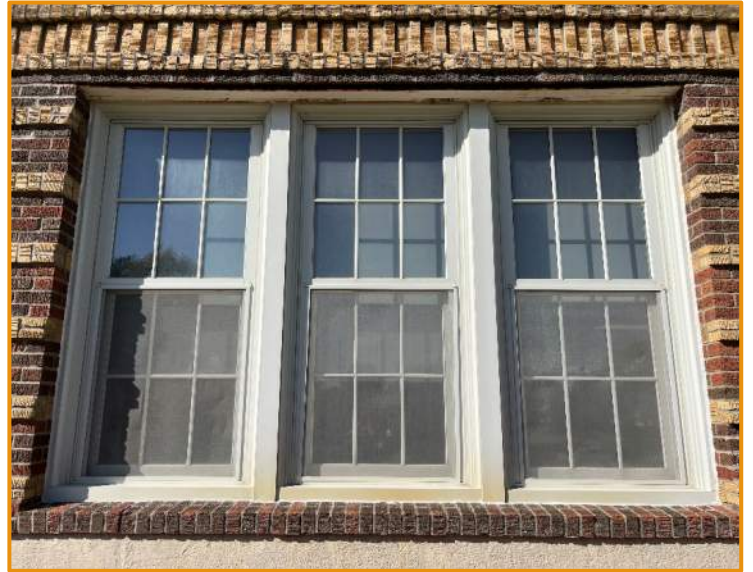
Figure 5: Masonry failure – East sagging brick above window; crumbling brick

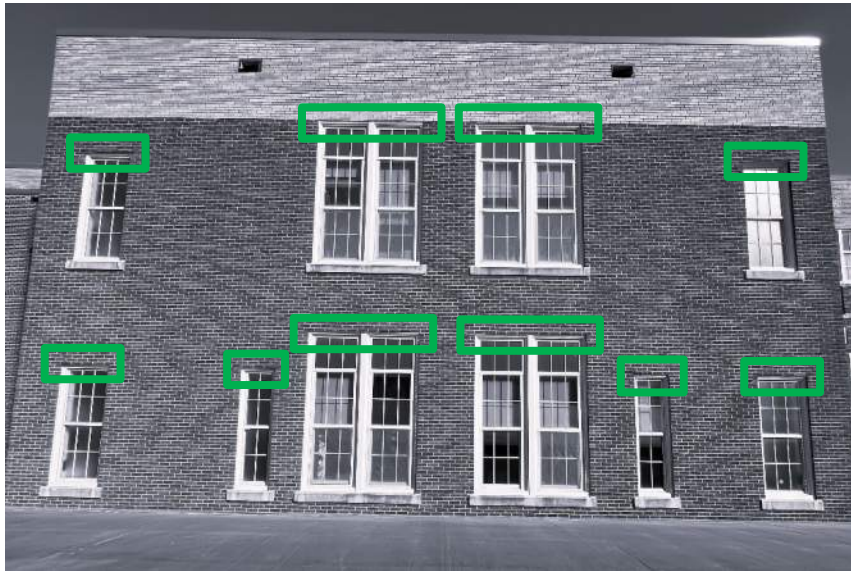
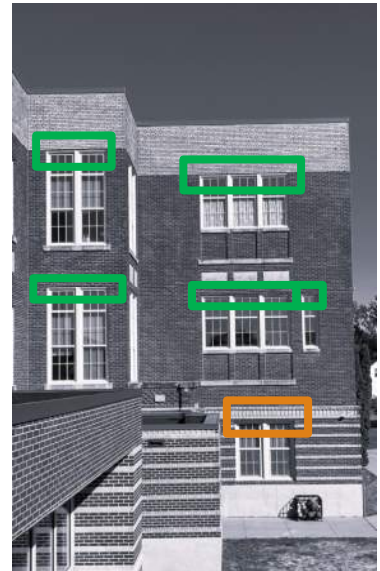
Figure 6 & 7: South/Southeast Façade – Masonry failure locations

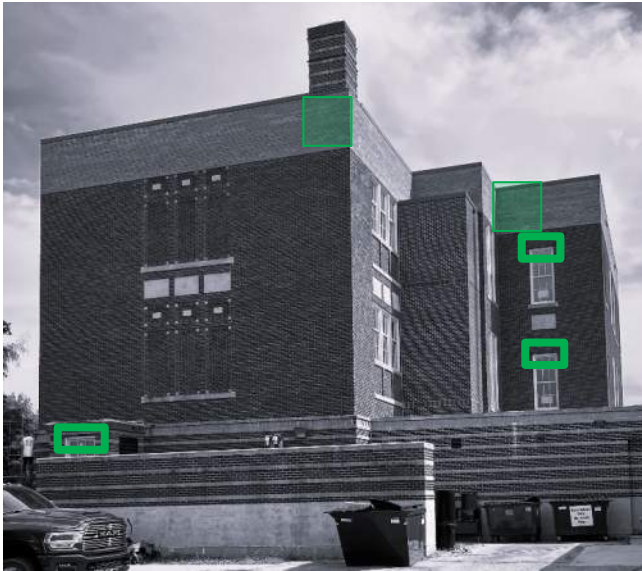
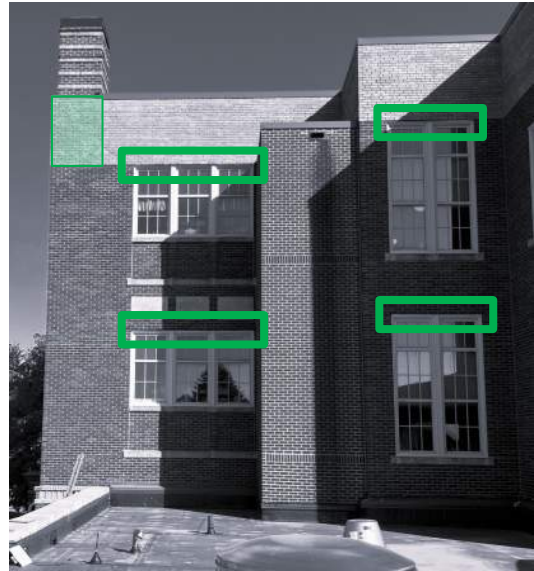
Figure 8 & 9: West/Southwest Façade – Masonry failure locations
Green highlights indicate area of investigation

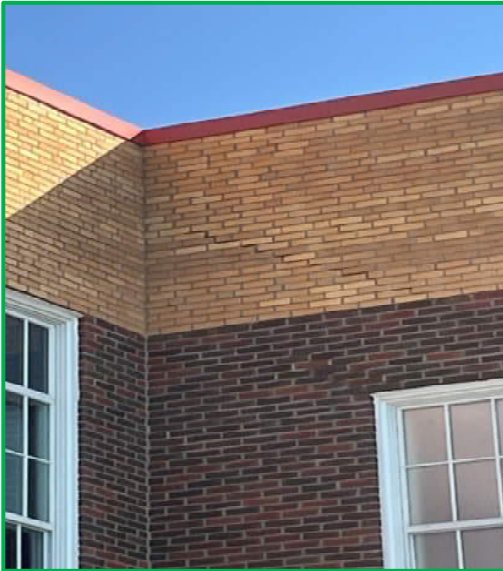
Additionally, there are locations on each façade where the masonry veneer and mortar joints are cracking in a stair-step pattern indicative of settling or load shift issues. There are also locations of potential settling occurring at the north, east and west portions of the building (Figure 10 & 11) where the exterior plaster veneer is cracking below the windows on the main level.

Figure 10: Masonry failure - West
stair stepping cracking

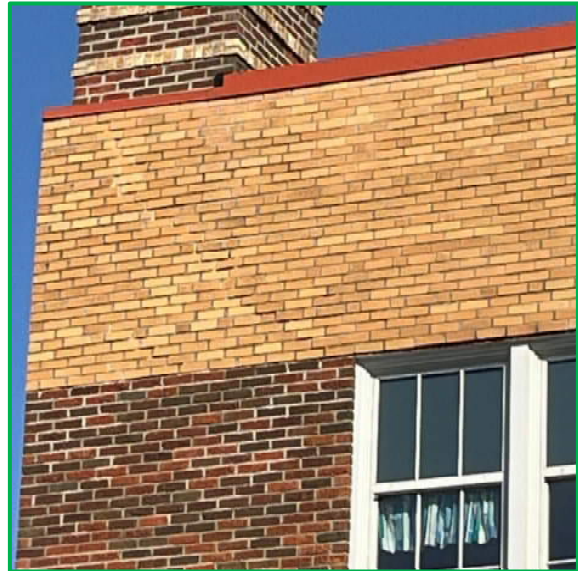
Figure 11: Masonry Failure - Southwest
Stair stepping cracking

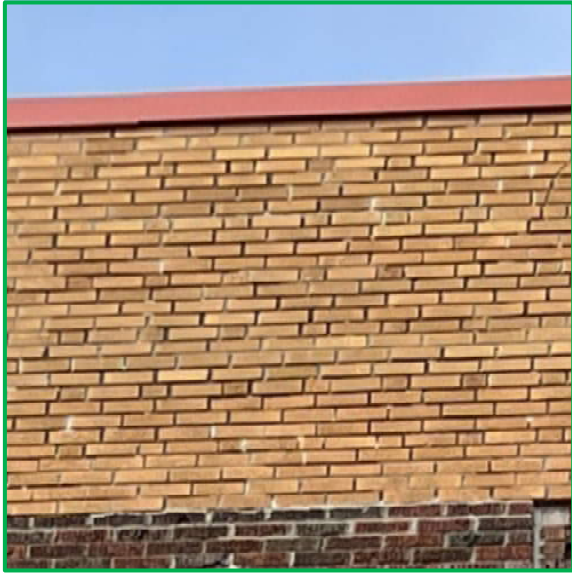
Figure 12: Masonry Failure – Beige Brick
Tuckpointing – priority 2

- Small opening repairs: Remove existing exterior wythe of brick and associated steel angle lintels, replace lintels with hot-dipped galvanized angles and fastener, install flashings to protect lintels, sills and projected courses, reinstall / replace brick to match existing coursing and patterns.
- Tuck pointing for beige brick (Figure 12)

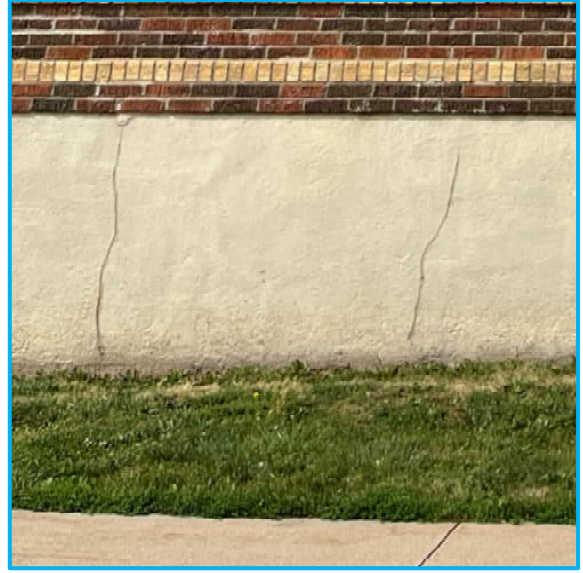
Figure 13: Masonry Failure – See Reference Floor Plan
plaster veneer cracking – priority 3

- Patch and repair of plaster veneer (Figure 13)
