## **Report of Findings, Recommendations and Probable Cost**

Re: Colusa USD District Office Building Stabilization  
Colusa Unified School District  
Project No.: 2023-003.00

## Report of Findings

Subject: **Colusa USD District Office**  
745 10<sup>th</sup> Street  
Colusa, CA  
Point 2 Job No.2023-011

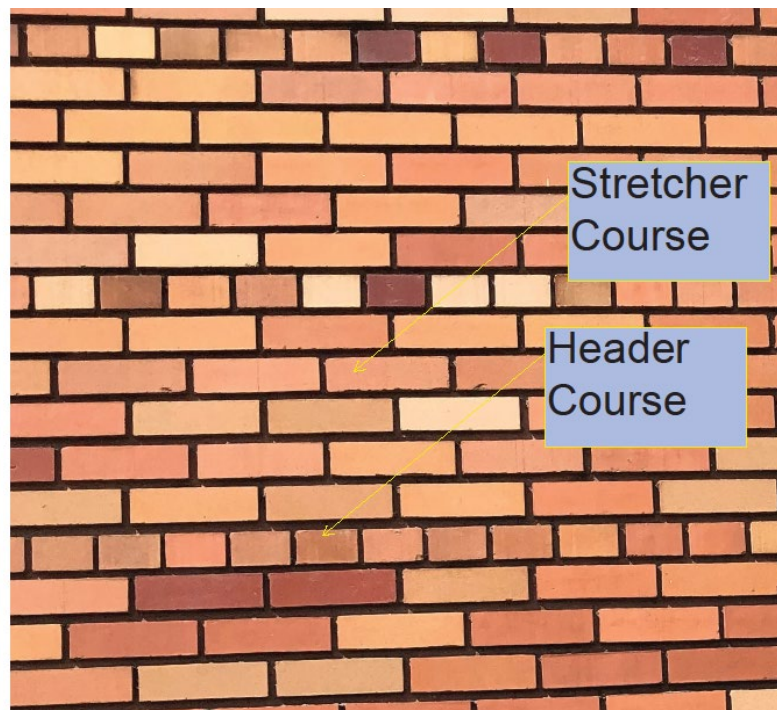
The URM building was a common construction method of the 1920's. The walls are constructed of 2 or 3 layers (wythes) of masonry brick, stacked, with mortar between the bricks in a pattern called "American Bond". The stretcher courses are typical, and they run parallel with the wall. The header courses are bricks turned inward, extend into the thickness of the wall, and are typically located at each 6<sup>th</sup> row. See the photo below:

The existence of the header course blocks the ability to have continuous vertical gap between the wythes for grout and rebar, so it is likely that reinforcing steel is minimal or does not exist in these walls.
