Needs Analysis Study Session

Los Gatos-Saratoga
UNION HIGH SCHOOL DISTRICT

SARATOGA HIGH SCHOOL SIGNIFICANT RESULTS & IMMEDIATE NEEDS

LOS GATOS HIGH SCHOOL SIGNIFICANT RESULTS & IMMEDIATE NEEDS

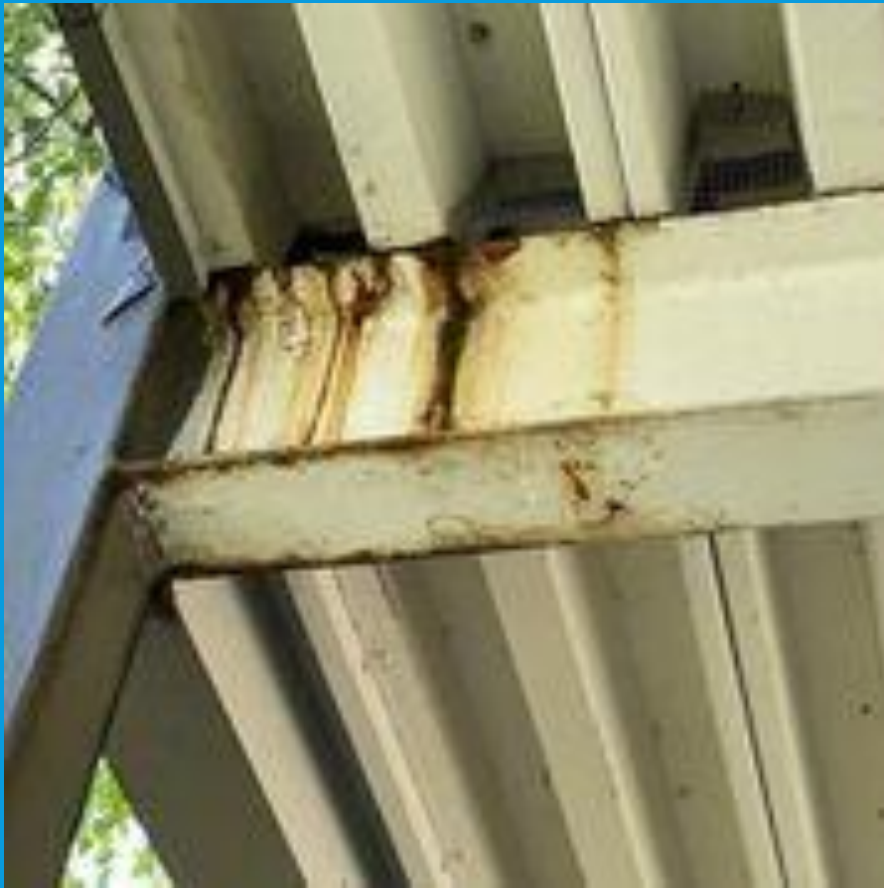
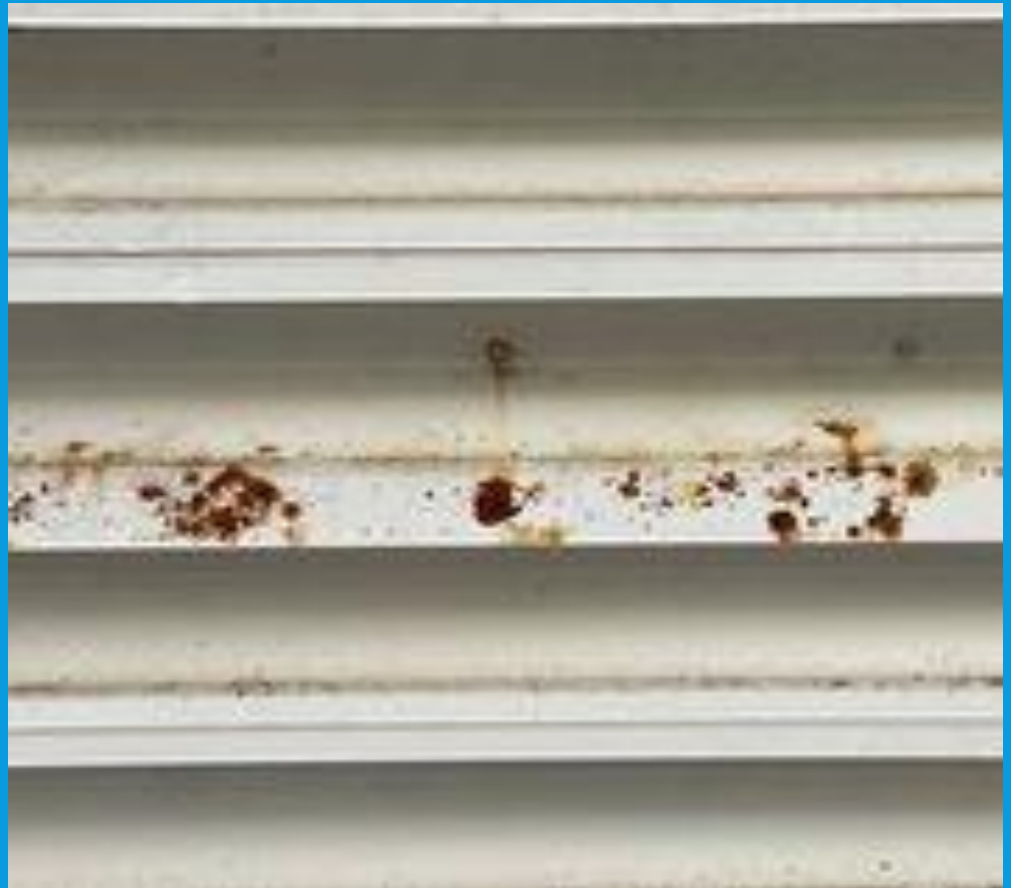
SARATOGA HIGH SCHOOL LEAD & RUST REMEDIATION

- Hazardous materials testing confirmed the presence of high levels of lead paint on the Covered Walkway. Rust is present on numerous columns and beams and the Pool Bleacher Canopy, necessitating replacement of each.
- The windows in the Gymnasium have outlived their useful life and require replacement as soon as possible.
- Based on the District's 10-year Roof Maintenance Plan, the roof of the Media Annex and Girls' Locker Room will need to be restored within the next two years.
- A significant number of HVAC units were replaced between 1998-2005 and are now 15-22 years old. As stated, complete and imminent failure is unlikely- however, prudence would dictate the district maintain a 20% reserve of total replacement cost.

- Rust-damage replacement for columns, beams and Pool Canopy:
Estimated replacement cost: \$0.596M
- Gymnasium Window Replacement:
Estimated replacement cost: \$0.640M
- Media Annex and Girls Locker Room Roof Restoration:
Estimated restoration costs: \$0.182M
- 20% HVAC Replacement Reserve:
Estimated reserve value: \$1.87M
- **Total Estimated Immediate Needs: \$3.29M**

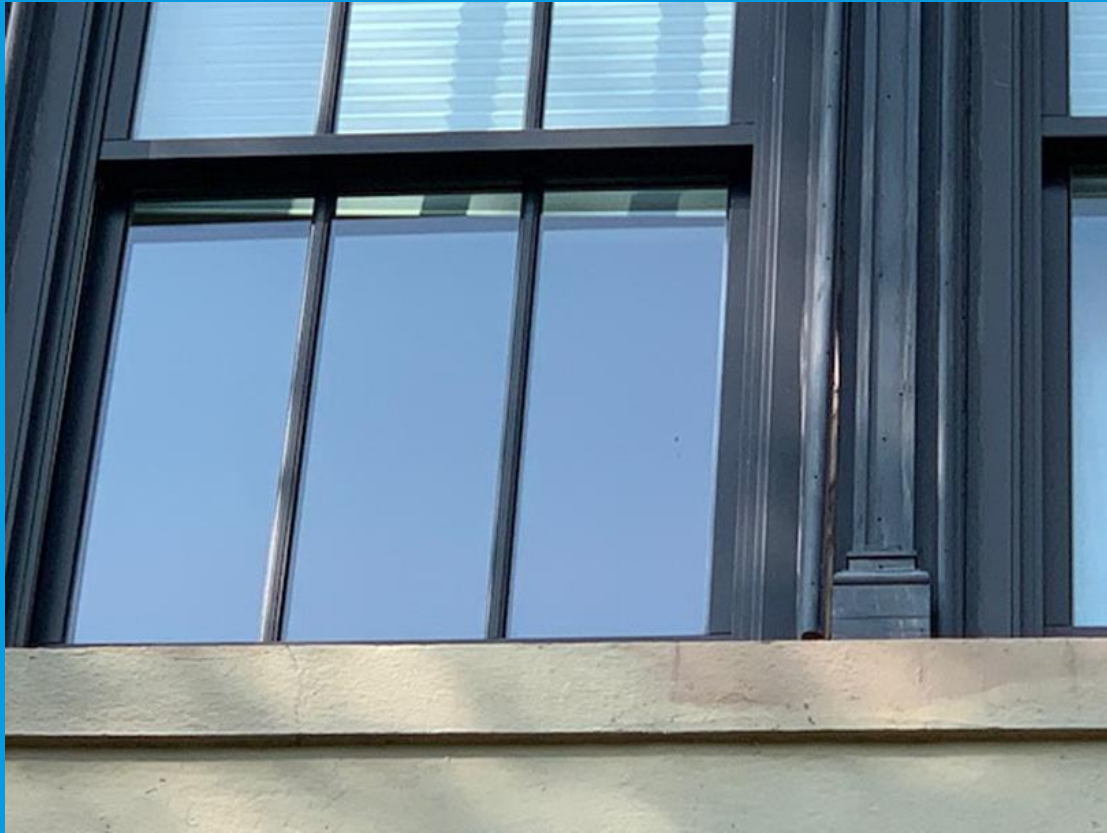
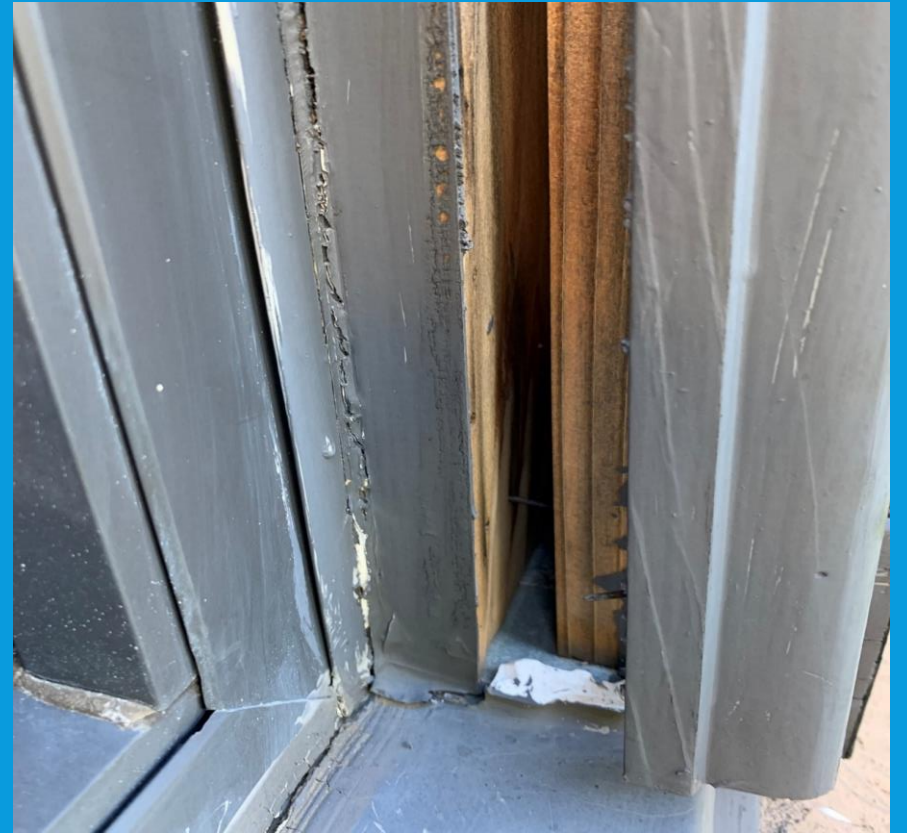
LOS GATOS HIGH SCHOOL ADMIN WINDOW REPLACEMENTS

- Hazardous materials testing confirmed the presence of high levels of lead paint on the Administration building windows, 700 wing trim and Drama building. Lead paint remediation is needed.
- The west facing windows in the administrative building have outlived their useful life and require replacement as soon as possible.
- Based on the District's 10-year roof maintenance plan, the Math Building, Art History Building and Studio/ Paint Room will need to be restored within the next two years.
- A significant number of HVAC units were replaced between 1998-2005 and are now 15-22 years old. As stated, complete and imminent failure is unlikely- however, prudence would dictate the district maintain a 20% reserve of total replacement cost.

- Lead abatement for Administrative Building windows, 700 Wing trim and Drama Building:
Estimated remediation cost :\$0.109M
- Administration Building Window Replacement:
Estimated replacement cost : \$0.680M
- Math, Art History, Paint Studio Roof:
Estimated restoration costs: \$0.294M
- 20% HVAC Replacement Reserve:
Estimated reserve value: \$2.49M
- Storm Sewer & Sanitary Sewer Hydrojet:
Estimated cost: \$0.03M
