**FAULT TRENCH INVESTIGATION
HIDDEN VALLEY ELEMENTARY SCHOOL
3435 BONITA VISTA LANE
SANTA ROSA, CALIFORNIA**

Project 1079.120

Prepared For:
Santa Rosa City Schools
211 Ridgway Avenue
Santa Rosa, California 95401

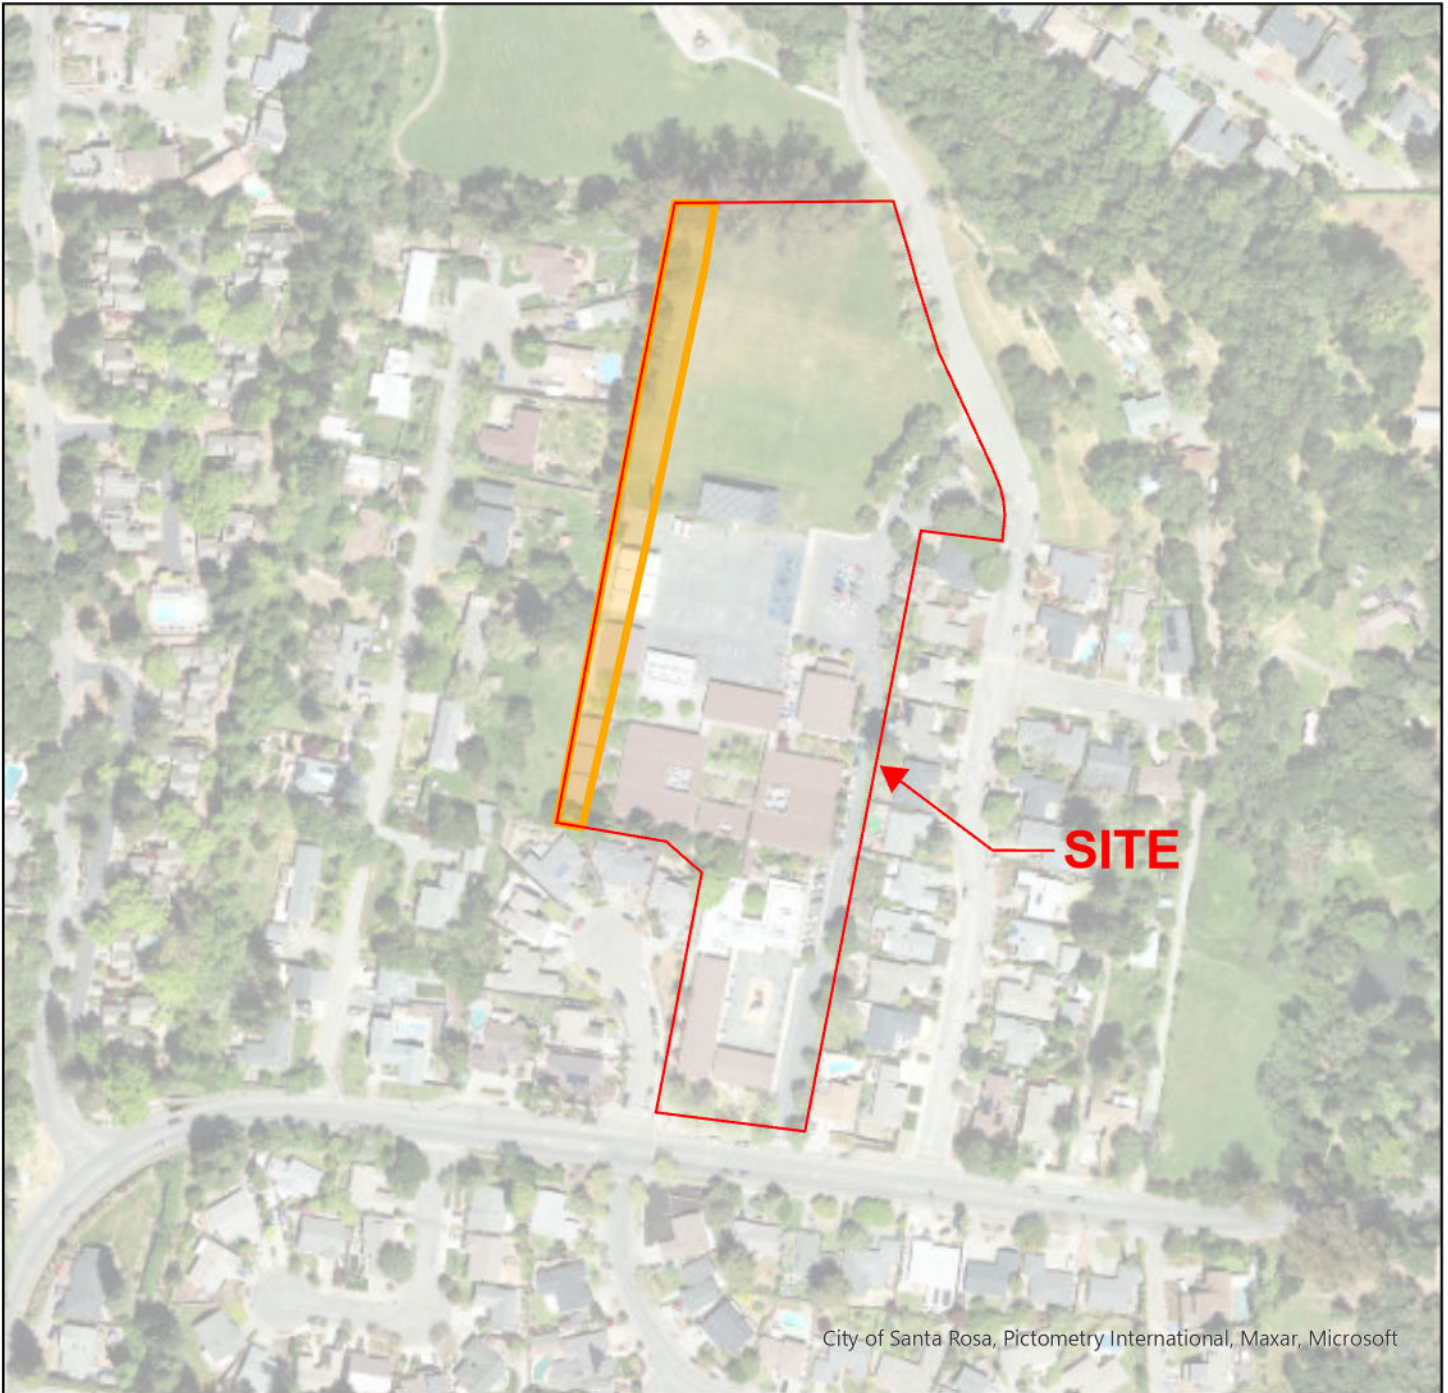
7

RECOMMENDED "NO BUILD" ZONE

Based on interpreted subsurface conditions as described in Section 5.0, we conclude that no Holocene active faults exist within the areas explored. However, it should be noted that because trenches could not be extended beyond the west property line, and because the AP Act requires minimum setbacks of 50 feet, we recommend that setbacks for new structures be imposed along the western margin of the site. As shown on Figure 7, the recommended “no build” zone extends 50-feet east from the western end of the seismic profiles.

If needed, further study could be performed to further evaluate areas beyond the western property line in order to “clear” the recommended “no build” zone shown on Figure 7. Such study would probably require coordination with neighboring landowners and/or the City of Santa Rosa to accommodate additional seismic surveying and/or subsurface trenching or drilling.

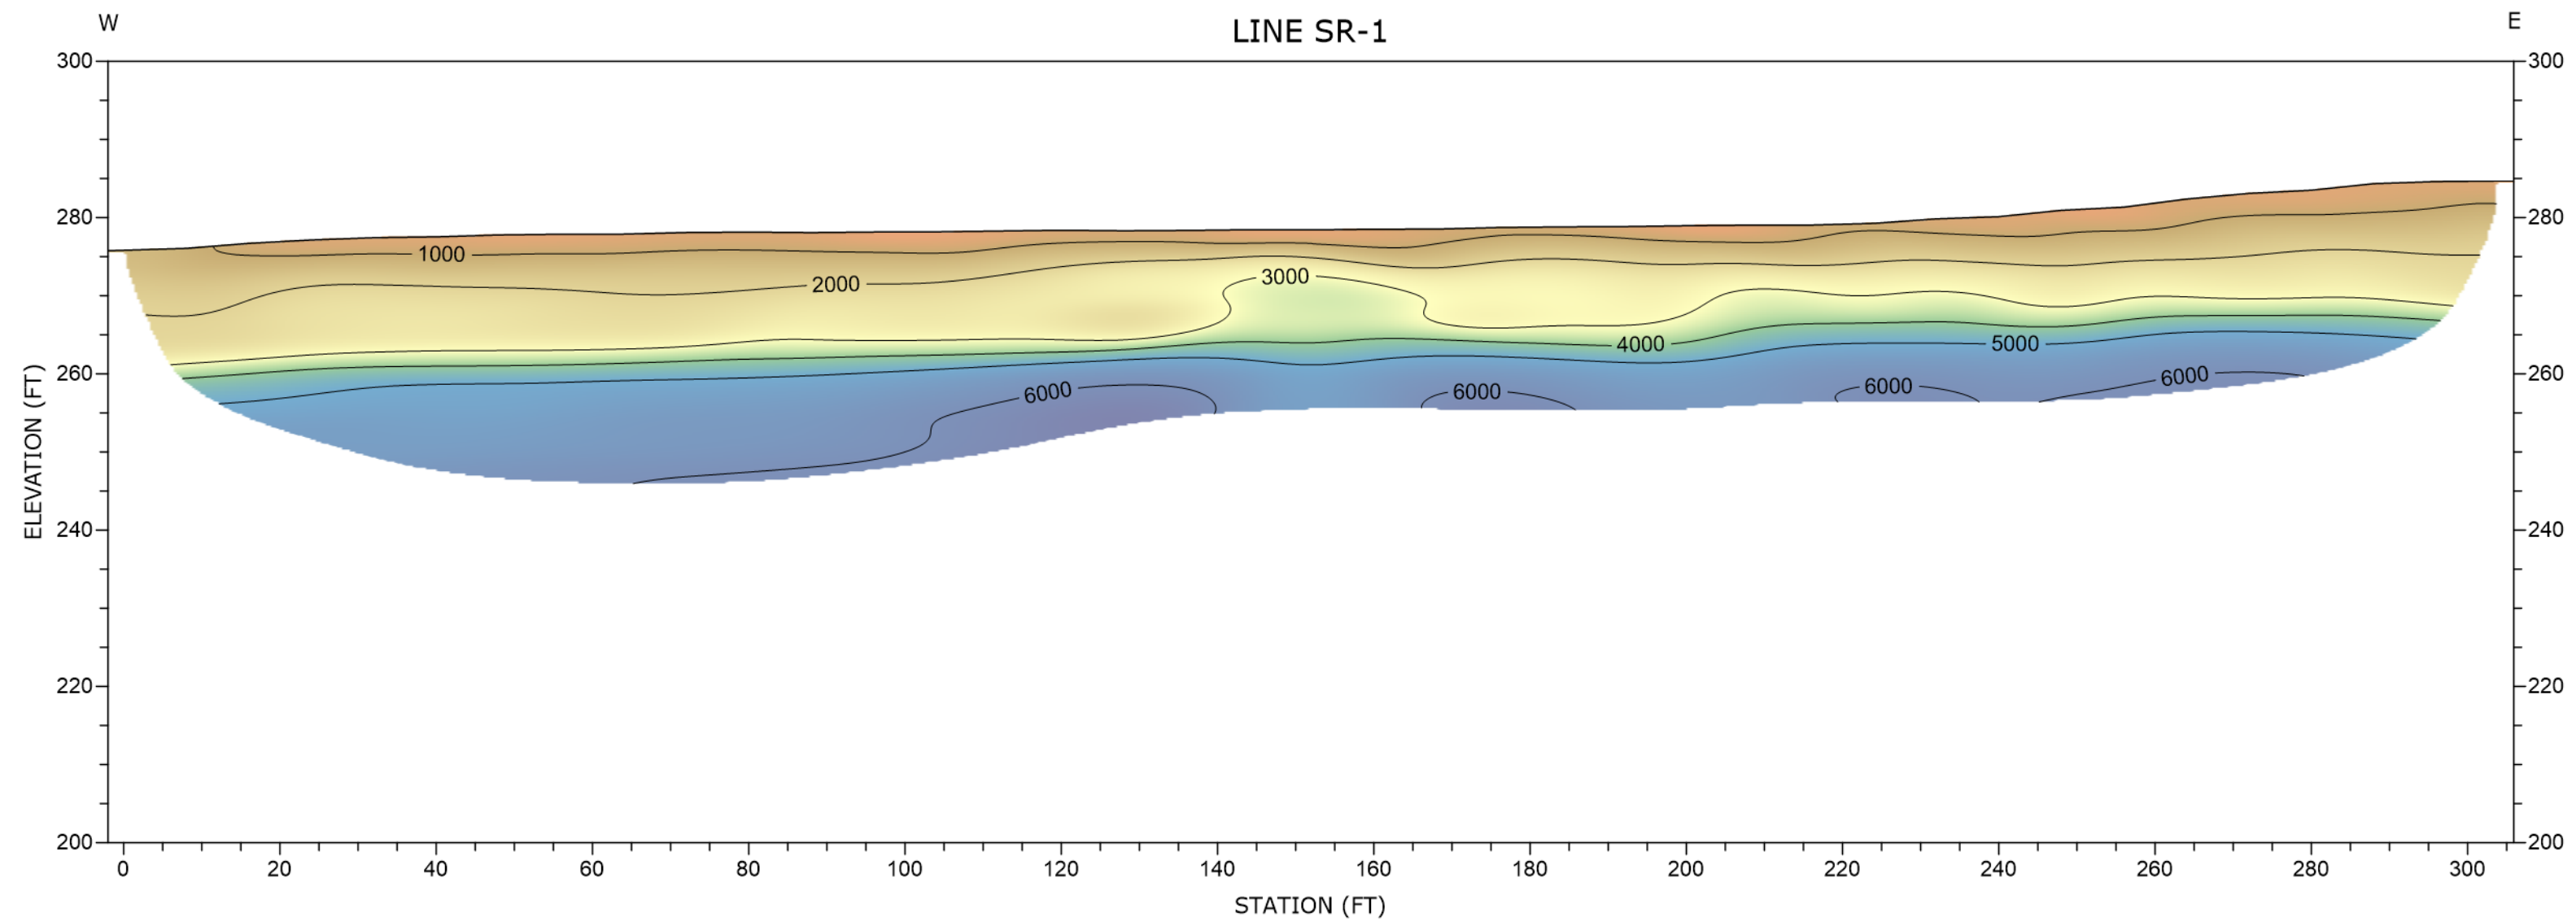
PLATE
2A

SEISMIC REFRACTION PROFILES LINES 1 & 2 3435 BONITA VISTA LANE	
LOCATION: SANTA ROSA, CALIFORNIA	
CLIENT: MILLER PACIFIC	
JOB #: NS255109	DATE: JULY 2025
DRAWN BY: M. SPERRY	APPROVED BY: JSW
7/1/2025
