WOODRIDGE ELEMENTARY SCHOOL

RENOVATION

**DEKALB COUNTY SCHOOL DISTRICT
PRELIMINARY REPORT**

OCTOBER 29, 2021

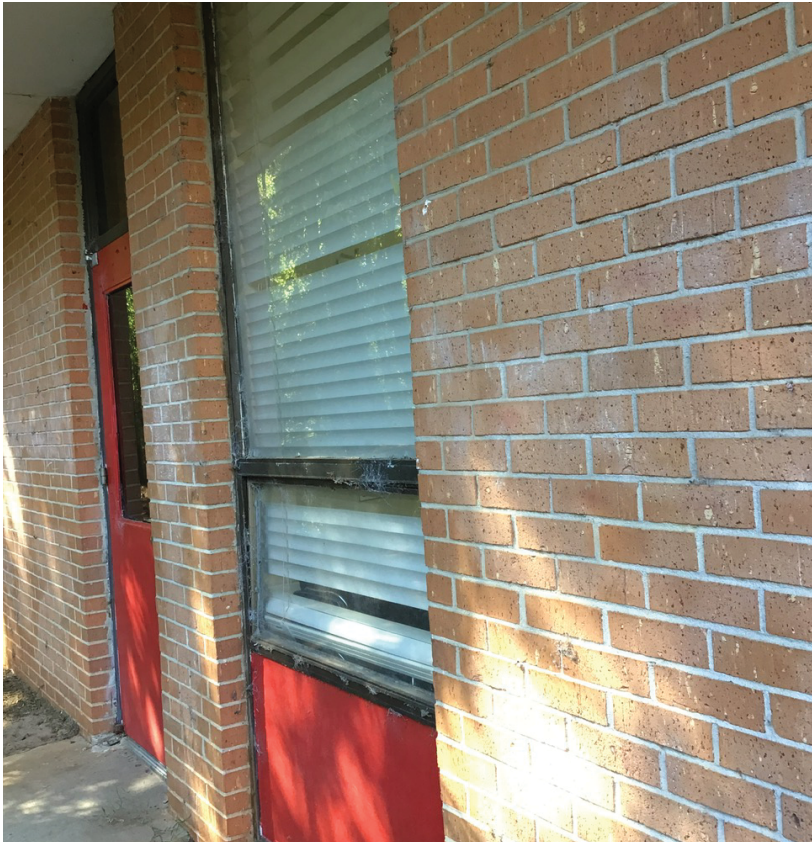
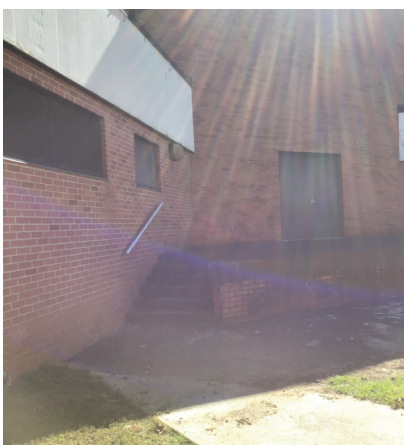
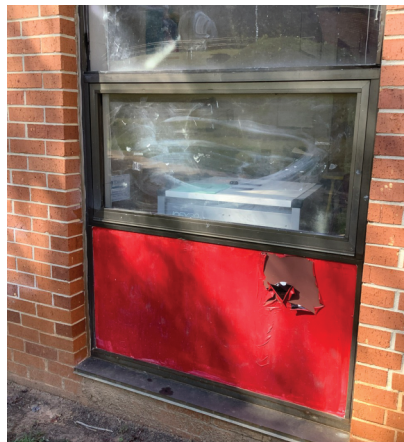
The existing building exterior is in fair condition.

- It is recommended to refresh all painted window panel portions around the exterior facades.
- There is currently no access to the roof. A roof hatch or exterior ladder should be added to provide safe access to the roof. It is recommended that the roof ladder is added near the exterior loading platform, on the back side of the stage.

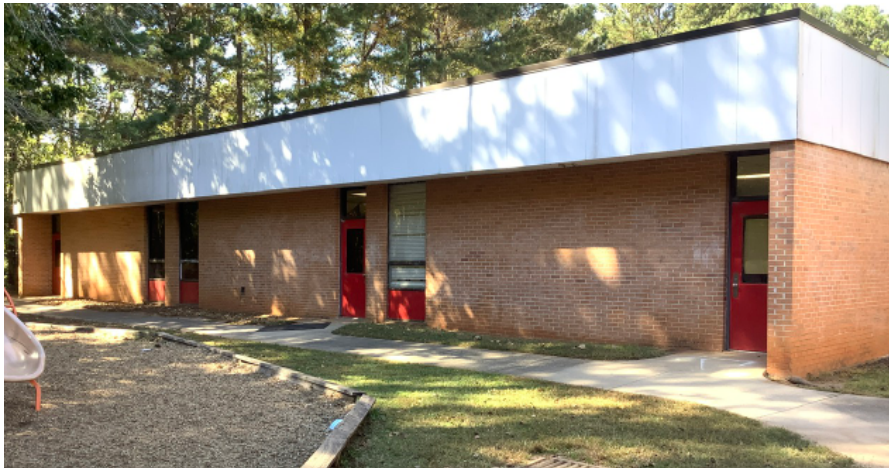
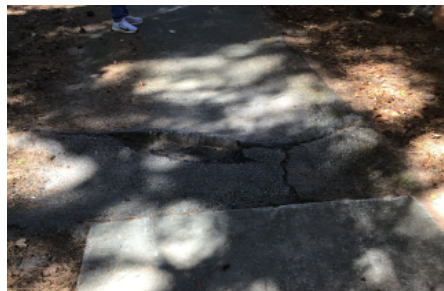
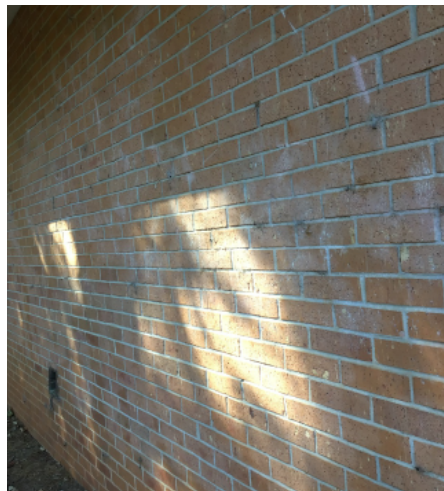
- Exterior brick has some defects typical of a building of its age. Mortar has been washed away by weathering or pressure washing.
- Some of the walkways surrounding the school are cracking and a trip hazard.
- Proposed Repairs:
 - Repoint brick at areas of mortar damage.
 - Provide roof access via ladder with cage
 - Repaved and level damaged walkways and provide proper railing where necessary per ADA access requirements.

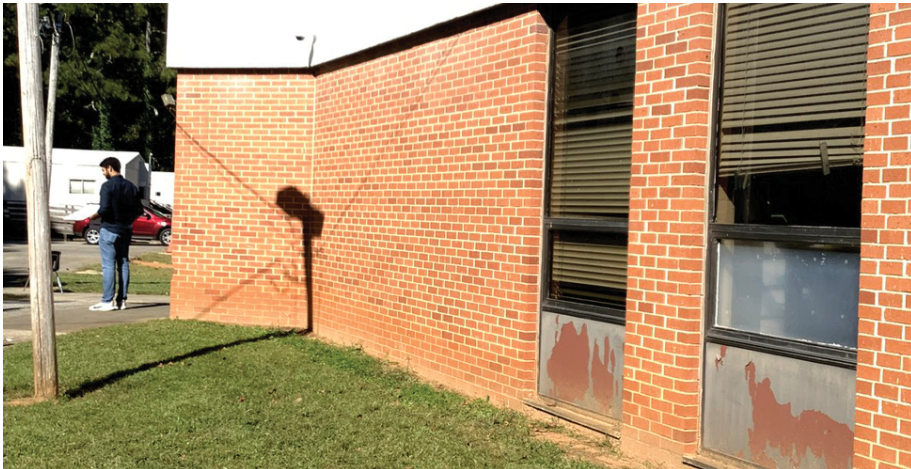
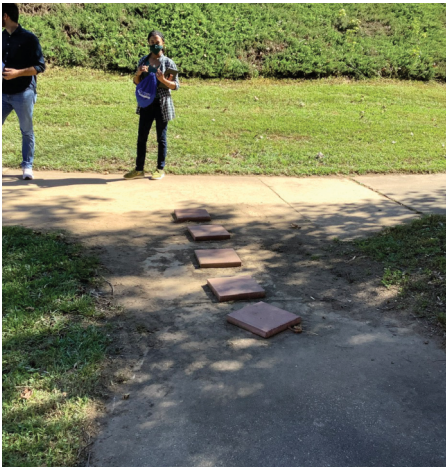
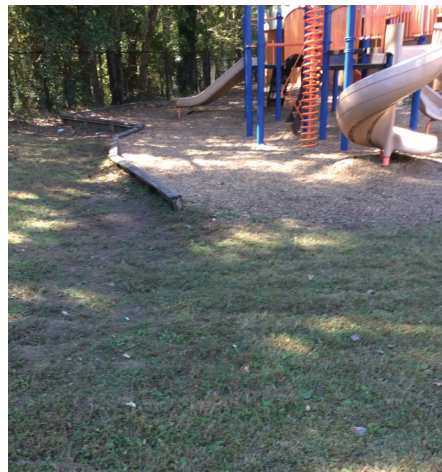
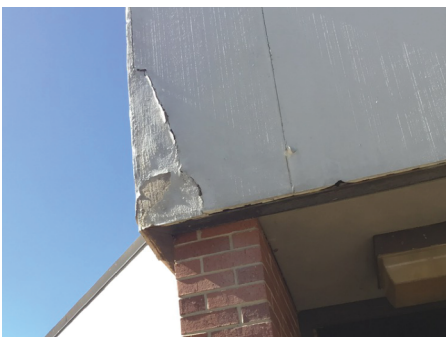
- There are some drainage problems near the playground area from excess water drainage from hill near-by and improper or impeded drainage paths.
- There is facade/lower roof damage at loading areas for the kitchen. Damaged concrete panels have been replaced with plywood.

- Proposed Repairs:
 - Create a proper drainage channel to avoid puddling and water accumulation near play area and outside of classroom's (exterior) exits.
 - Provide bollards or stops to limit trucks from hitting building facade.

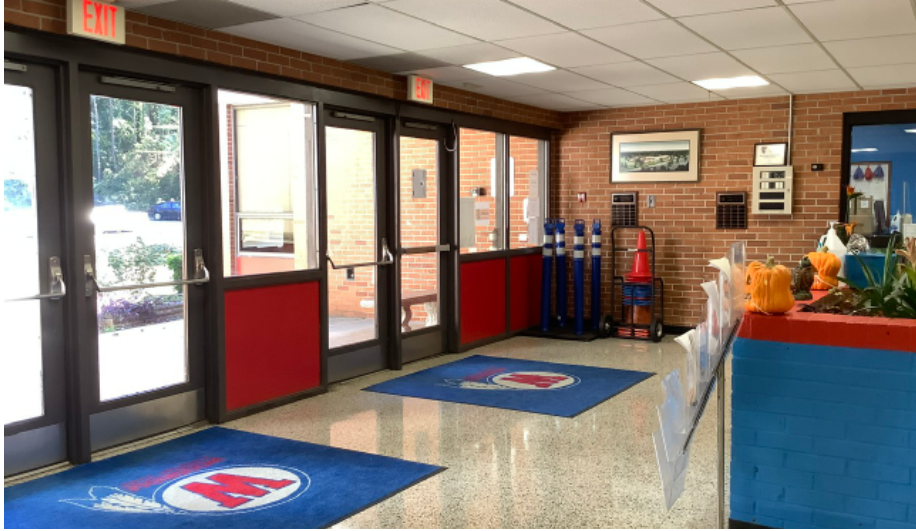
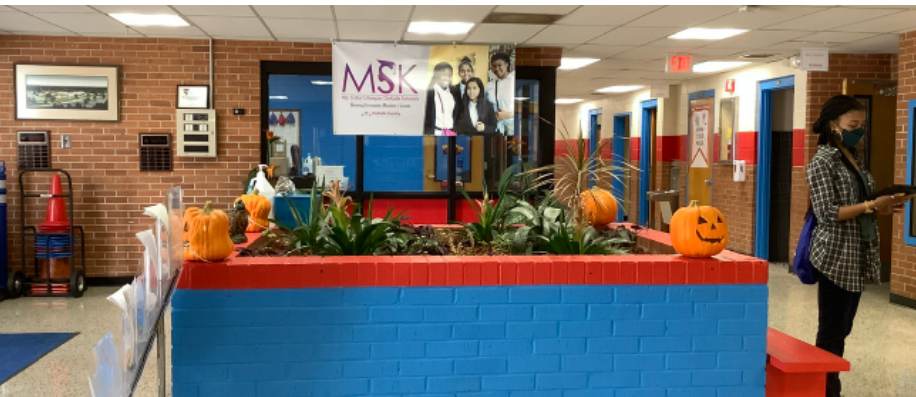
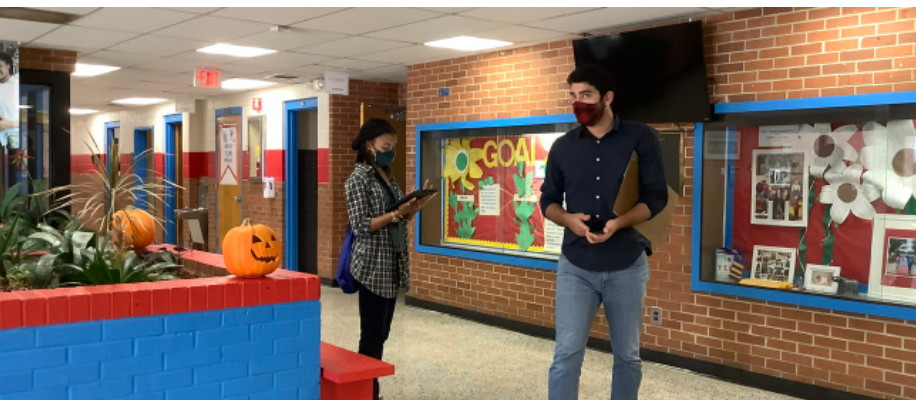
- We propose a secure vestibule will be added to the main entry. This would require the removal of the existing central planter/ seating build-out and the addition of some storefront to enclose the entry. Security systems will include but may not be limited to surveillance cameras, electric strikes with buzzers, and bulletproof glass.
- The school contains a mixture of fluorescent and LED light fixtures. The architect proposes that these all be replaced along with the acoustical ceilings throughout.
- There are floor material changes throughout the corridors.
- There are ceiling leaks throughout the school in isolated areas.

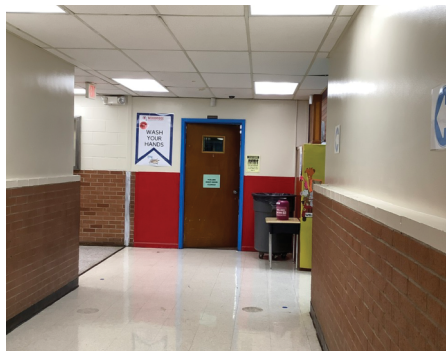
- Proposed Repairs:
 - Investigate source of roof leaks and repair is required
 - Replace light fixtures with LED
 - Replace damaged acoustical ceiling tiles

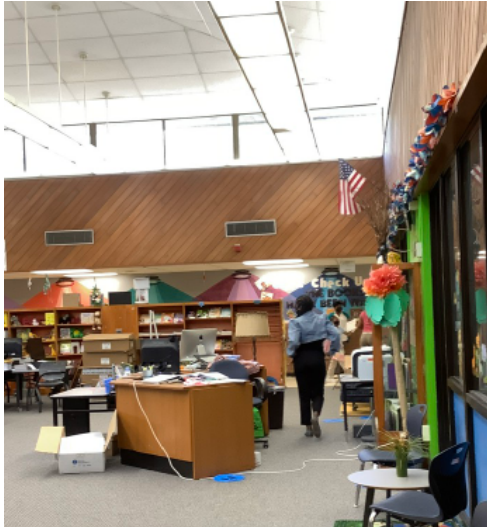
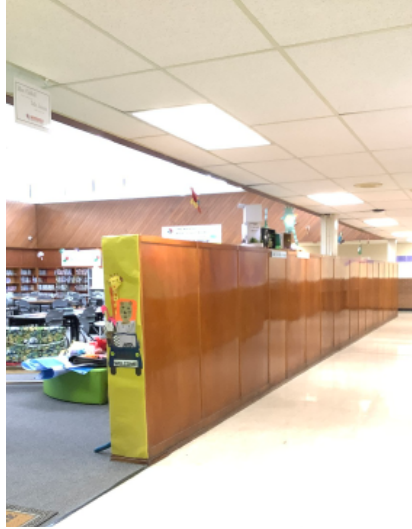
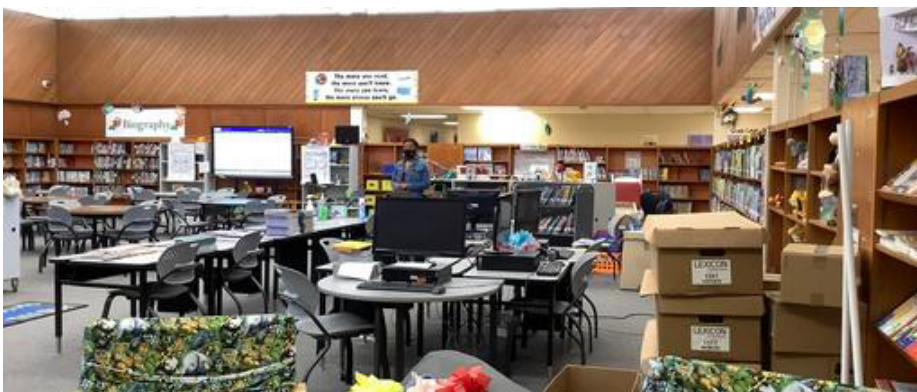
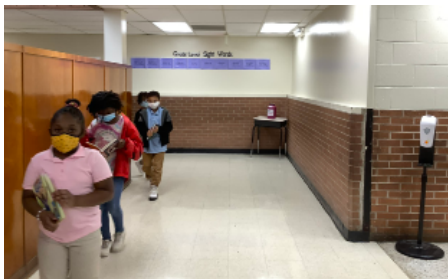
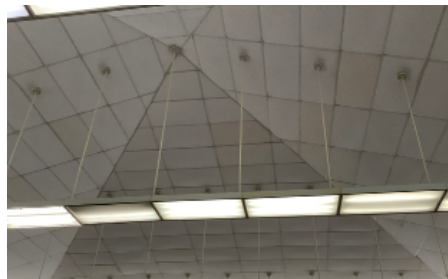
- Recommended to update all lighting in media center to LED.
- Build CMU walls adjacent to bookshelves.
- Might provide a mild barrier at media center entrance for better traffic control.

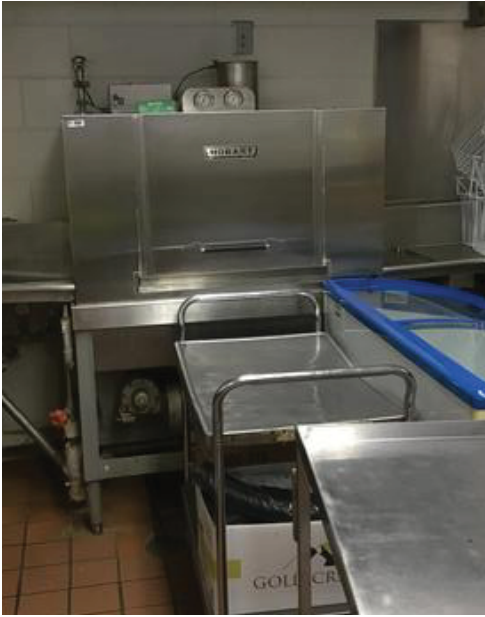
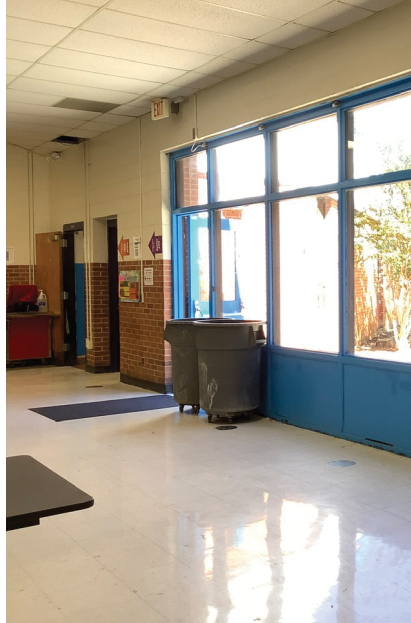
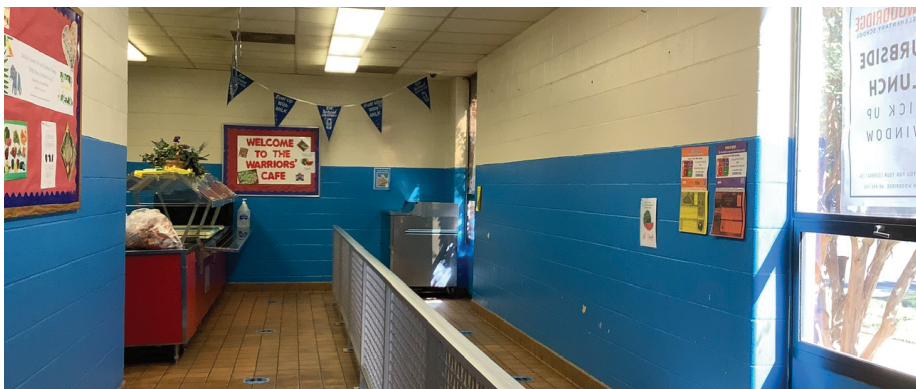
- The existing kitchen contains equipment that either is not used or is not operating properly.
- Vent hood can be resized based on unused equipment that can be removed.
- Proposed Repairs:
 - Determine what equipment needs repair or can be removed.
 - Resize vent hood to accommodate equipment changes.

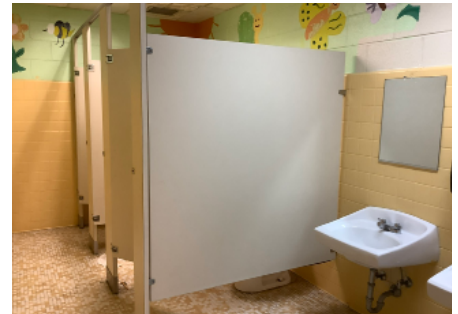
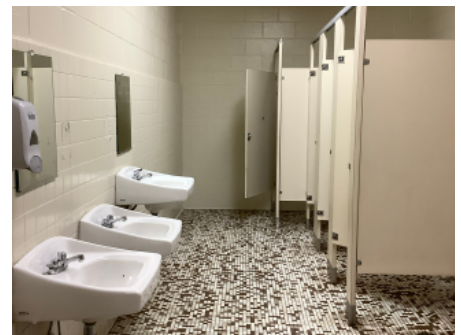
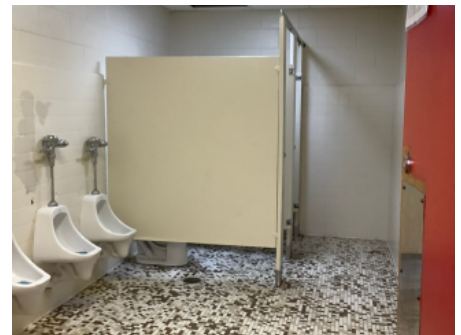
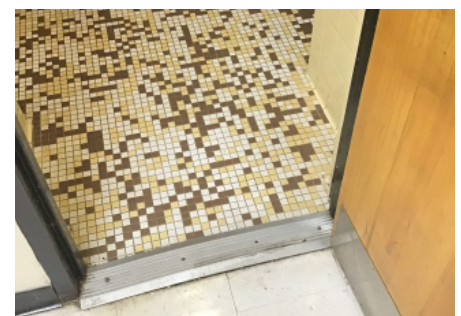
- Existing water coolers appear to be in proper condition. The owner may want to add bottle fillers at existing water cooler locations.

- Toilet fixtures appear to be in proper operating condition.

- Multiple restrooms require the installation of toilet paper holders and sanitary napkin dispensers.

- Floor finishes for the restrooms include VCT and ceramic tile. Patch and provide thresholds between floor material transitions.

- Recommend bringing water coolers up to ADA Standard heights and clearances.

- Recommend bringing gang restrooms and individual restrooms up to ADA Standards.

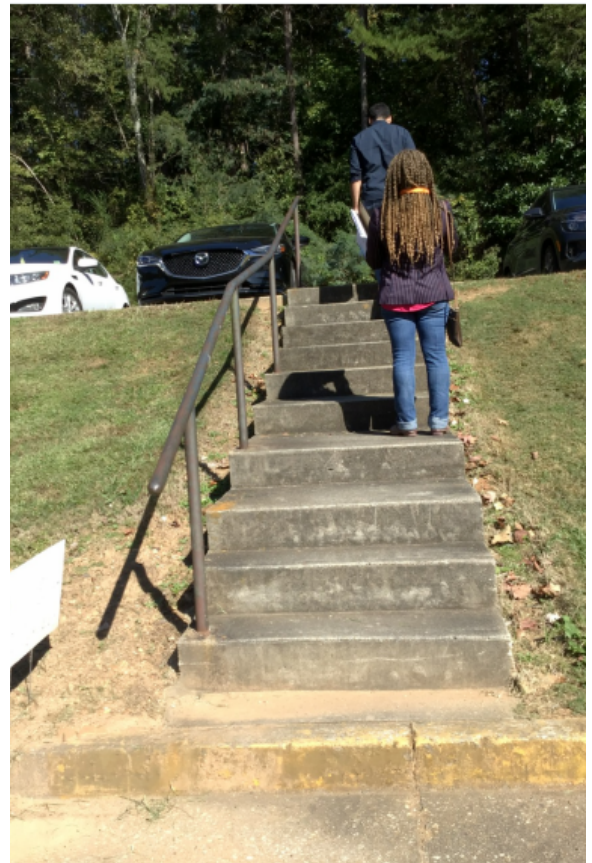
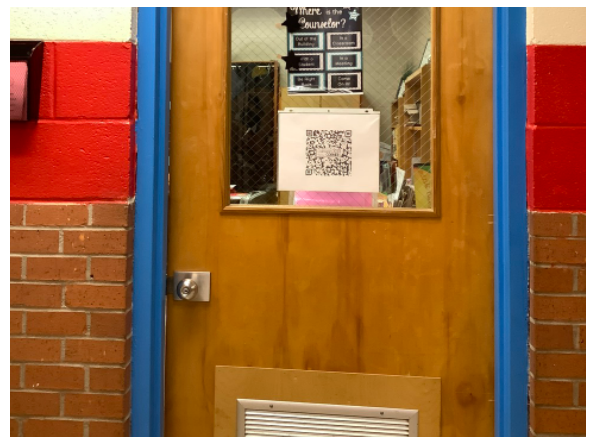
- Interior and exterior handrails do not currently meet the standards for egress. Many handrails do not extend the proper distances at the top or bottom of staircases. There are multiple cases where the handrails are not continuous where required.
- Current, main stairway from parking lot to school entry does not have the proper top and bottom landing requirements.
- Door hardware does not meet ADA requirements in multiple locations. Round door knobs should be switched out for levers.
- Door clearances do not meet ADA requirements in multiple locations.
- Exterior concrete ramps may need handrails depending on slope of ramp.
- Light switches are currently mounted too high to meet accessibility requirements.
- There is no ADA access to the stage in the cafetorium.
- Restrooms have multiple ADA concerns including turning radius and door clearances.

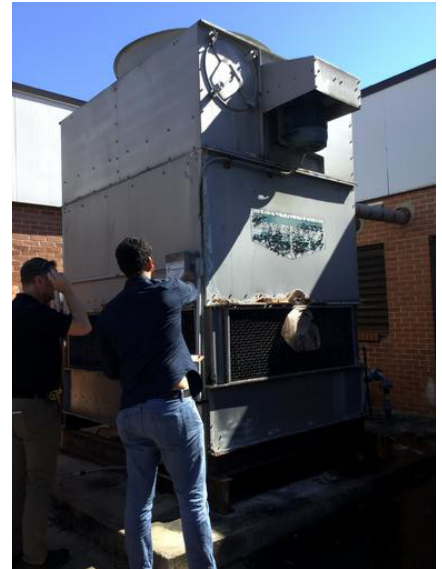
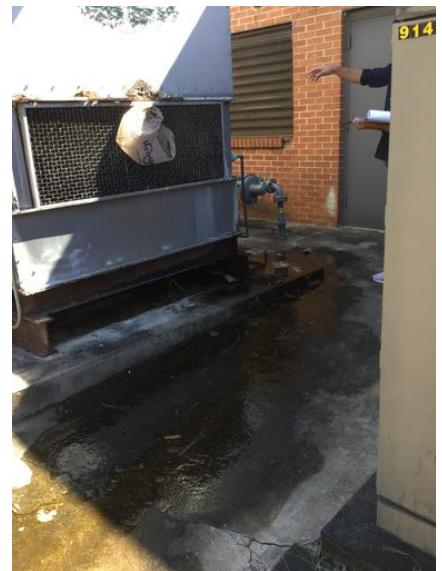
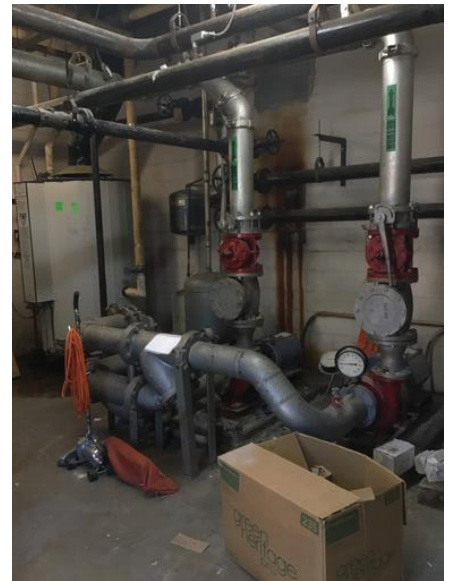
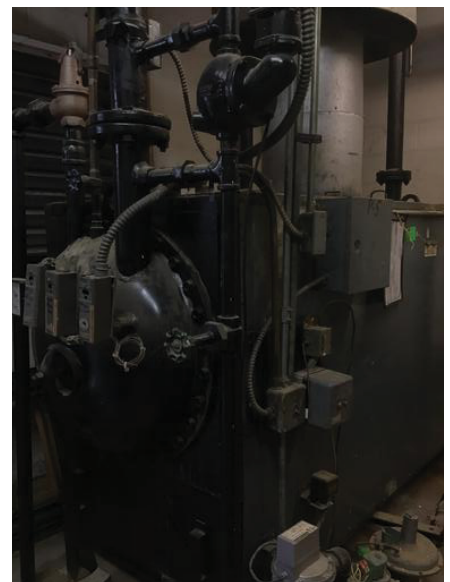
- HVAC:
 - The school is conditioned using cooling tower and boiler combination, which circulates chilled water/hot water to hallway plenum mounted water source heat pumps in most classrooms and corridors. Kitchen ventilation and makeup is achieved using the cooking equipment exhaust hood along with a conditioned air makeup system.

- Fire Suppression:
 - Currently, the school has limited fire protection service, isolated to the stage of the cafetorium. The remainder of the school is not served by a fire protection system. A hydrant is located on the school property in front of the main private drive of the school.

- a) Replacement of HVAC components throughout the building. This includes classroom and common area water source heat pumps, kitchen ventilation and makeup air equipment, boiler(s) and pumps, air distribution. Exhaust systems for toilet rooms will need to be redesigned.

b) Kitchen Ventilation system may be redesigned with cooking equipment optimization. A full review of the cooking equipment use, including dishwashing machine, may be considered for redesigning the exhaust systems in the space.

c) Design and install a fire suppression system for the entire school. This system will be separate from the current system in place in the cafetorium. A fire hydrant directly in front of the building may provide an entry point for the sprinkler riser and installation of the riser in the mechanical room near this location. The fire line location would need to be confirmed and possible branch point installed near the southern portion of the site.

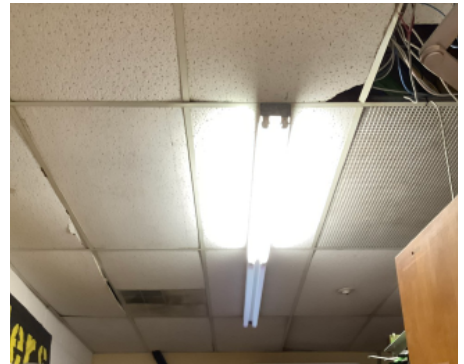
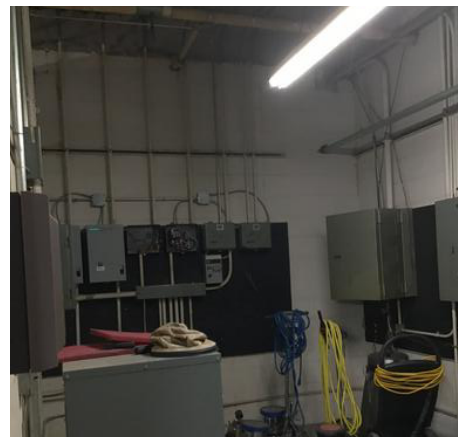
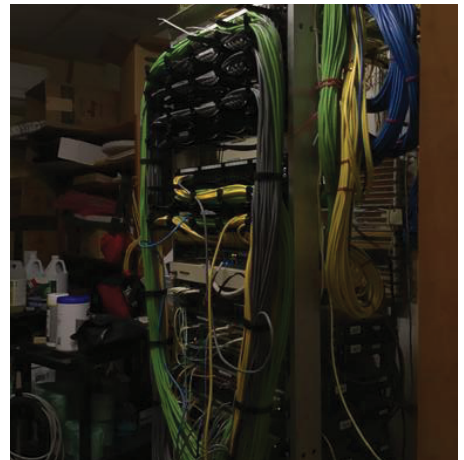
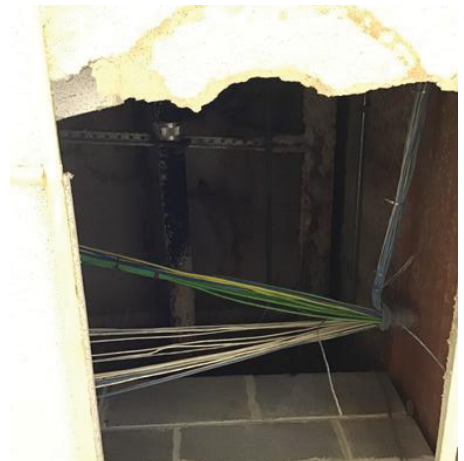
- Power Distribution Systems
 - Existing electrical service is original to building and is in poor condition. Service is rated for 1000 Amps at 277/480 Volts, 3-Phase, 4-Wire.
 - Panelboards and transformers throughout building are original to building and in need of replacement.
 - Emergency generator does not exist for this school.
 - Emergency lighting is currently tapped ahead of main and is a code violation.
- Lighting
 - Existing lighting is 2'x4' fluorescents and in need of replacement.
 - Existing emergency lighting is provided by battery packs on walls. All are fed by tap ahead of main and is a code violation.
- Fire Alarm
 - Fire alarm system does not meet current life safety codes and is in need of replacement

- Power Distribution
 - Upgrade electrical service, provide new panels and circuiting for HVAC system replacement.

- Lighting
 - Provide new LED lighting and controls throughout building to meet IECC. This includes new LED lighting in Gymnasium.
 - Provide new emergency generator and separate life safety and non-life safety systems.
- Fire Alarm System
 - Provide new fire alarm system throughout building per DeKalb County design guidelines.
