K.E.G. Plumbing & Mechanical, Inc.

AIC – Initial Findings

1701 Mountain Industrial Boulevard – Stone Mountain, GA

Summary of Observations (as of June 18, 2025)

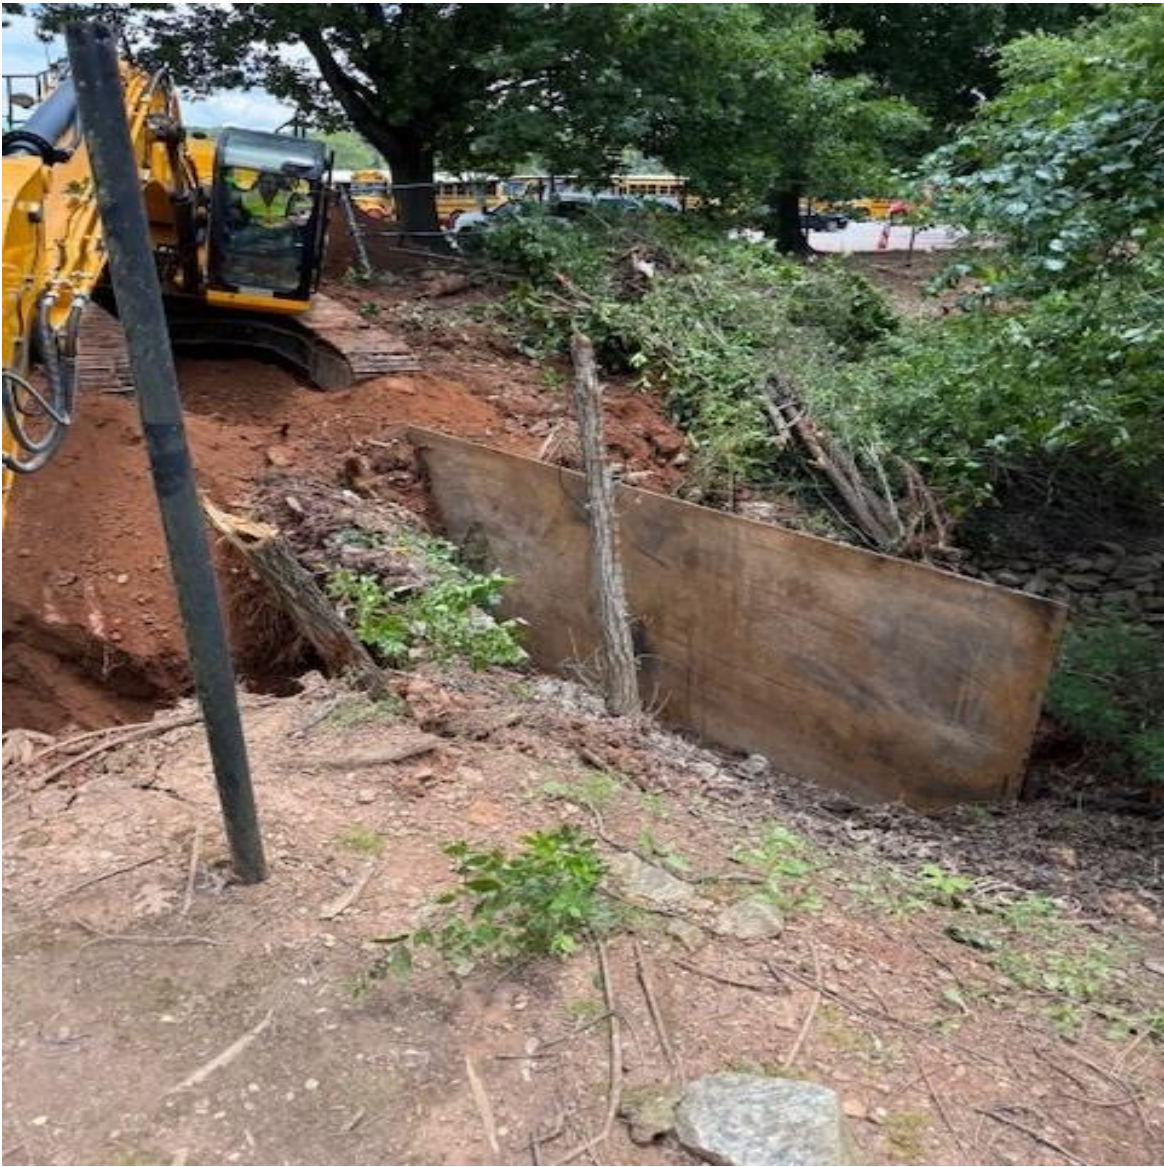
Wednesday – 6/11/2025 - Cofferdam Installation

1. Install Cofferdam due to heavy downpours and upcoming periods of rainfall, during this installation we had multiple affected utilities re-located out of the affected work area. These utilities included phone and fiberoptic. (Complete)

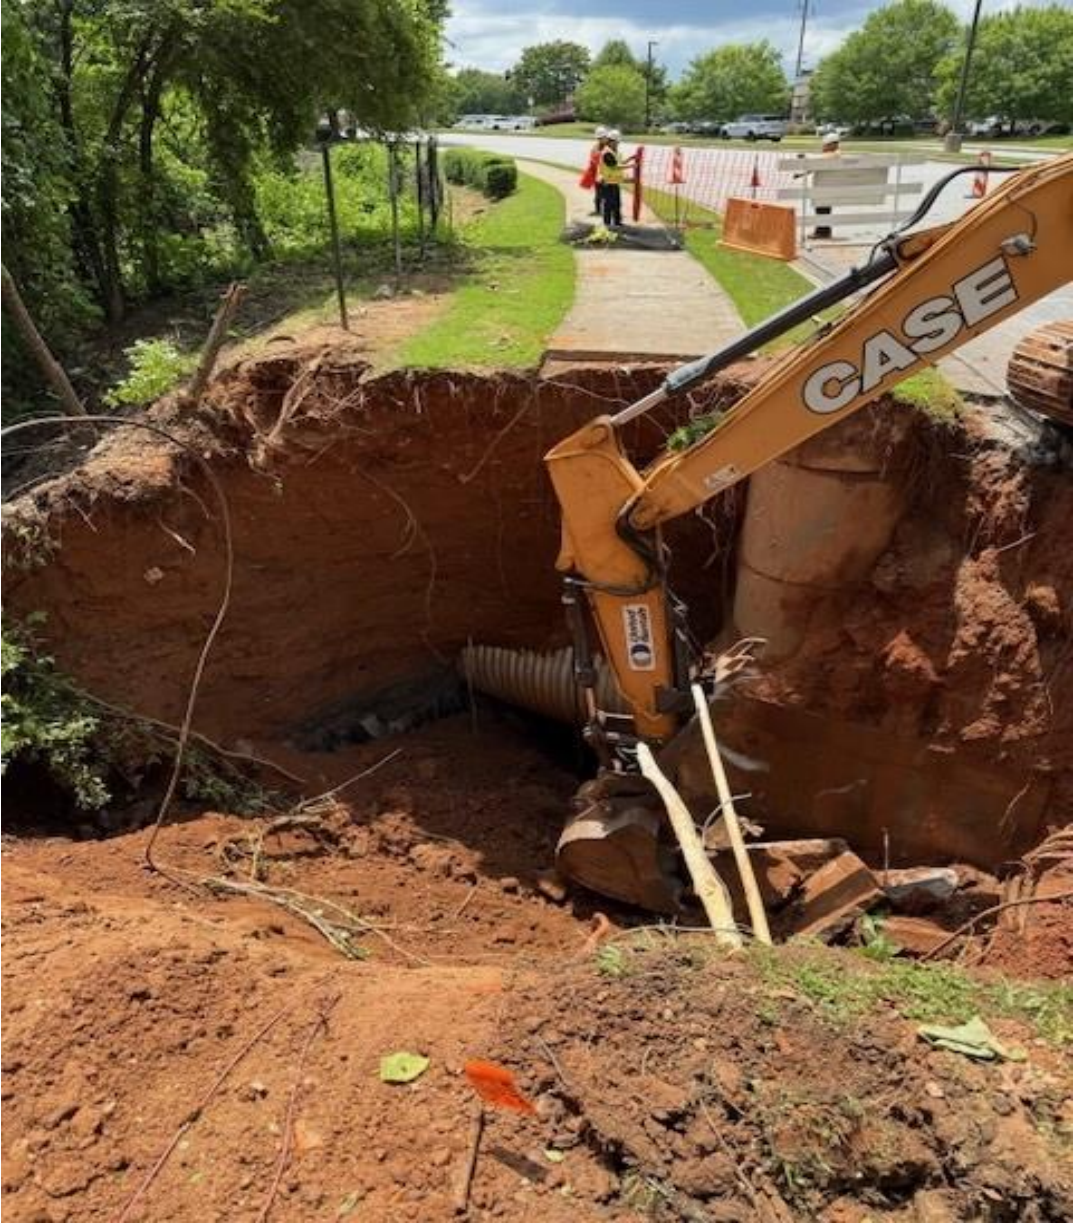
Wednesday – 6/11/2025 – Removal of collapsed structure, street, and 72” CMP & Installing containment fencing.

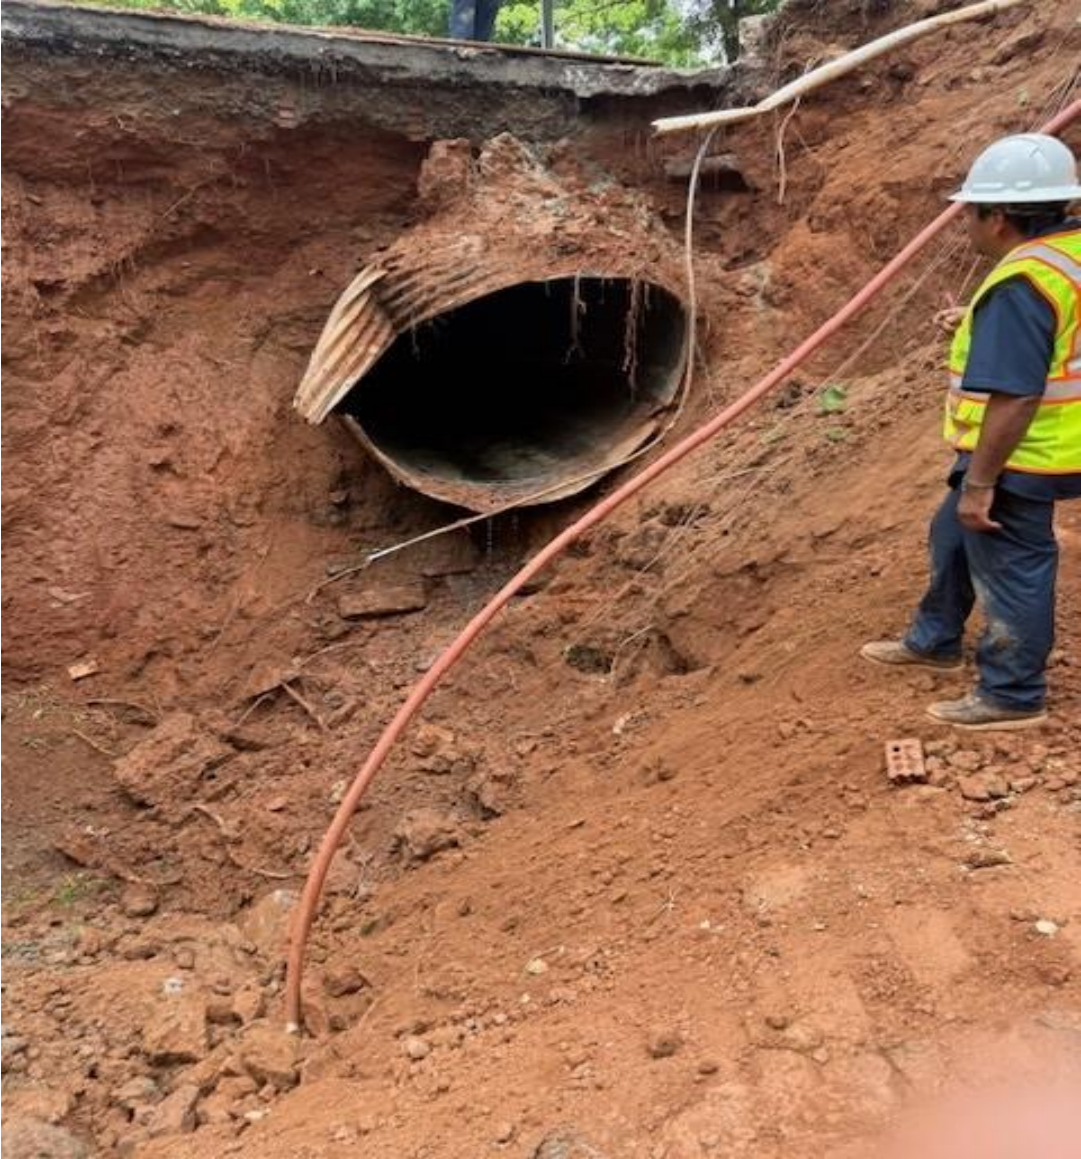
1. Pipe Deterioration:
 - The bottom of the 72" CMP is rusted and deteriorated, likely due to age and prolonged exposure to moisture.
2. Silt Accumulation:
 - The retention pond is over capacity with silt, reducing its ability to manage stormwater effectively.
3. Flood Gate Failure:
 - The emergency flood gate is broken and stuck shut, causing the underground system to act as an overflow during heavy rain.
4. Hydraulic Overload:
 - During storms, water follows the path of least resistance, exacerbating erosion and structural failure.

Wednesday – 6/11/2025 – First inspection of remaining 72” CMP. Stabilized area so crews could safely enter.

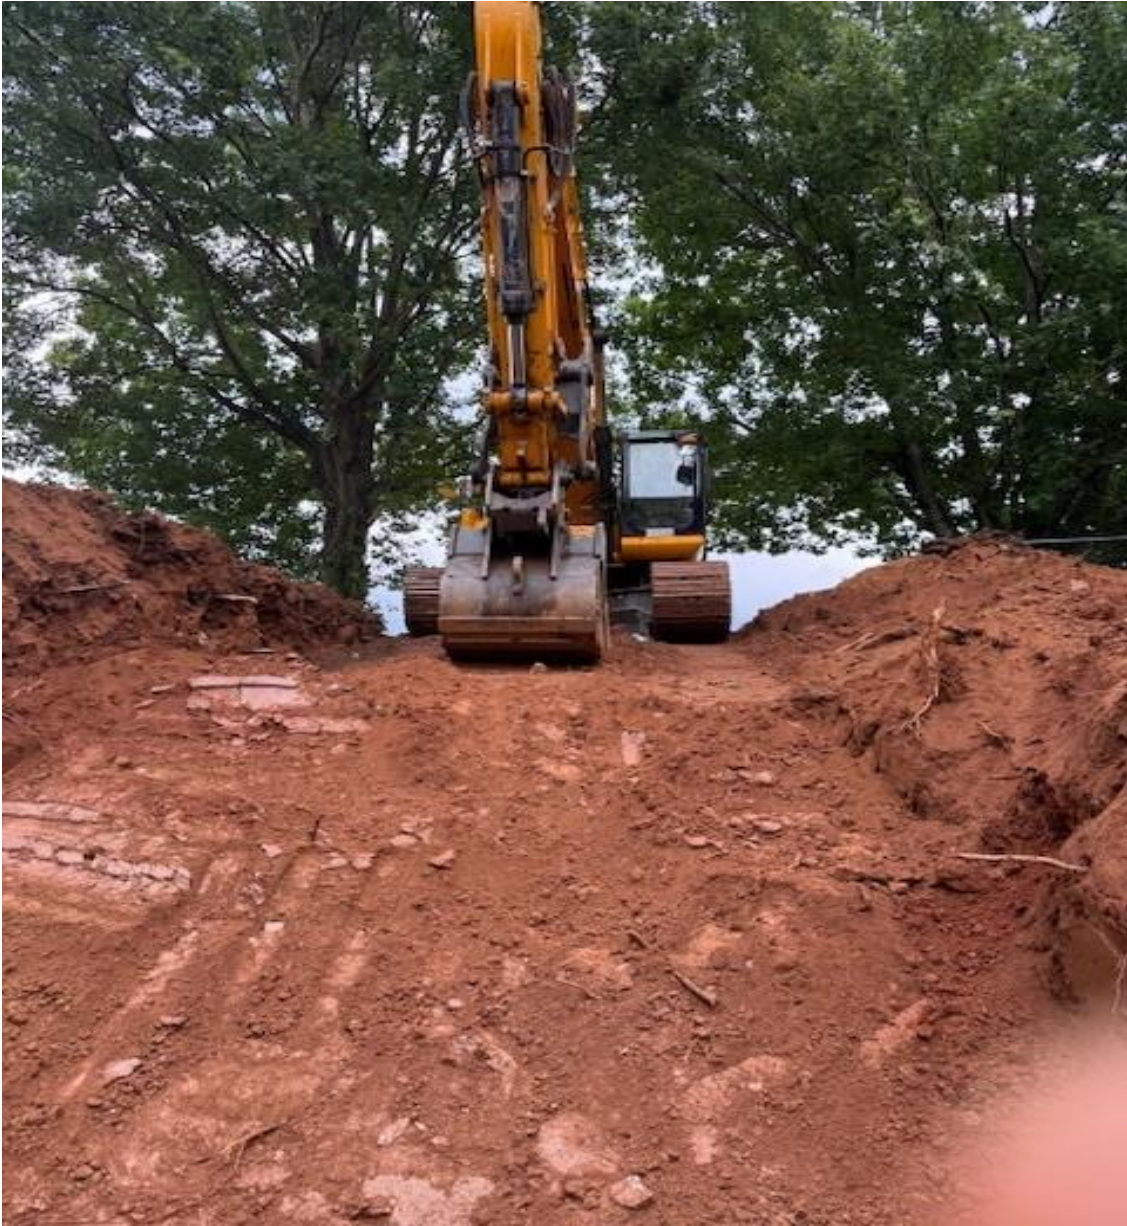
Wednesday – 6/11/2025 – 1':2' egress slope created for entry.

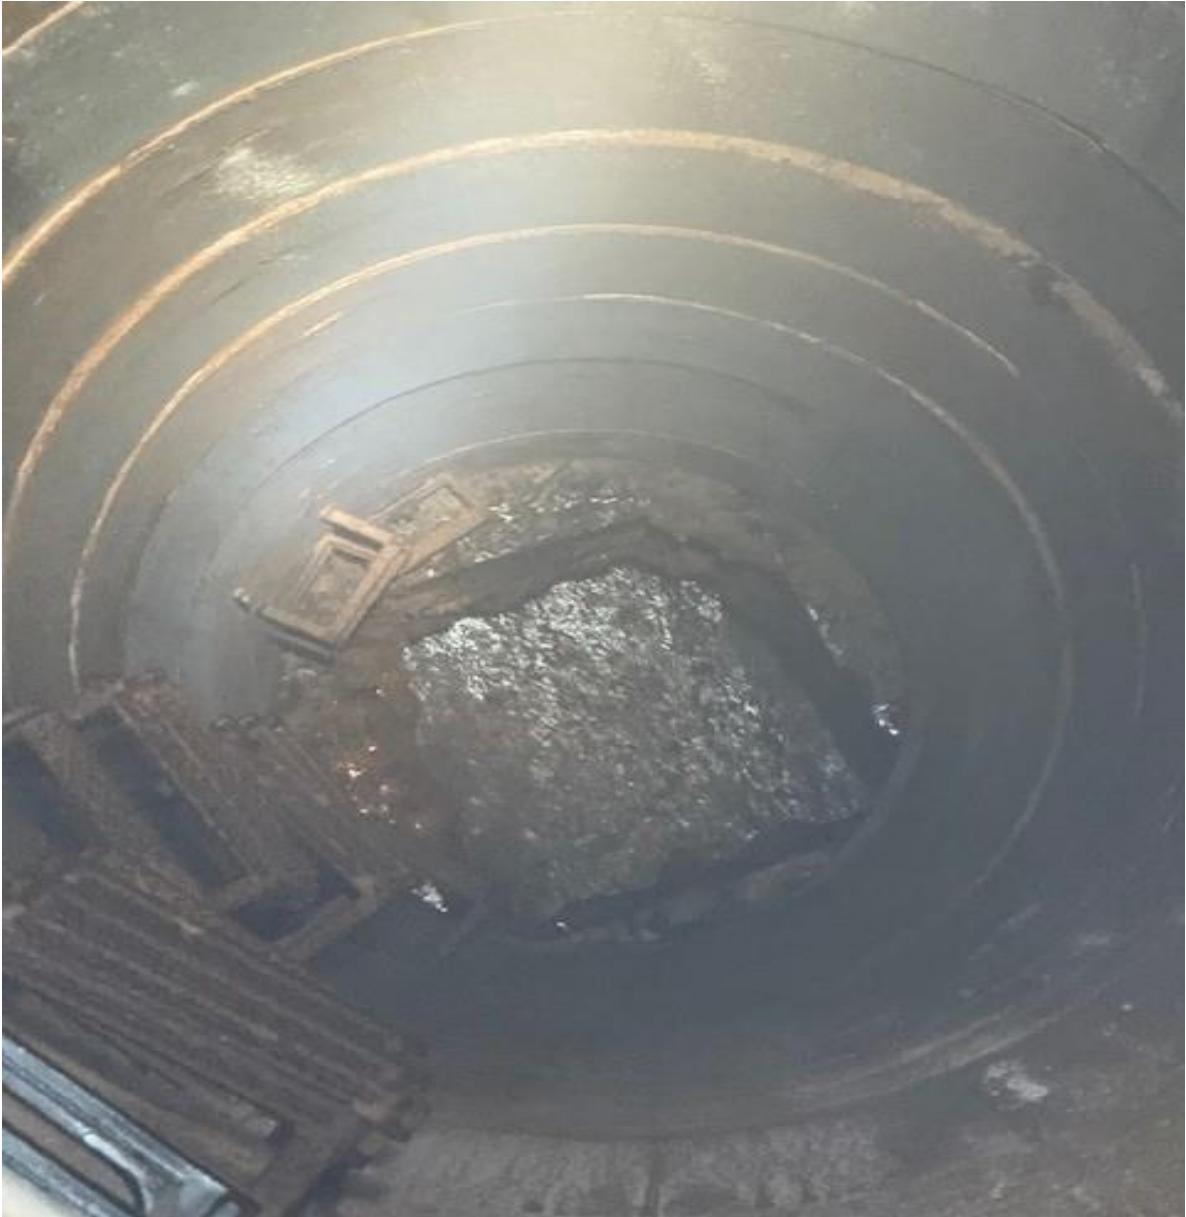
- The retention pond outlet leads to a vertical drop within 30' of the collapsed CMP.
- An existing structure drops approximately 20' into an underground transmission vault, which sits atop an older vault (pre-dating Dekalb County records).
- This system continues another 20' down into a stone and cement aqueduct, suggesting a historic or legacy drainage system.

Wednesday – 6/11/2025 – Downstream riser to existing aqueduct system.

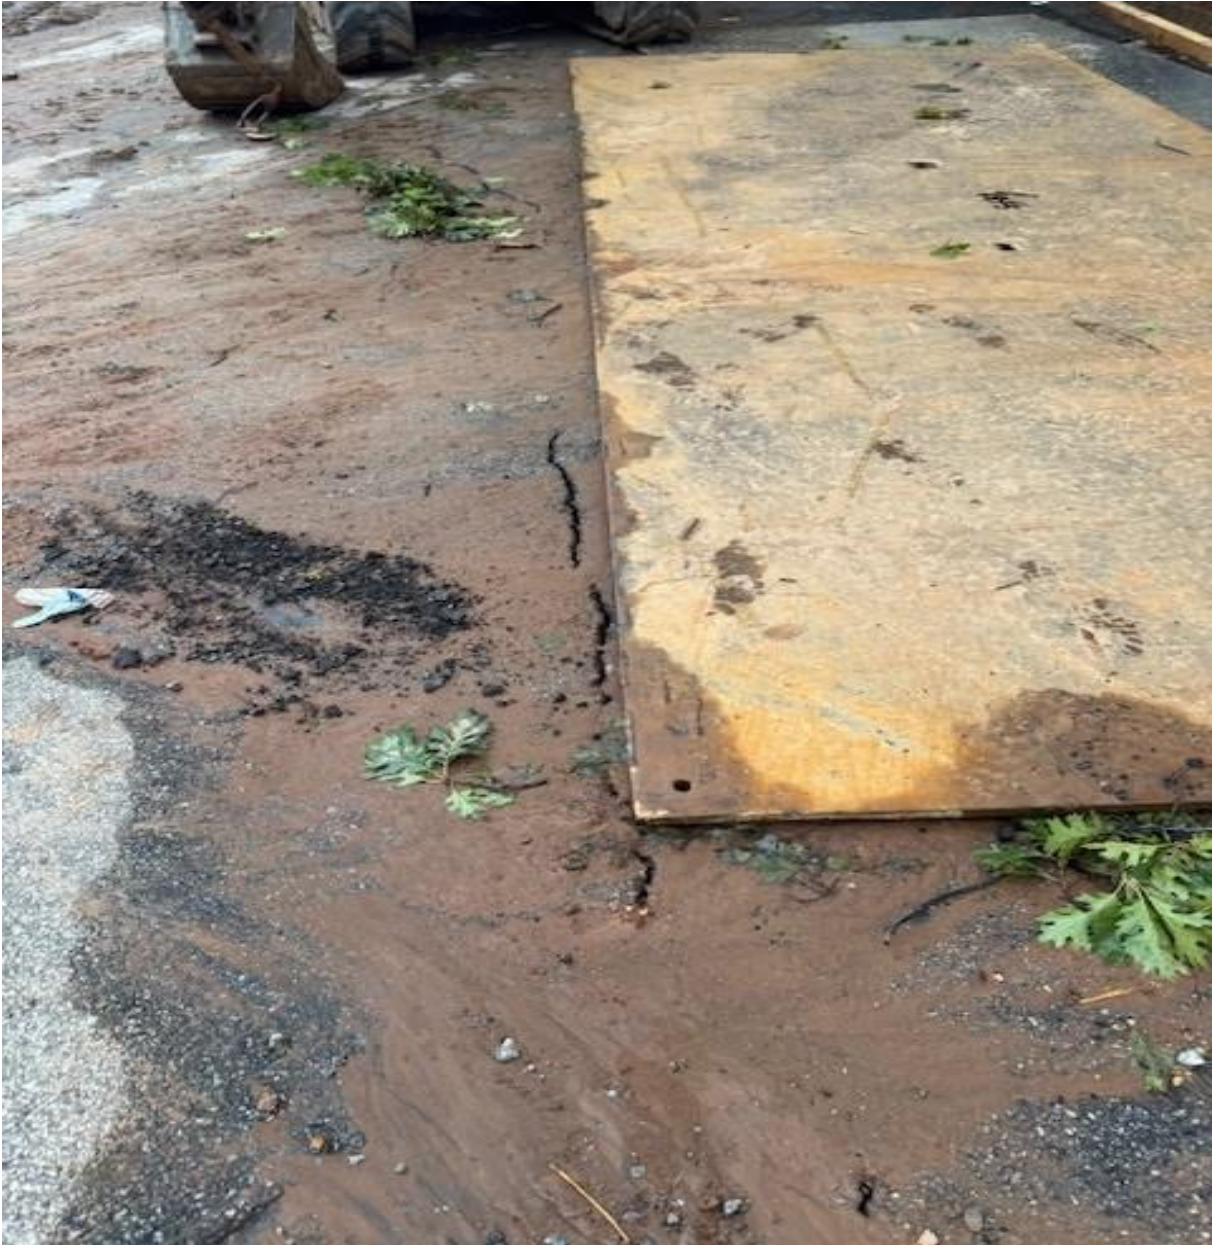
Thursday – 6/12/2025 – Morning – Found road separated after rainstorms throughout the night it has eroded away and must be removed.

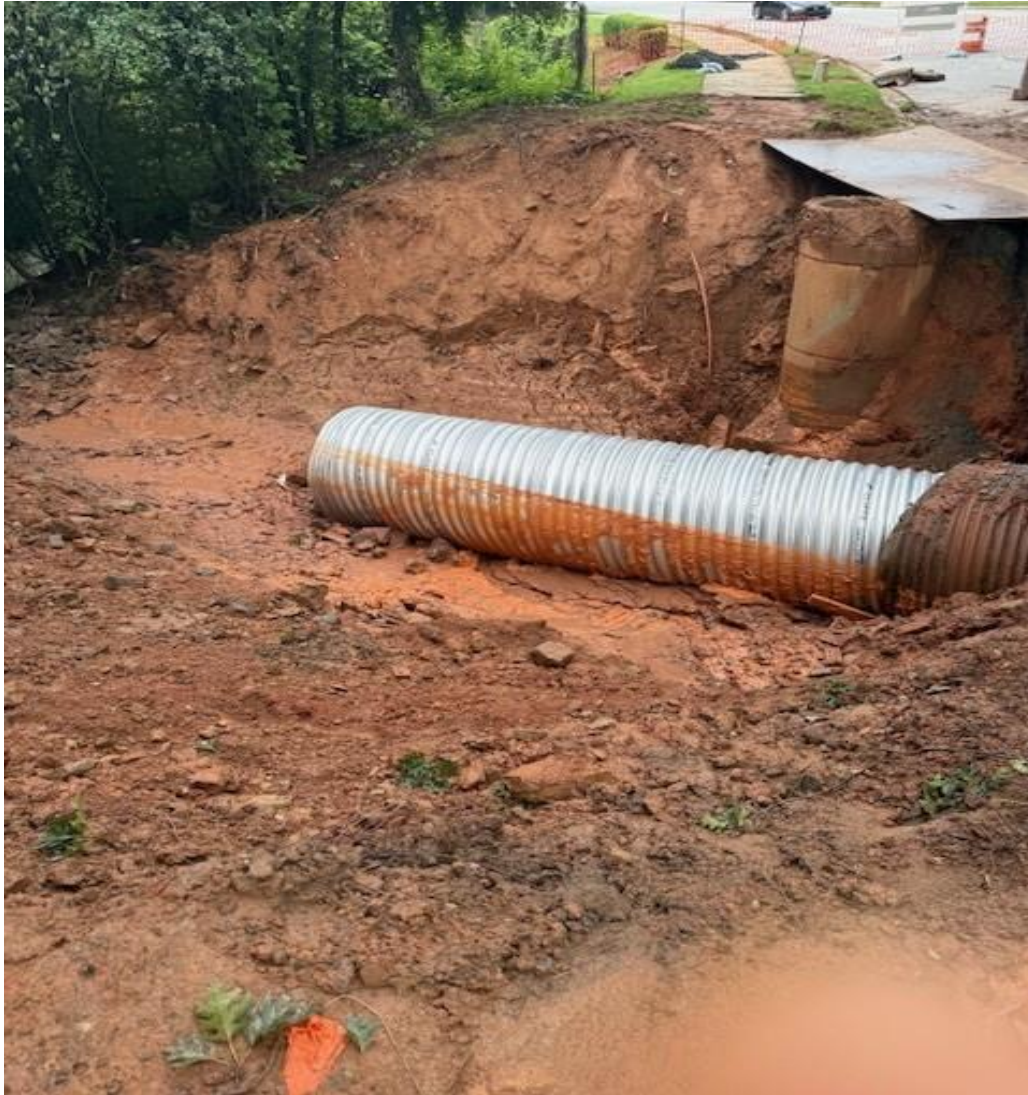
Thursday – 6/12/2025 – Installation of new 60” CMP under entire entrance to stop any more erosion below roadway and connected to immediate upstream basin.

2. Replace existing piping as needed, possibly all of piping under entrance and connect to upstream catch basin and curb inlet. (Complete)
3. Bridge entire affected area with erosion matting after being properly shored and all areas exposed as applicable. (Complete)

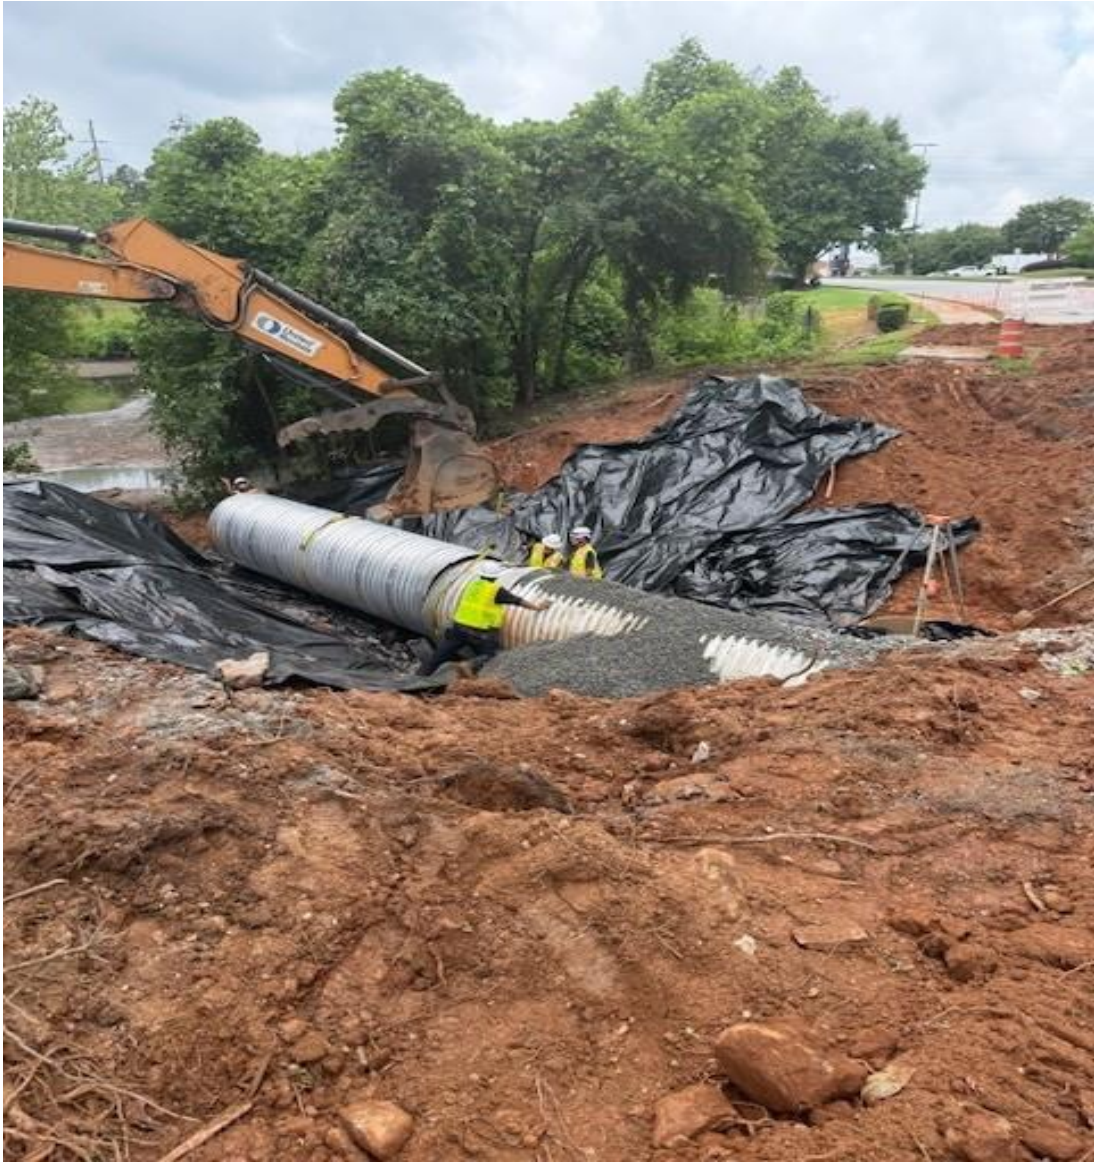
Friday – 6/13/2025 – Installation of bridging matting and connection to retention pond. Removed cofferdam.

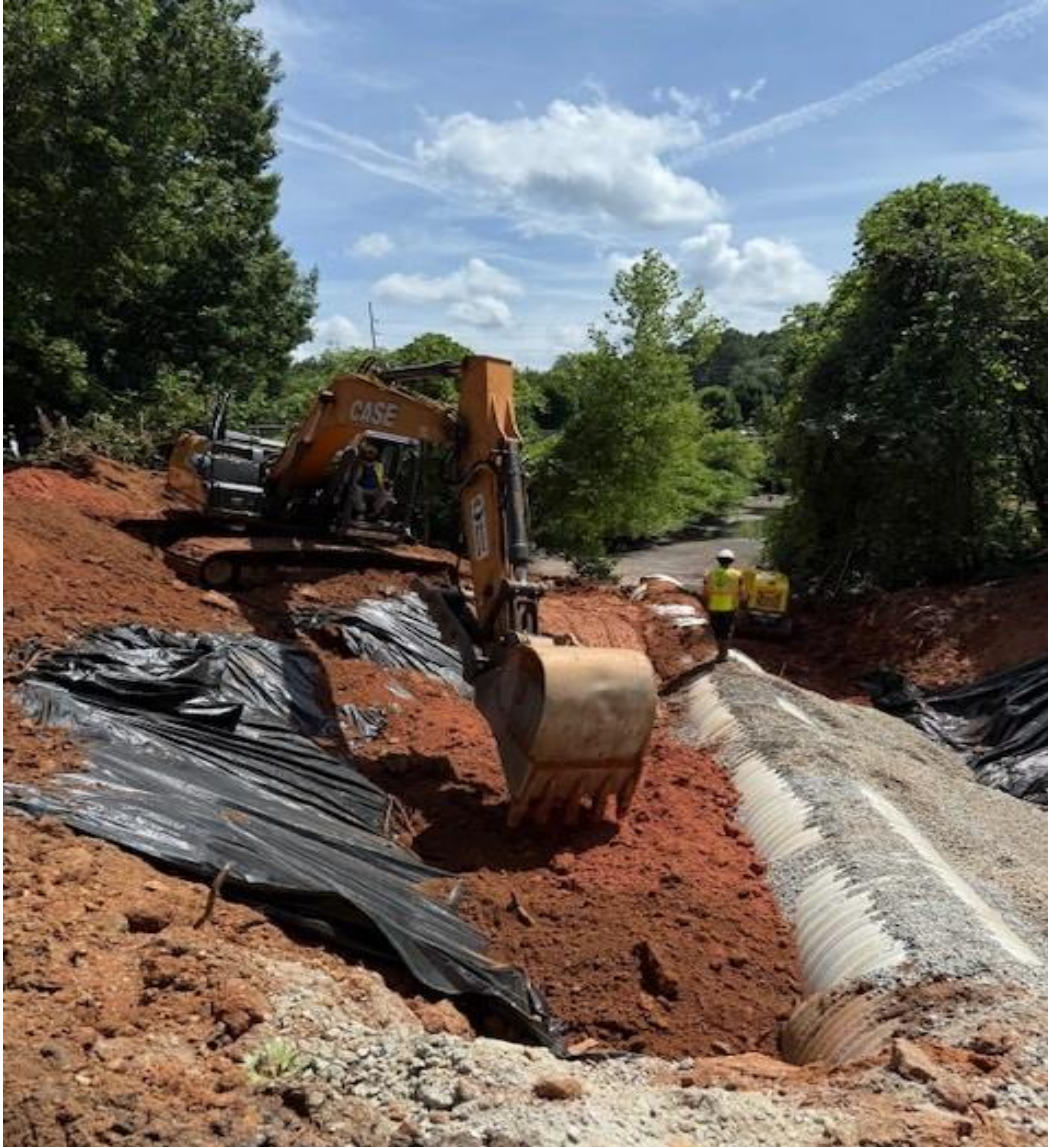
Friday – 6/13/2025 – Replacing retention pond dam and bedding in new 60” CMP.

6. Backfill and compact in 12" lifts with suitable soils including clean red clay in the dam area. (Complete)
7. Open existing flood gate to allow maximum flow during heavy rainfall. (Complete)

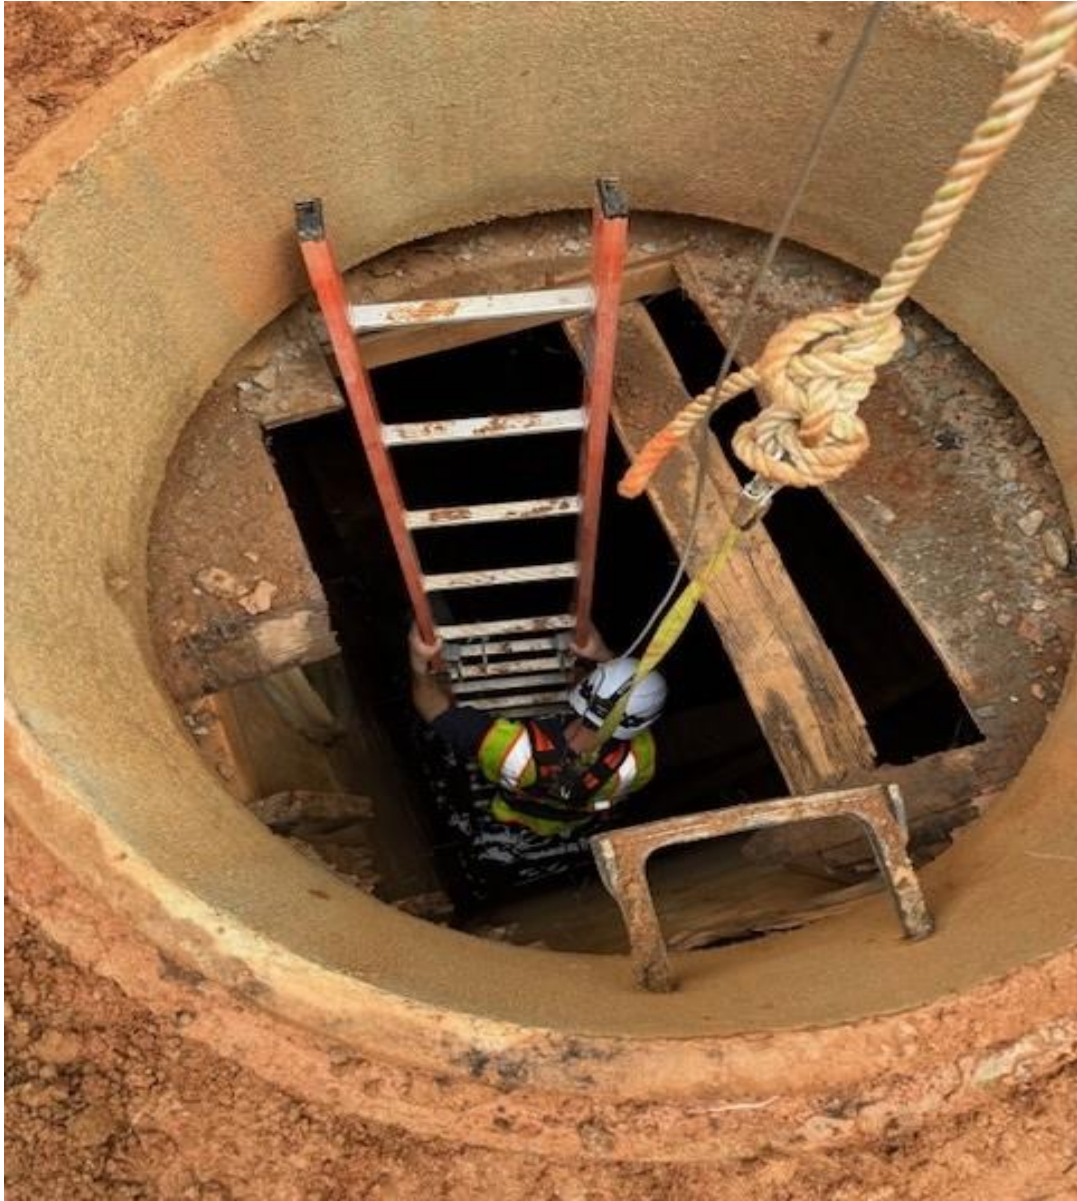
1. Completed inspection June 16, 2025, of vertical outlet and downstream outlet.
2. As captured images show the two vaults were not joined or sealed together, the upper-level vault was set over atop of the existing structure and there is a 12" gap from the exterior point to the interior point of the structures that will need to be sealed and caulked.

Friday - 6/13/2025 – First time entering sub-level basin.

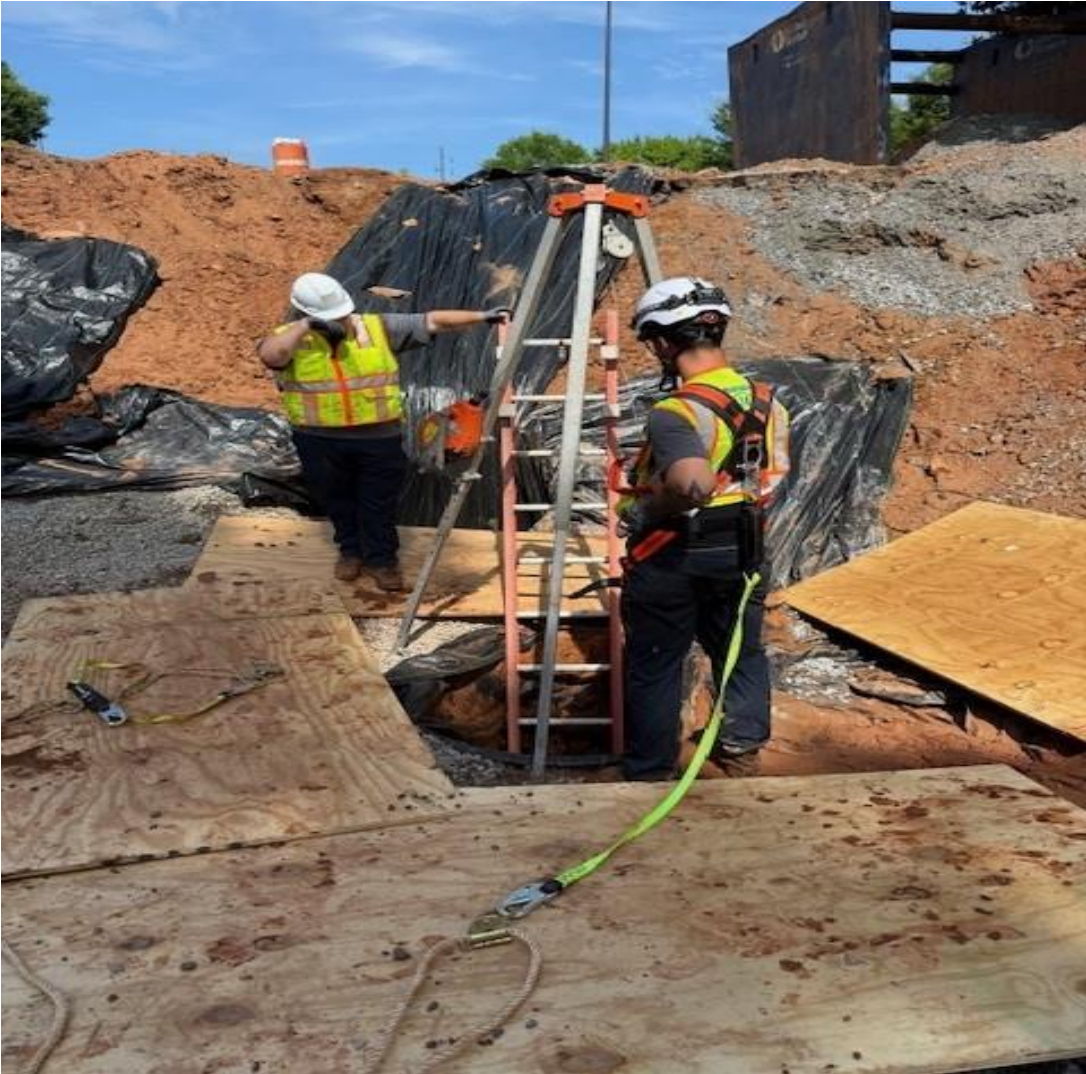
Monday – 6/16/2025 – Safety check for confined space entry.

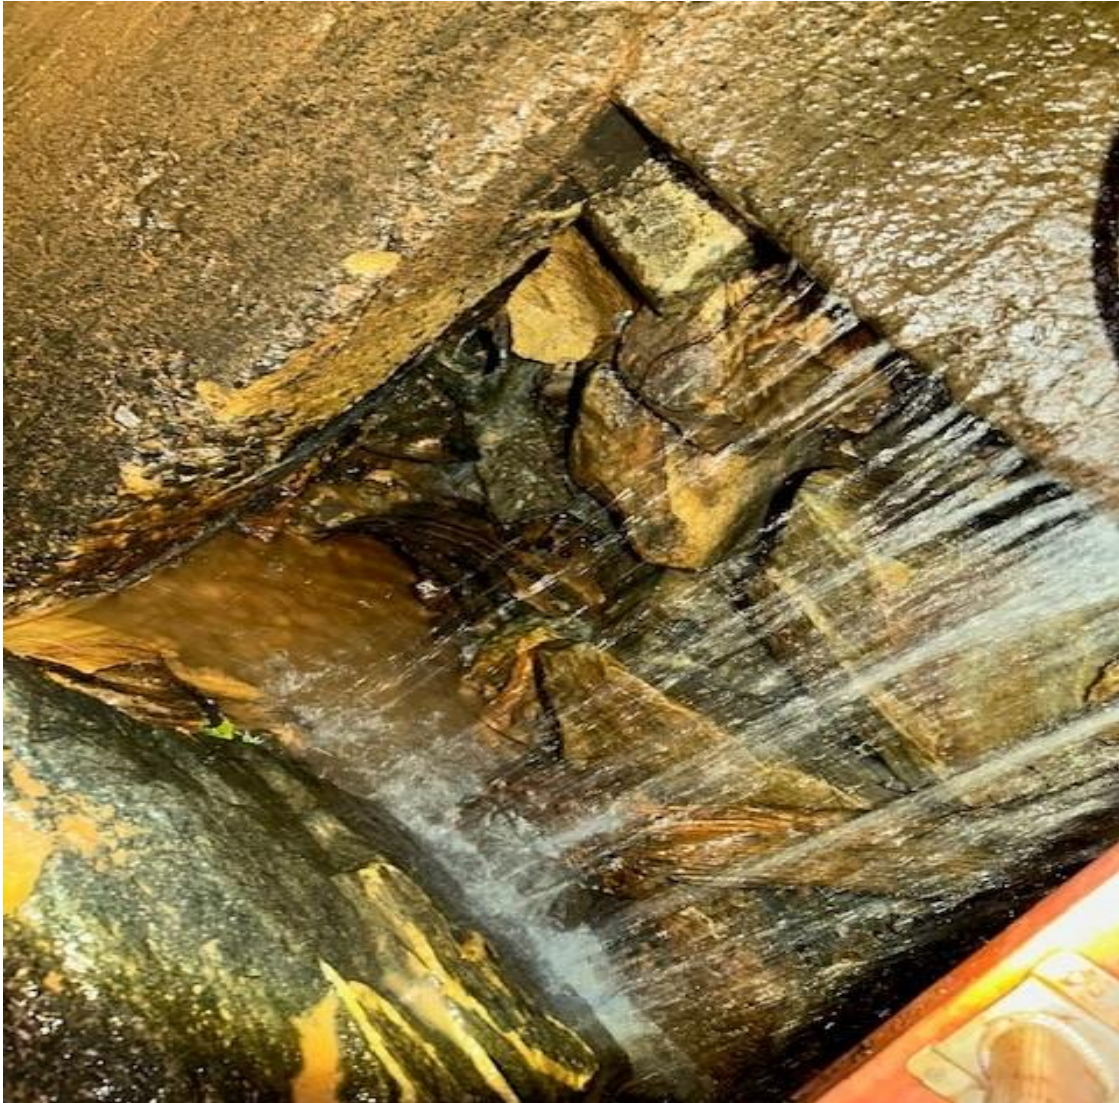
4. Before we entered the lower-level system, the images show that the upstream portion of the legacy drainage system had been condemned and caved in. We believe this occurred when the retention pond was created and the surrounding land parcels were re-developed. The means in which they capped, bridged and sealed the upstream portion of this vault has failed.

Monday – 6/16/2025 – Inlet side of lower-level vault was not properly capped or plugged.

5. We will be entering the lower-level basin and forming and casting a permanent concrete cap or plug that shall be 12" thick re-enforced with rebar to stop any further erosion or soils entering this system. Our inspection of this structure to the horizontal downstream appears to be in good condition given its age. We will conduct another inspection with the robotic camera later this week to determine where it terminates and the impact on the termination area.

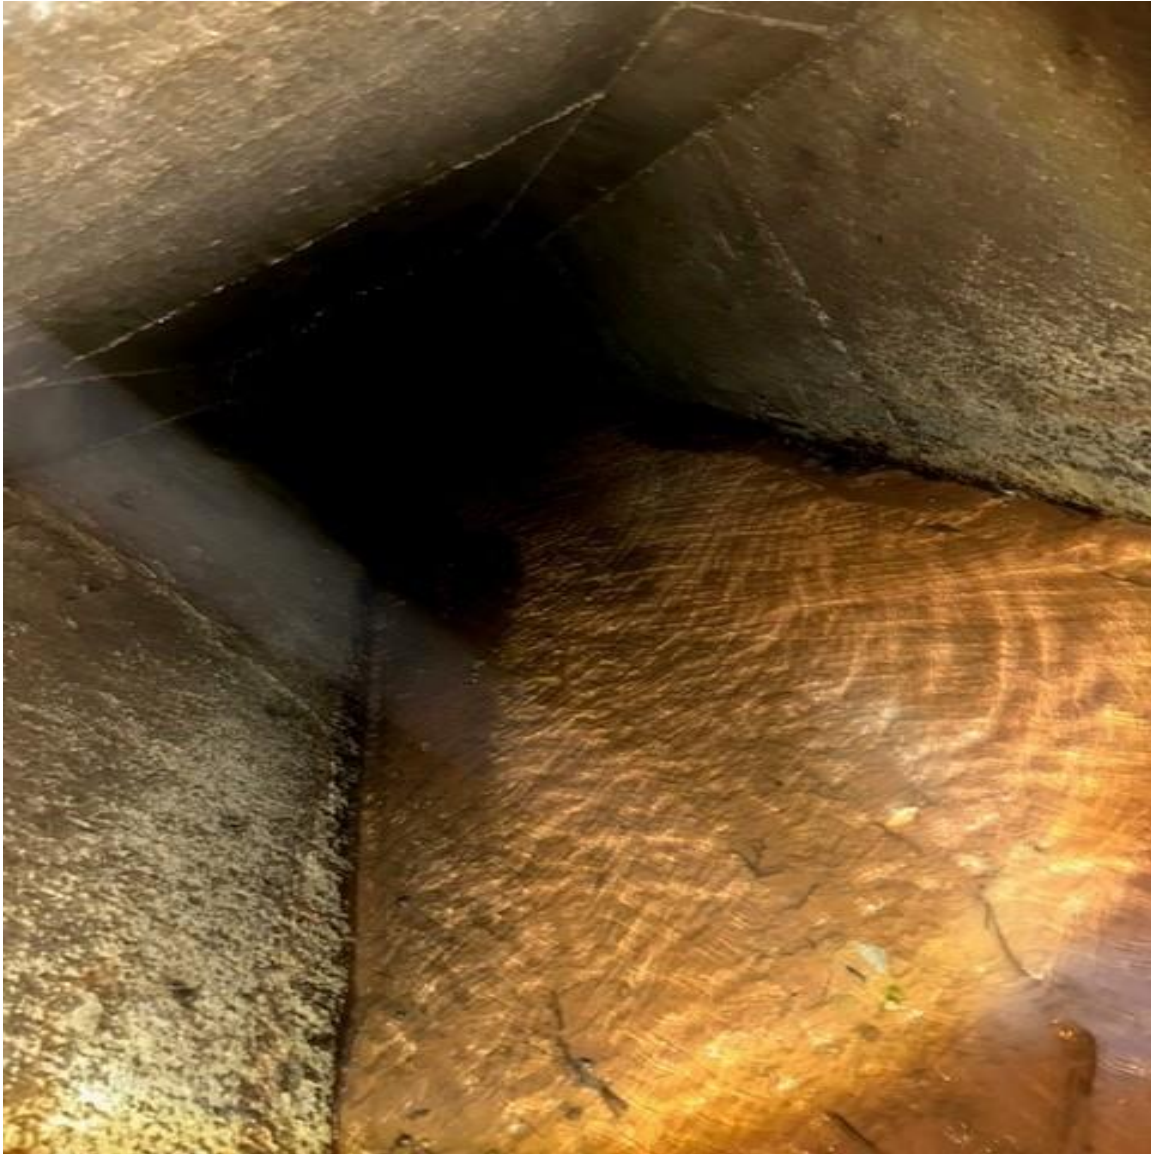
Monday – 6/16/2025 – Downstream outlet of lower-level vault. Upon this inspection the system was found to be in good working condition.

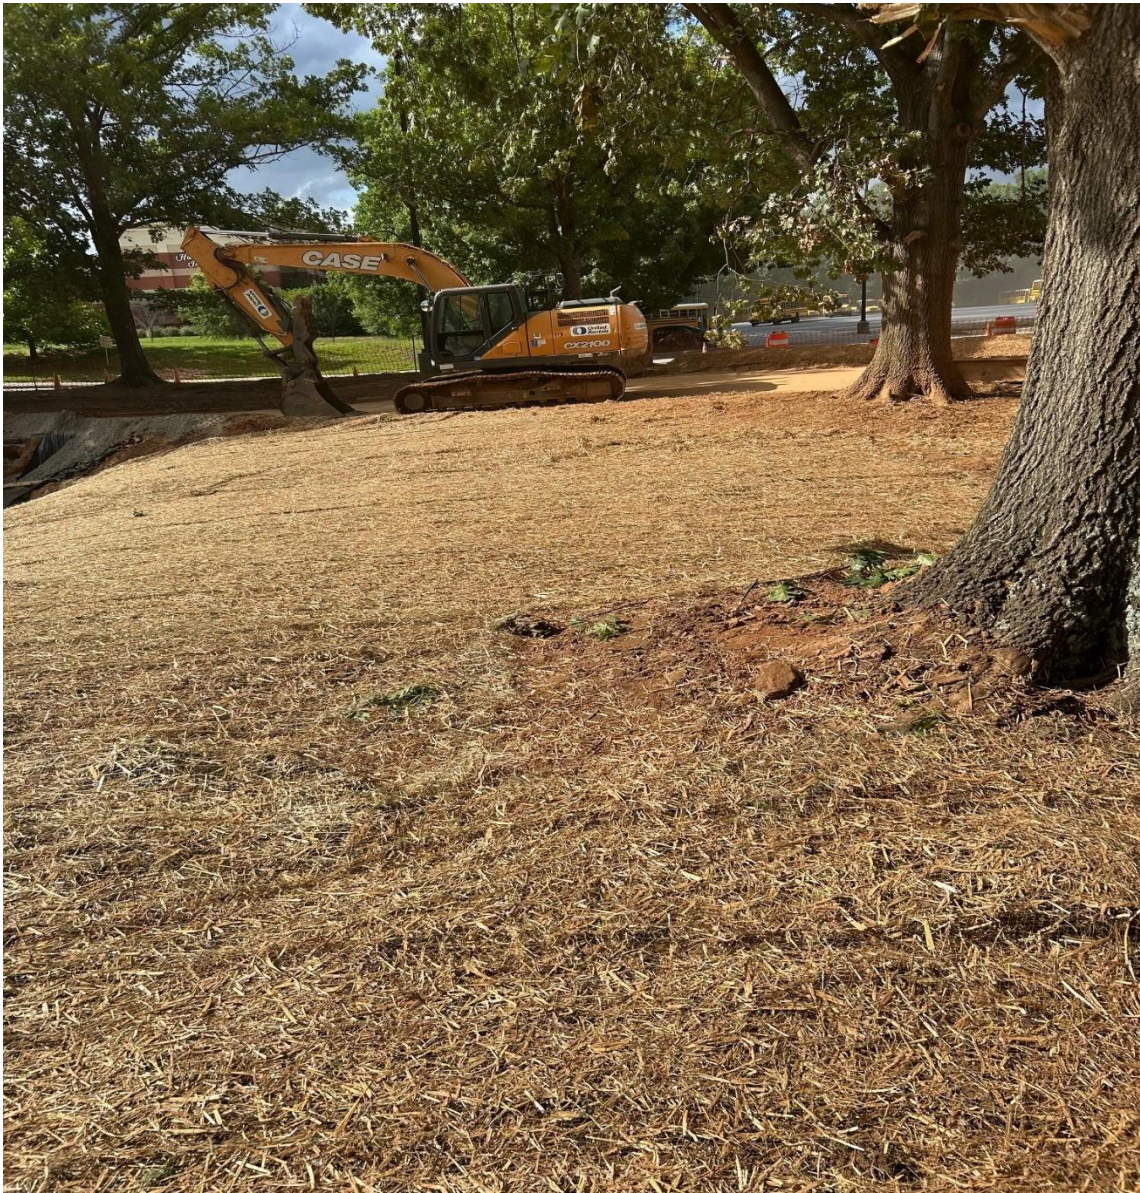
Tuesday – 6/17/2025 – Erosion Control

10. Create an erosion and maintenance plan for long term duration of project. (In-Progress)
