K.E.G. Plumbing & Mechanical, Inc.

AIC – Initial Findings

1701 Mountain Industrial Boulevard – Stone Mountain, GA

Summary of Observations (as of June 18, 2025)

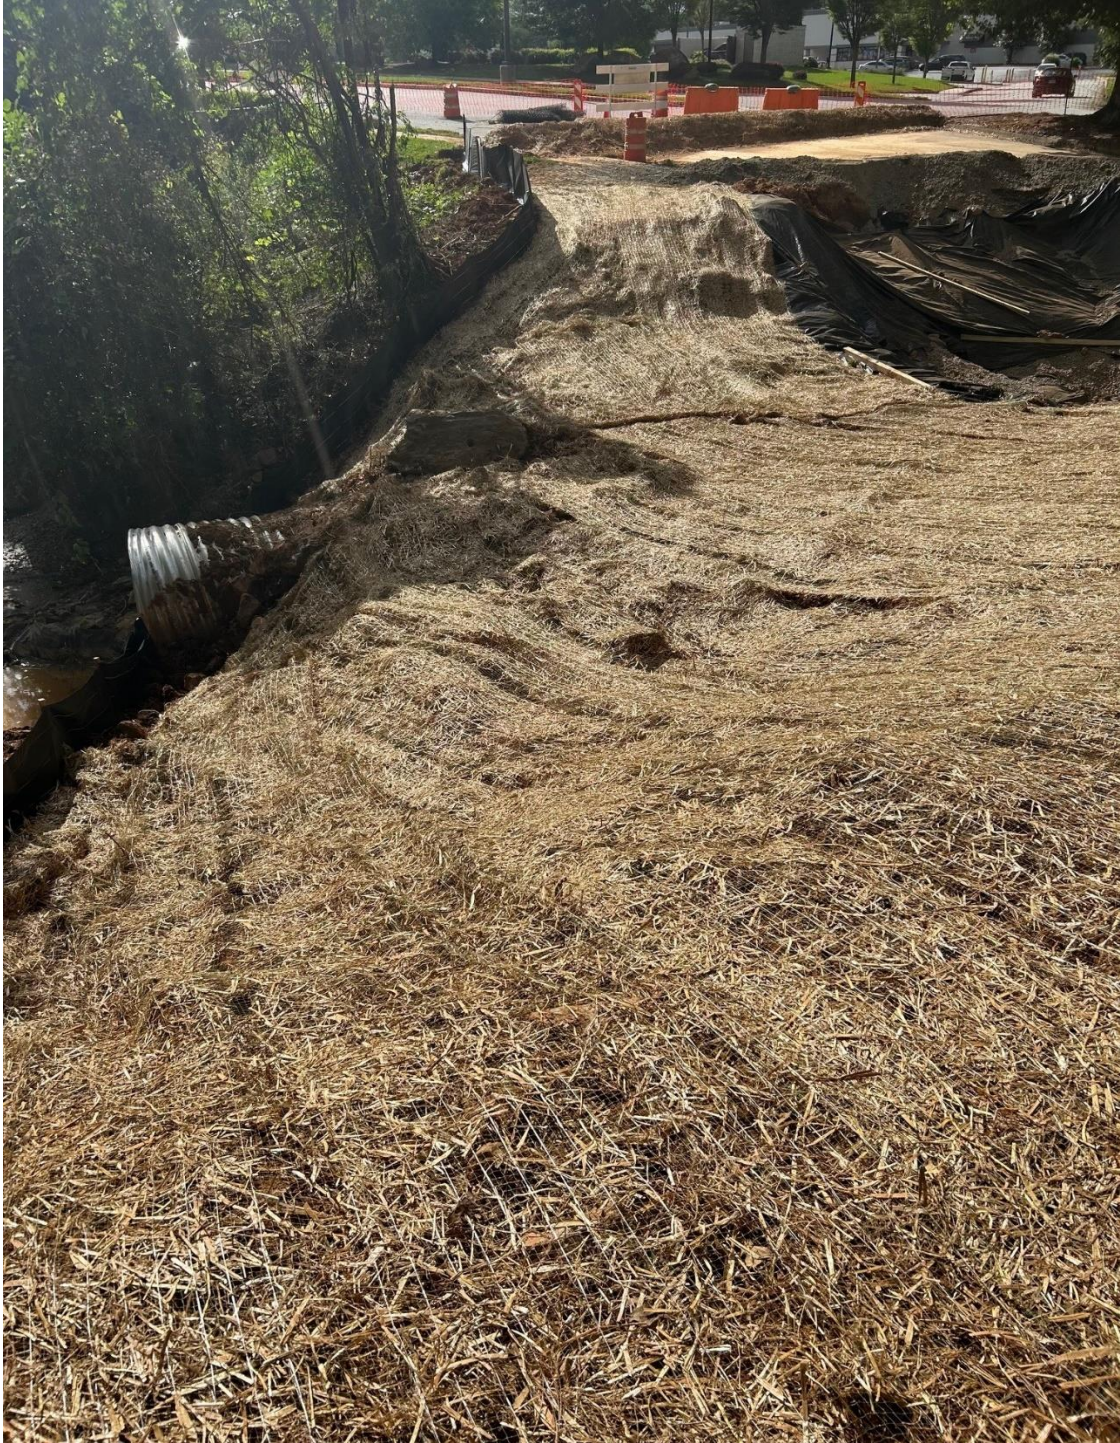
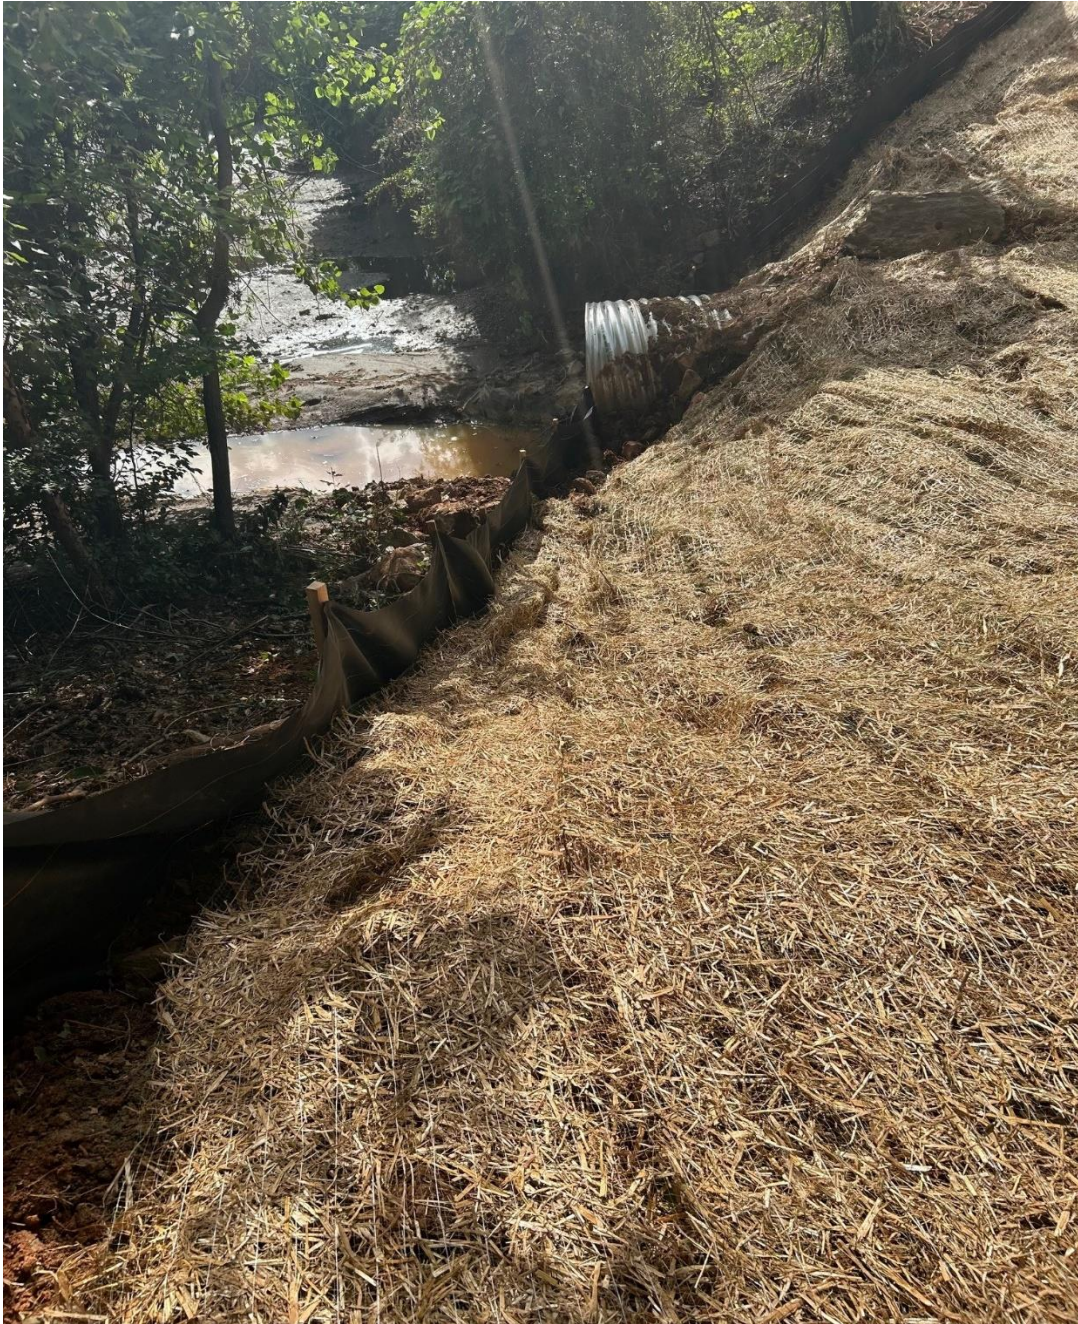
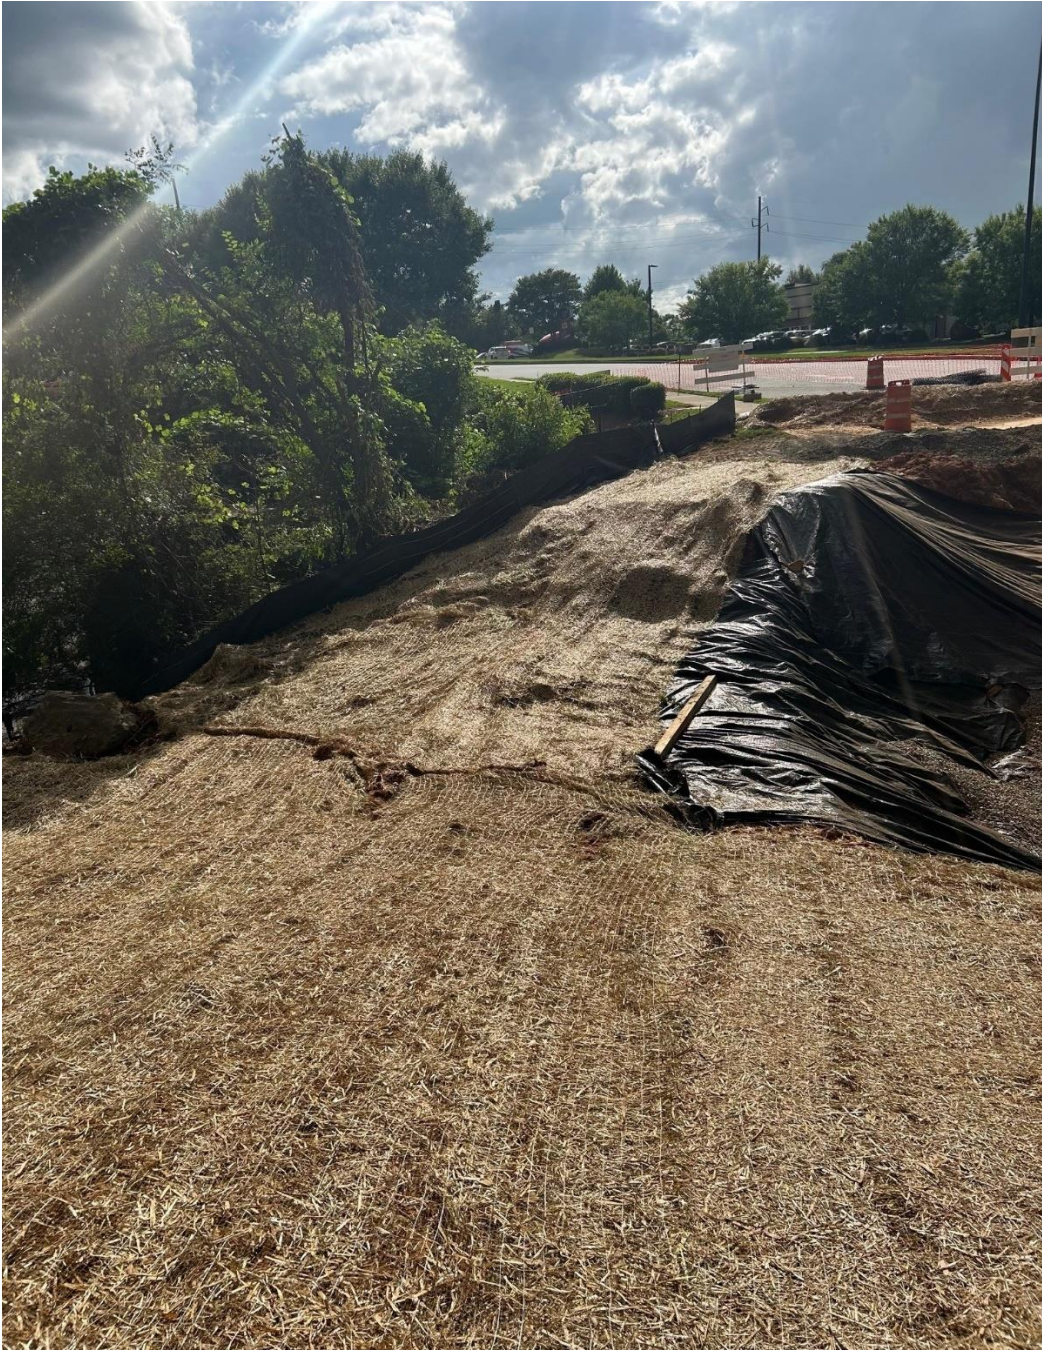
Tuesday – 6/17/2025 – Erosion Control

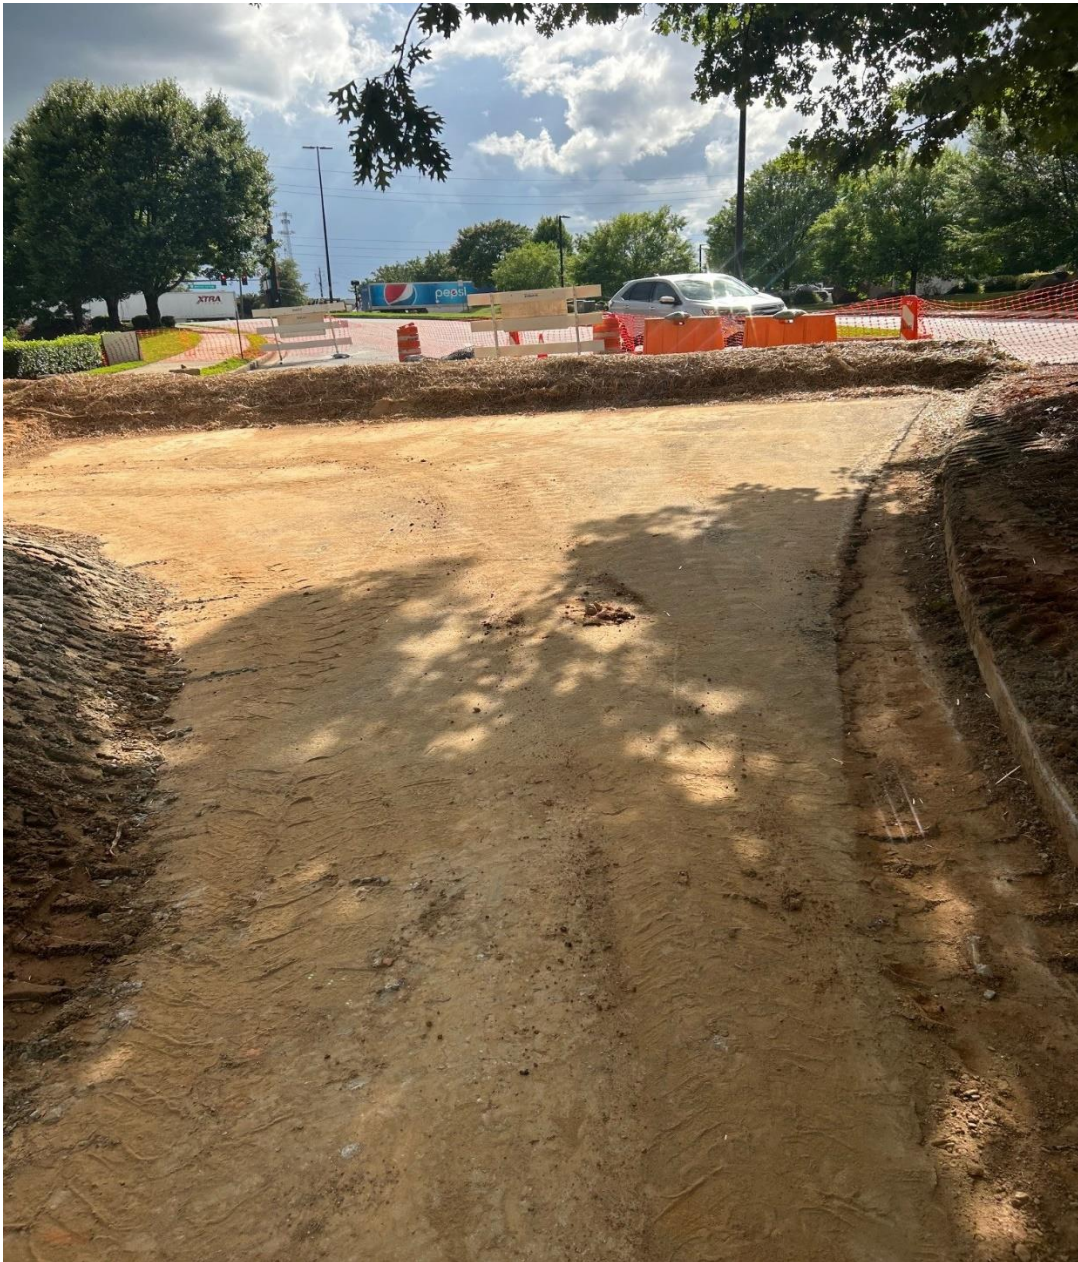
Tuesday – 6/17/2025 – Erosion Control

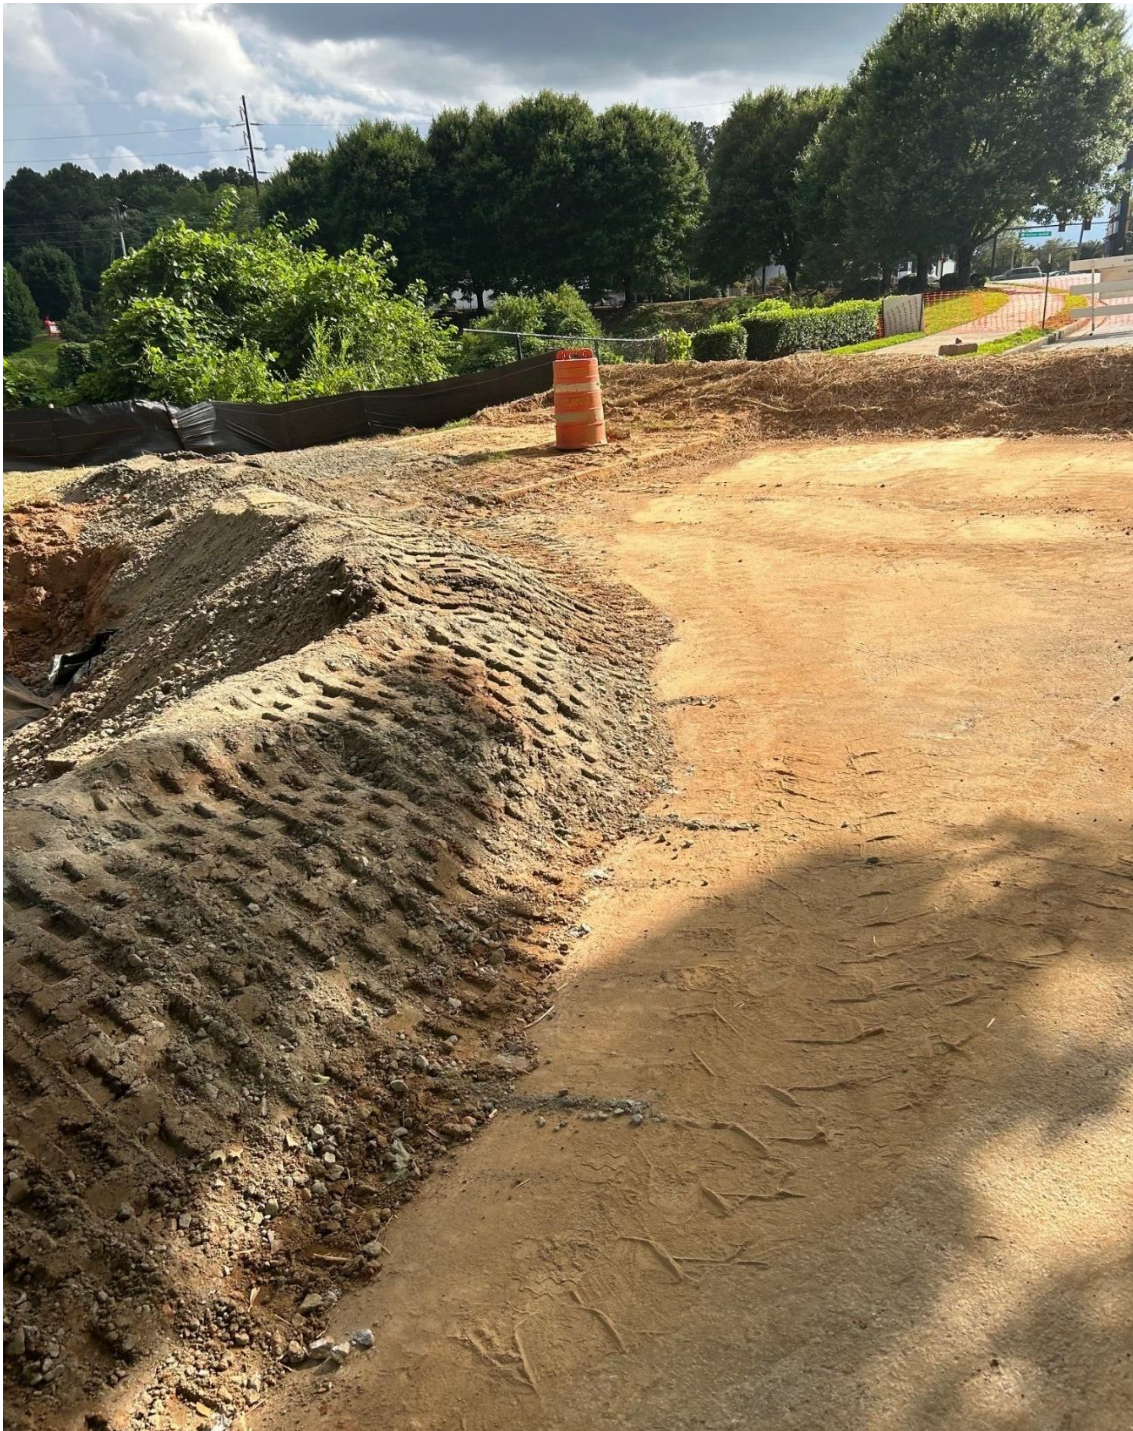
Tuesday – 6/17/2025 – Erosion Control

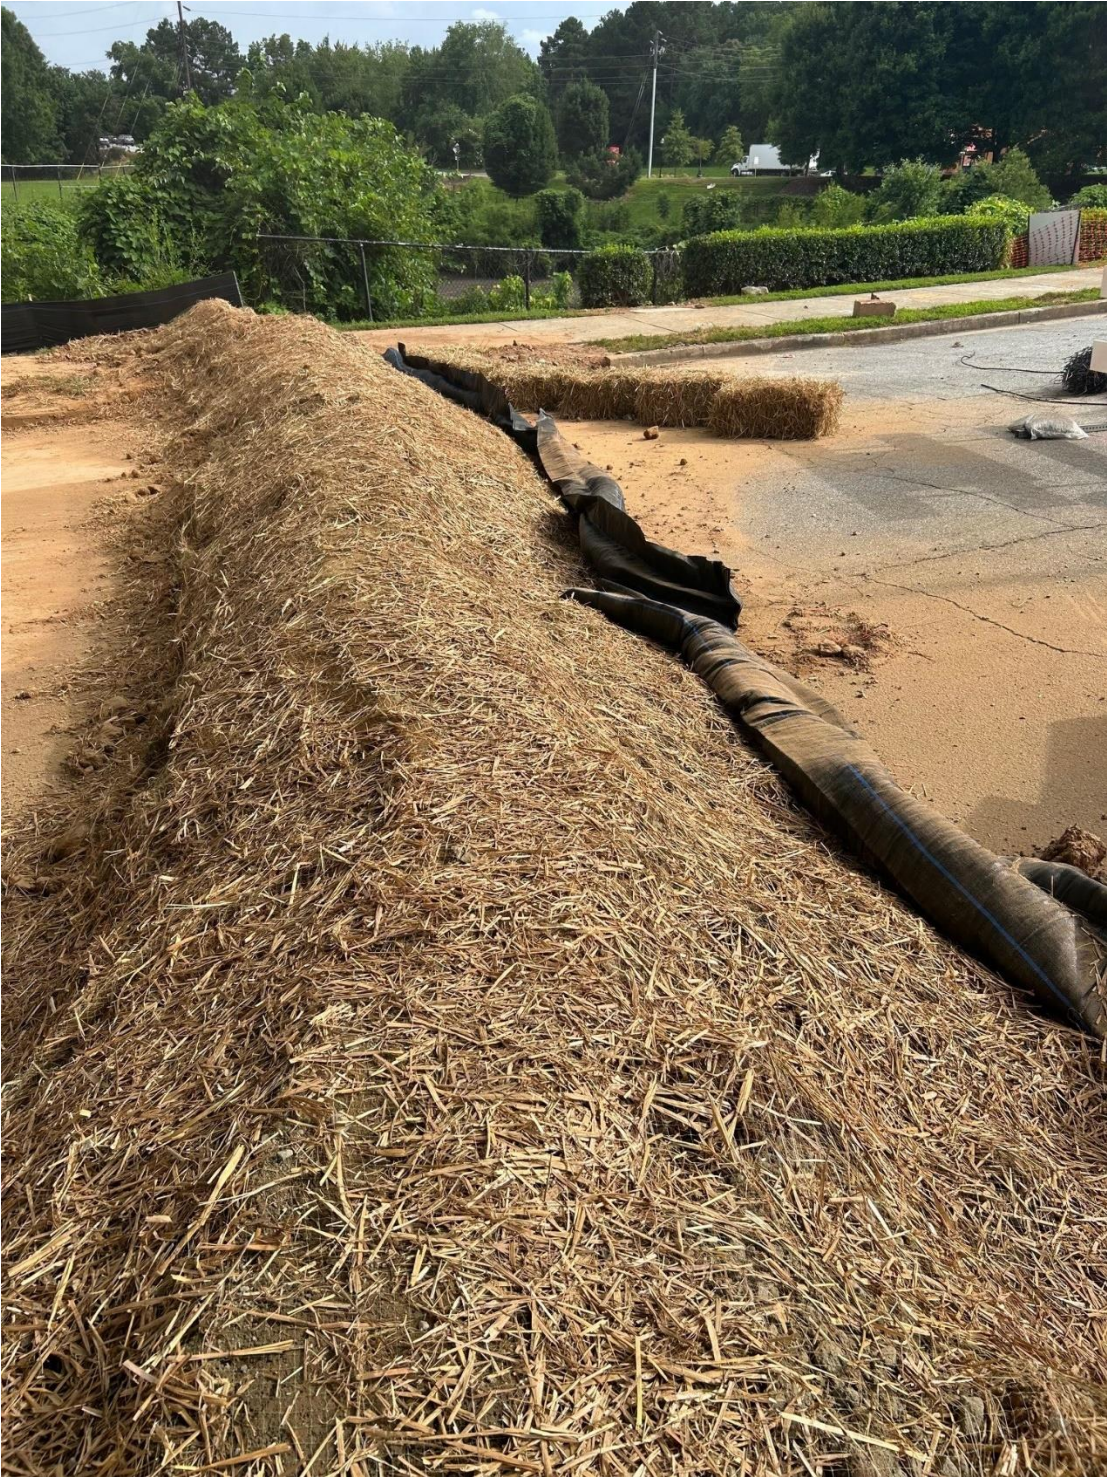
Tuesday – 6/17/2025 – Erosion Control

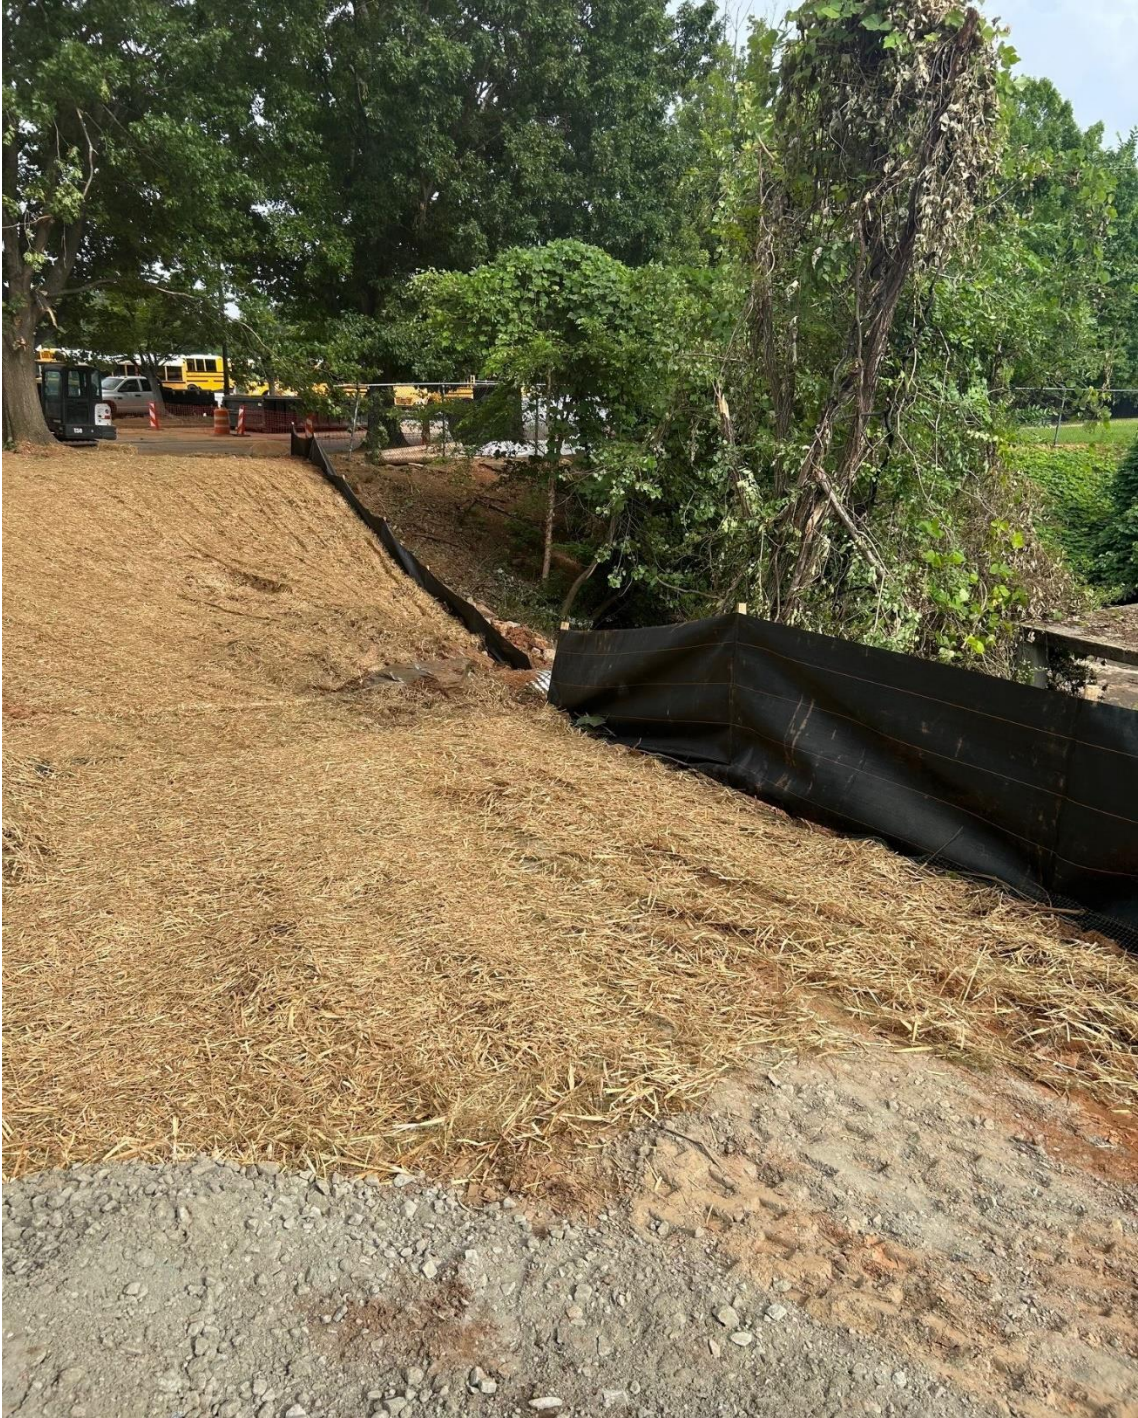
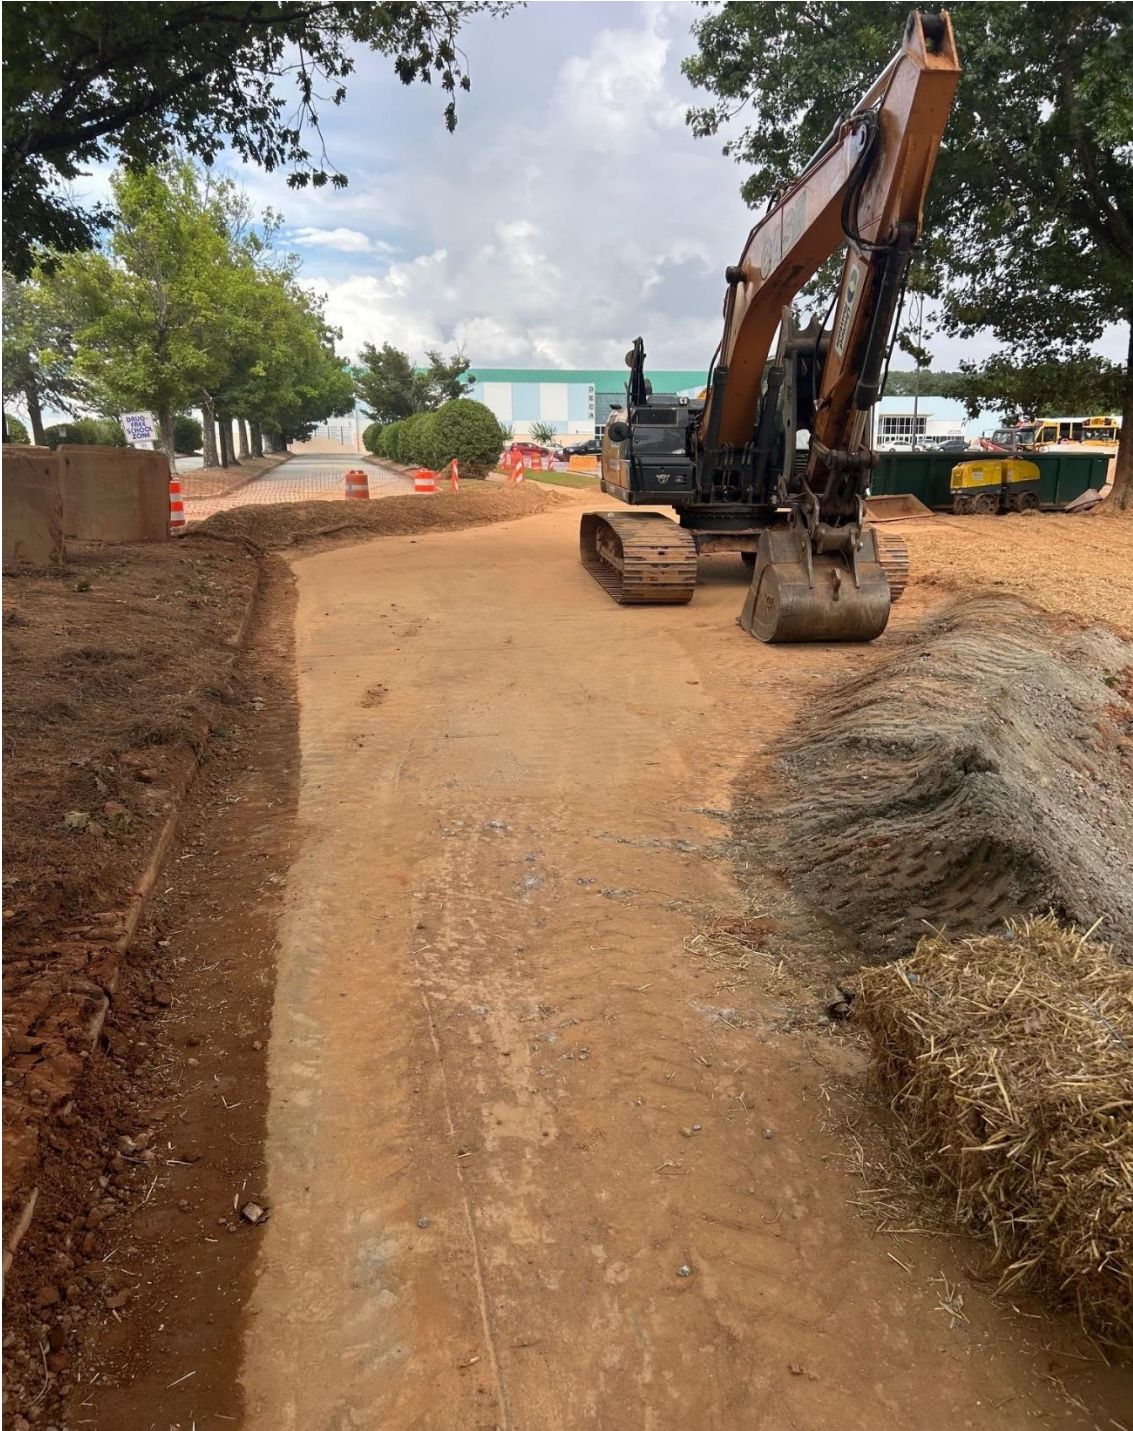
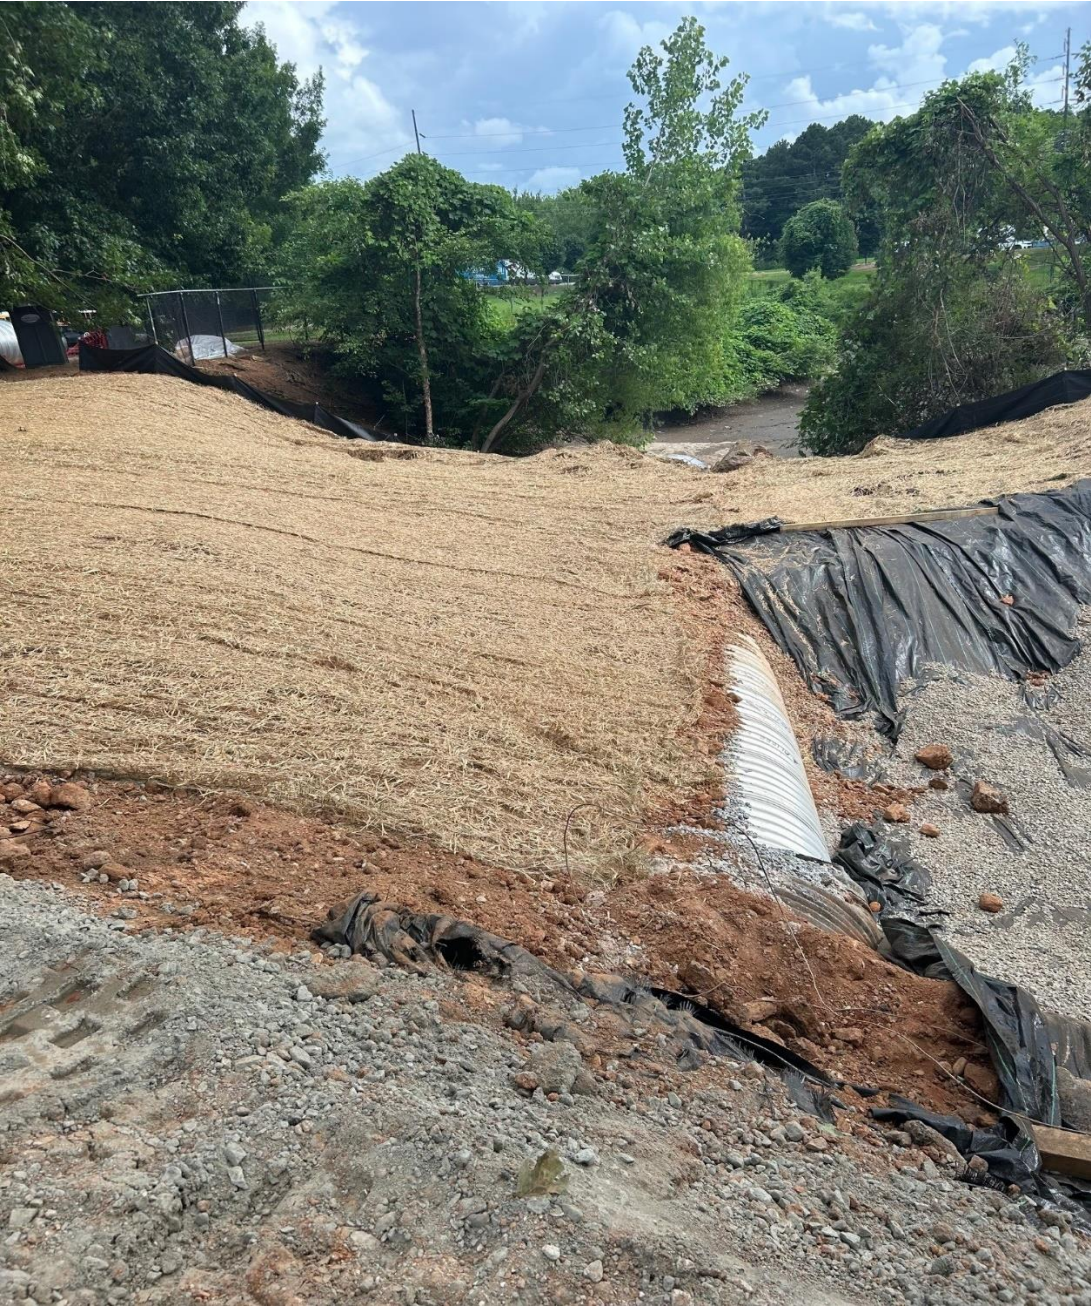
Tuesday – 6/17/2025 – Erosion Control
