# Draft Facilities Master Plan

# SANTA ROSA CITY SCHOOLS FACILITIES MASTER PLAN

Board Meeting 2023.11.08: Draft FMP Presentation

# HERBERT SLATER MIDDLE SCHOOL

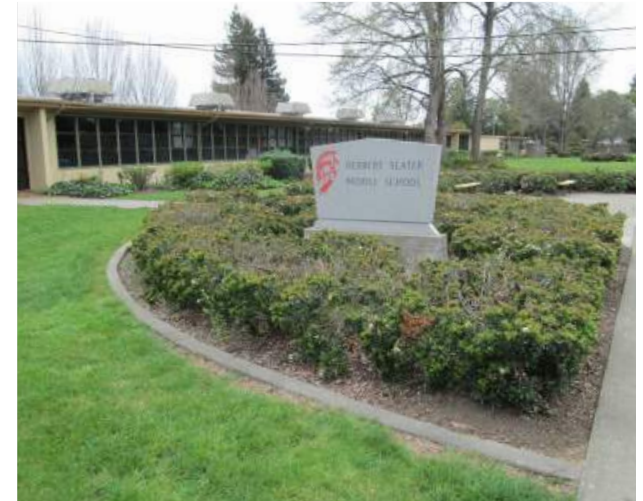
- No accessible student drop off provided
- Accessible path of travel slopes exceed allowable across campus
- Lacking ADA signage for path of travel
- Existing play area & driveway paving in general need of maintenance
- Mature trees, landscaping and play fields in need of renovation
- Foundation settling at classroom wings

School Entry on Sonoma

- Interior courtyards areas provide opportunities for small group instruction
- Provide storm water drainage away from buildings along Sonoma Avenue
- Provide more site storage and remove shipping containers

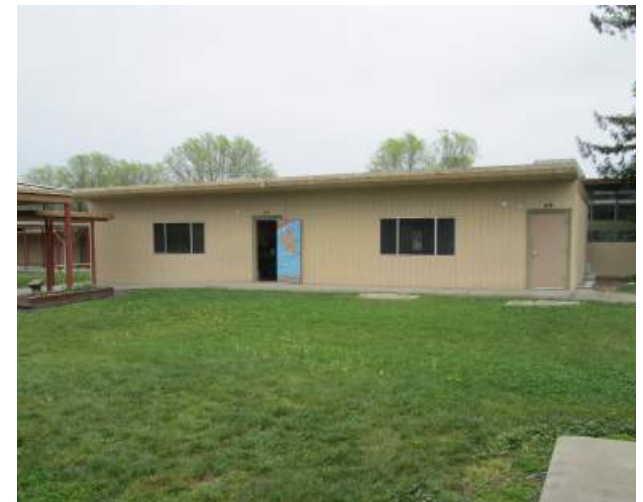
Interior Courtyard

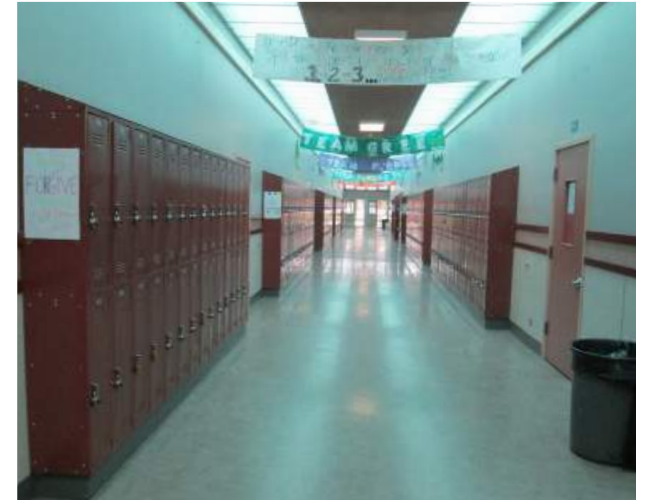
- Aged facilities in need of some modernization
- Evidence of water intrusion in some locations
- Lacking ADA compliant room signage
- Foundation settlement along South edges of Classroom wings

Internal Classroom Corridor

- Repurpose Sewing Room and Computer Rooms
- Improve natural lighting & ventilation
- Remodel food classroom to be ADA compliant
- Refinish outdated Finishes, Furnishings, and Equipment

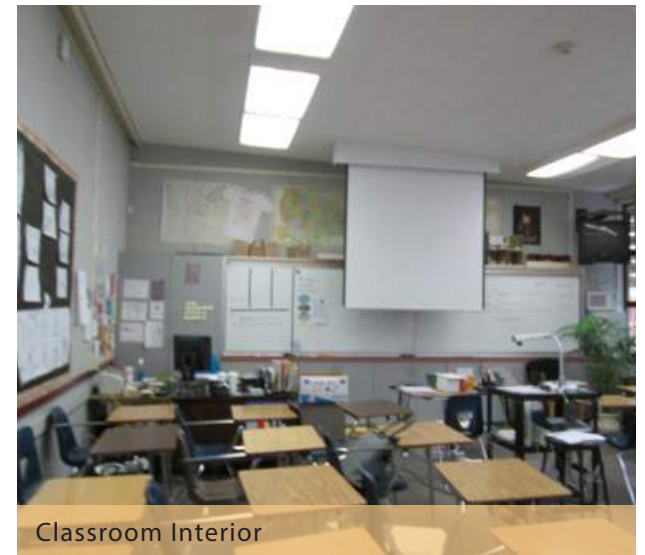
Classroom Interior

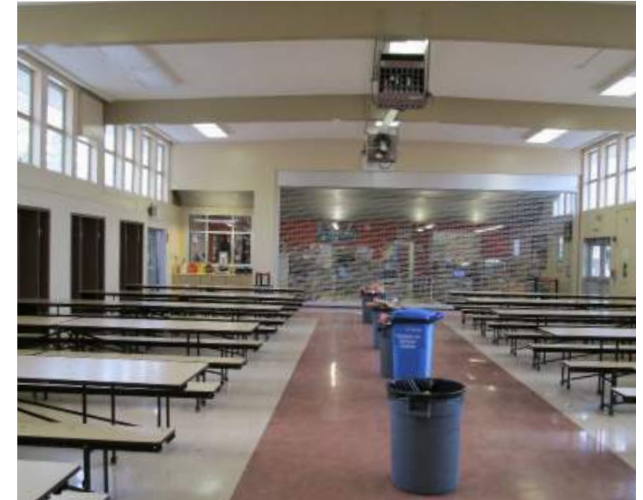
- Aged facilities in need of some modernization
- Evidence of water intrusion in some locations
- Lacks ADA compliant room signage
- Telescoping tables and benches in poor condition

Cafeteria Interior

- New Multi-purpose Room with additional performing arts

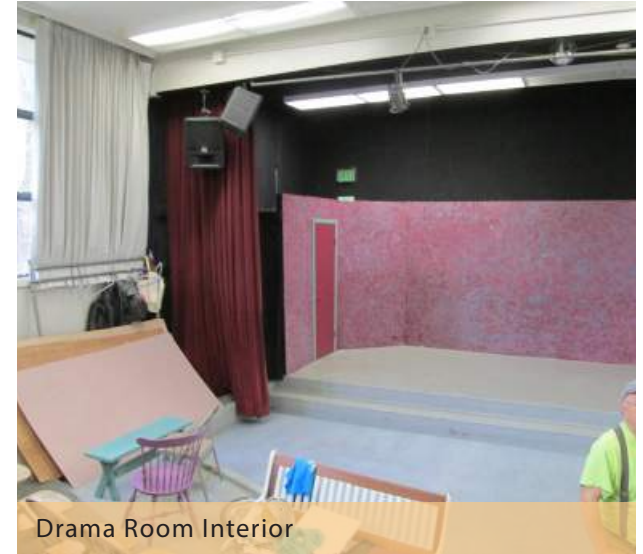
- Aging building in need of modernization
- Lacks real stage and theater seating
- Lacks ADA compliant room signage
- Exterior southwest entry at Drama Room not ADA compliant

Drama Room Interior

- Repurposing Vending Area
- Provide Choral Room
- Provide permanent risers in Music Room

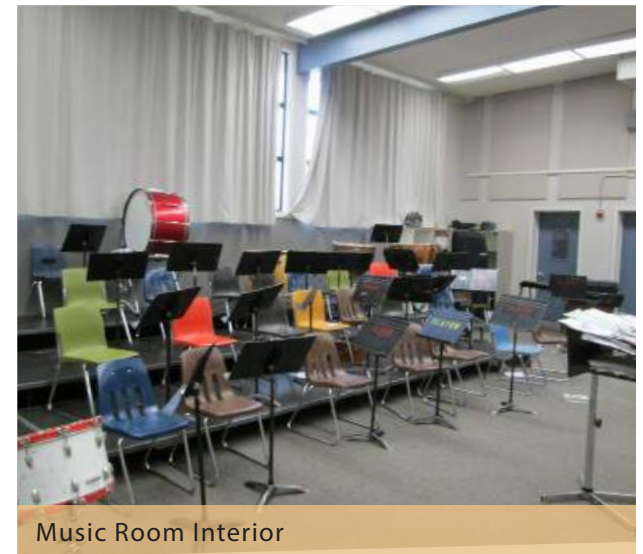
Music Room Interior

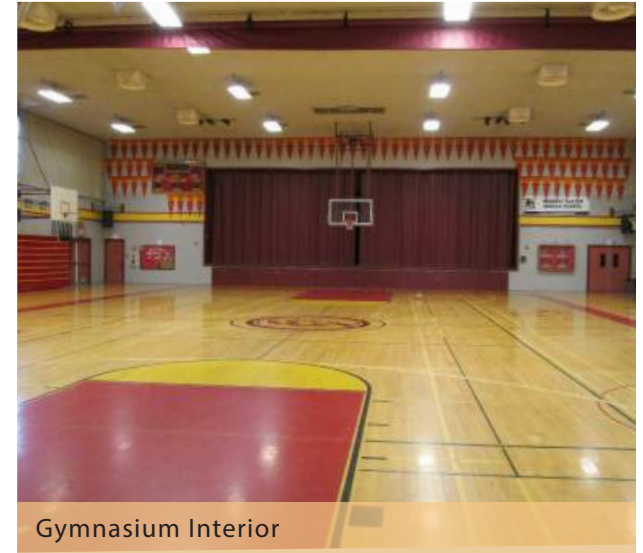
Gymnasium Interior

- Aged facilities in need of modernization
- Door thresholds are not ADA compliant
- Evidence of water intrusion in ceiling
- Locker rooms lack ADA compliant lockers
- Lacks ADA compliant room signage
- Telescoping bleachers in poor condition

- Replace wrestling mat storage
- Improve light and ventilation
- Provide accessible exterior entry to Stage

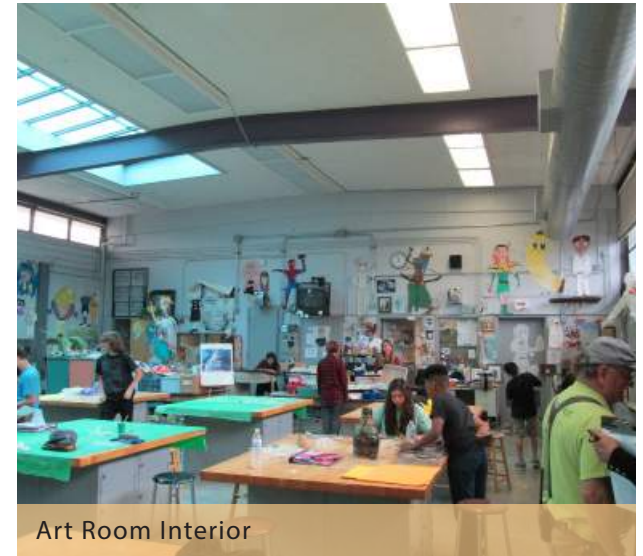
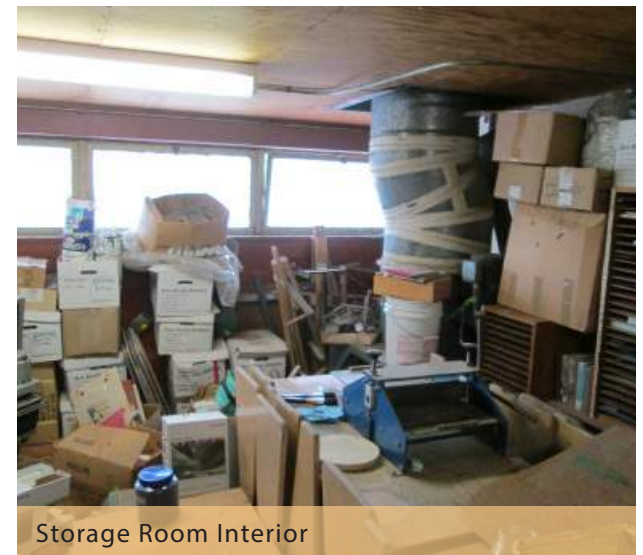
- Aged facilities in need of modernization
- Evidence of water intrusion in ceiling
- Lacks ADA compliant room signage
- Second Floor loft not ADA compliant

- Revitalize spaces
- Consolidate storage

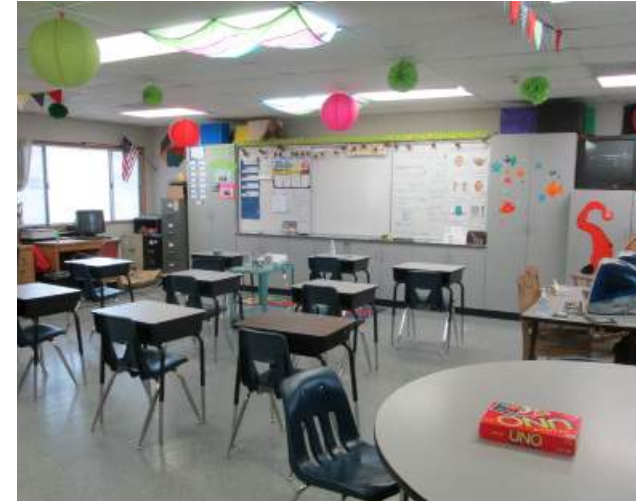
- Aged facilities in need of some modernization
- Evidence of water intrusion in ceiling
- Lacks ADA compliant room signage

Modular Interior

- Courtyard areas provide opportunity for group instruction

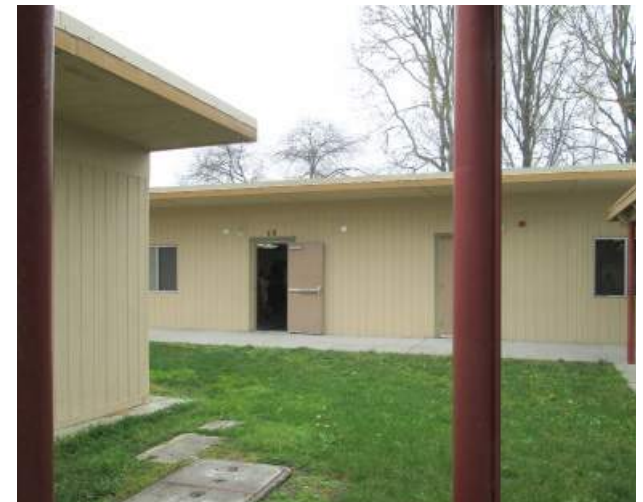
Modular Exterior Courtyard
