**MILLER PACIFIC
ENGINEERING GROUP**

**FAULT TRENCH INVESTIGATION
PROCTOR TERRACE ELEMENTARY SCHOOL
1711 BRYDEN LANE
SANTA ROSA, CALIFORNIA**

September 11, 2025

Project 1079.121

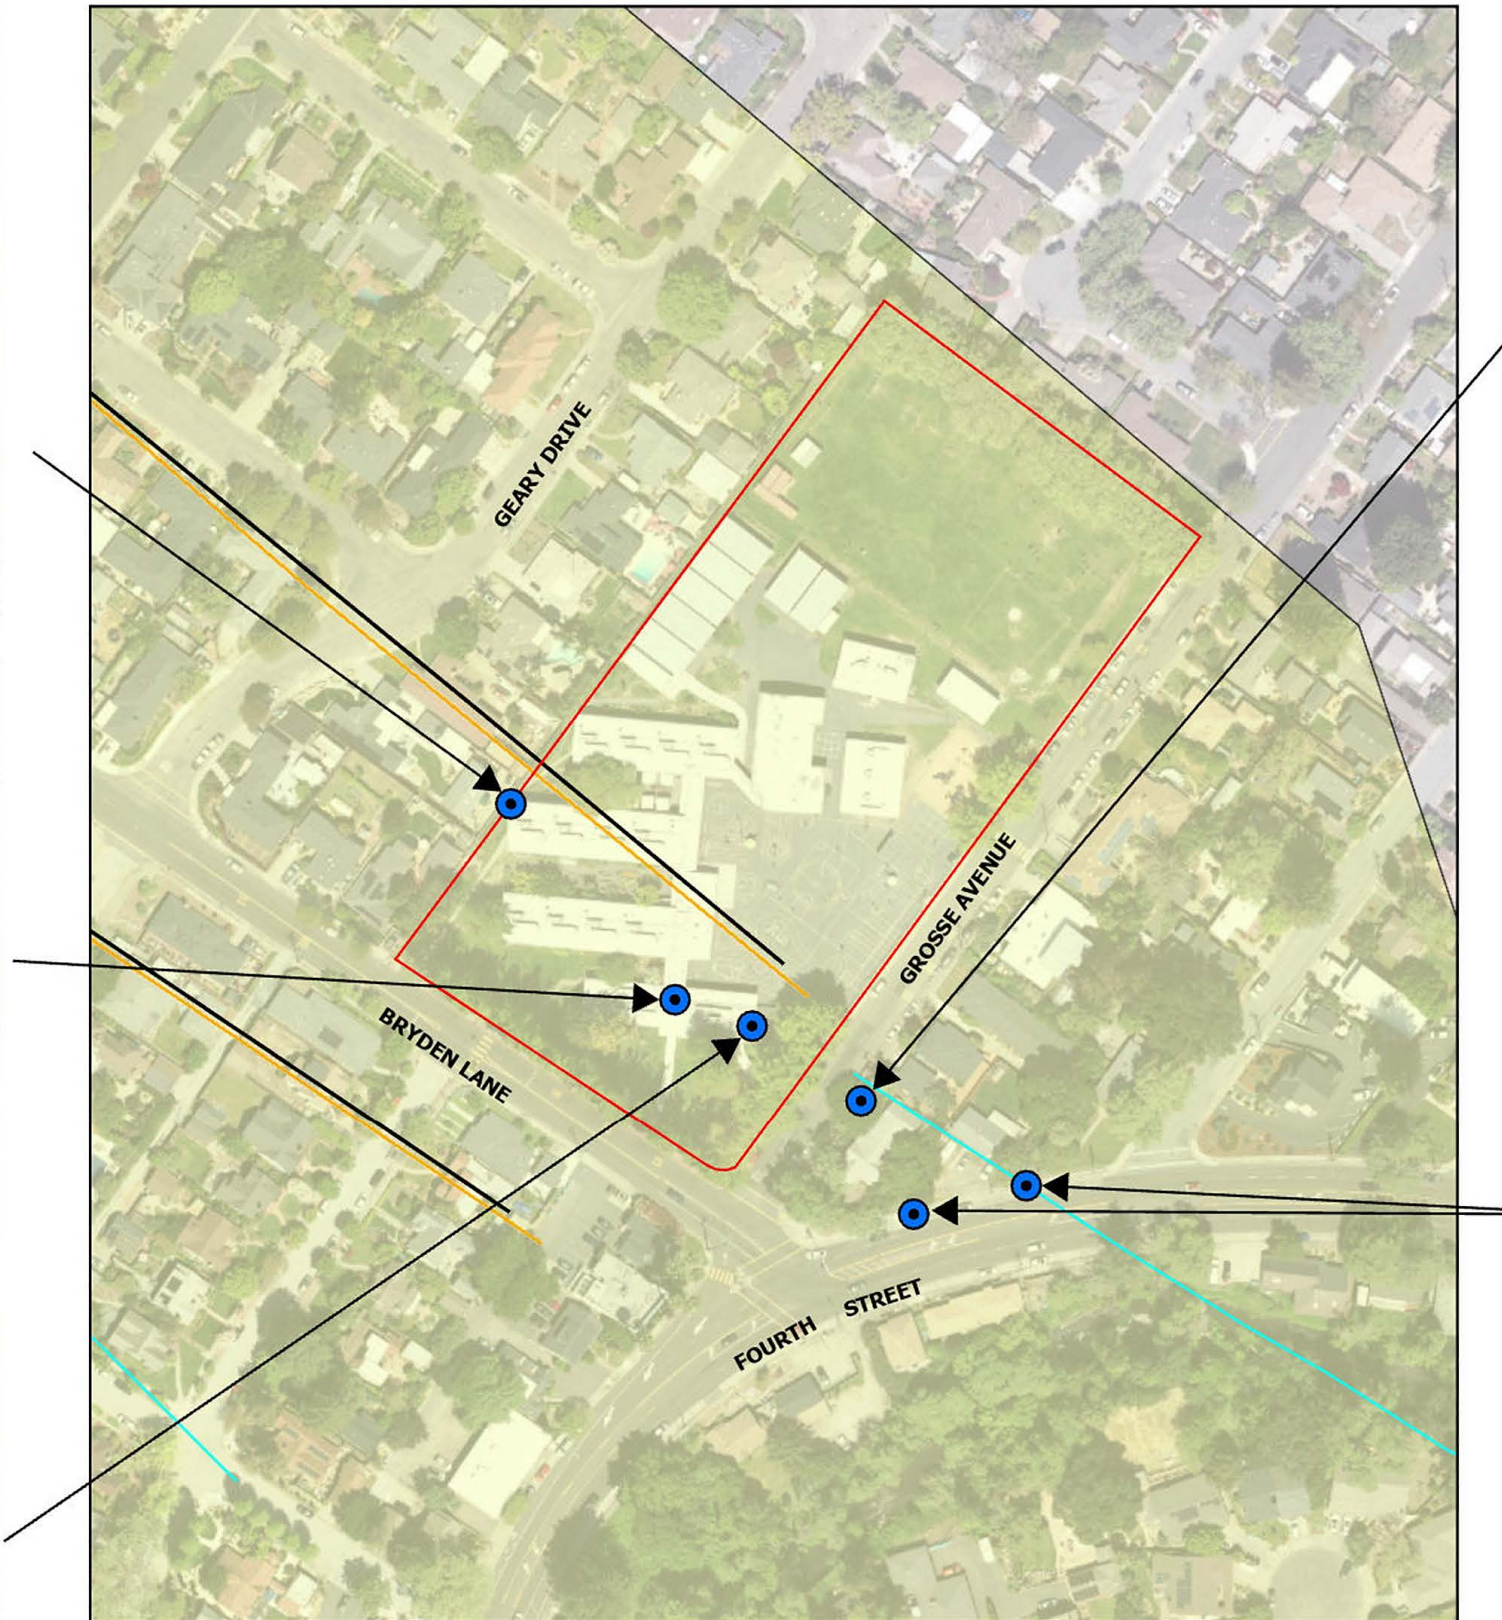
- In the central part of the main building, at the intersection of the western wing's hallway and the main hall connecting the other 2 wings, we observed that the linoleum floor is damaged, with visible cracks extending from the northern and southern corners of the hallway intersection. The cracks in the floor exhibit patterns typically associated with shear failure, including en-echelon cracks and apparent pull-apart zones. See Location 2 on Figure 5.

- At the southern corner of the main building's west wing, we observed similar damage to the exterior stucco as noted at the northern corner, as shown on Figure 5 (Location 3). Aside from the aforementioned locations, no similar distress was noted in either the interior or exterior of the campus structures.

- Along the southeast side of Grosse Avenue, the three concrete driveways closest to Bryen Lane exhibit conspicuous and extensive cracking. See Location 4 on Figure 5. Although this may also be the result of older improvements, poor subgrade conditions, and/or root intrusion from mature trees, we did note that all other driveways and residential flatwork on the southeast side of Gross Avenue appear to be of similar age but in much better condition.

- Farther southeast, sidewalks along the north side of Fourth Street show several apparent right-lateral offsets at the curb/sidewalk control joints. We noted a four locations at which offsets are between about ½ and 1-inch as shown on Figure 5 (Location 5). Cumulatively, we measured a total of about 2 ¾ inches of right-lateral offset across an approximately 70-foot wide zone. The eastern two locations appear to coincide with the projection of the fault from the south as mapped by McLaughlin (2008).

Location 1 - View to northeast of low northeast-facing scarp at northern corner of main building, approximately coincident with fault trace mapped by Hecker (2016, 2018) and CGS (2024). Note approximate 1-foot rise in ground surface against block wall and prominent cracks in stucco facade.

Location 2 - Cracked linoleum floor in main building hallway exhibiting an echelon fractures. Cracks extend across entire hallway along northwest trend.

Location 3 - View to north of damaged stucco at south corner of main building at location of deformation zone observed in Trench T-4 and approximately on strike with mapped fault and locations 1 and 2.

Location 4 - View to south of severely damaged concrete driveways. Most of the concrete flatwork in the surrounding area is older, but in reasonably good condition without similarly prominent or extensive damage.

Photo 5 - View to northeast of right-lateral offsets between sidewalk panels along Fourth Street. Total of 4 locations noted with apparent cumulative offset just under 3 inches.
