# **LAUREL RIDGE ELEMENTARY SCHOOL**

## **RENOVATION**

### **DEKALB COUNTY SCHOOL DISTRICT PRELIMINARY REPORT**

**OCTOBER 29, 2021**

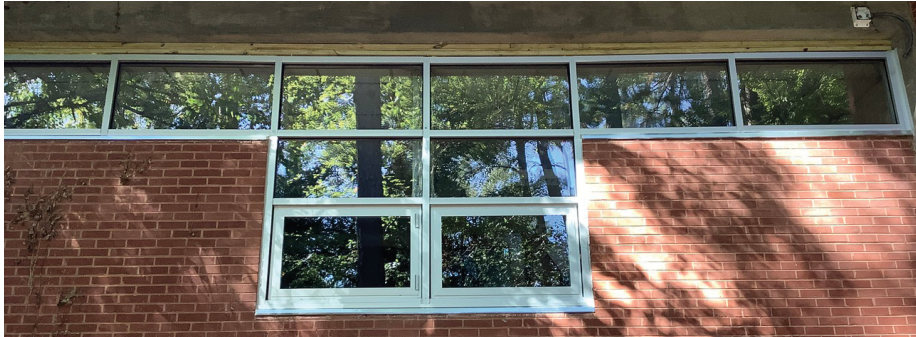
- Exterior brick has some defects typical of a building of its age. There are multiple locations where brick has been patched with excess mortar.
  - Multiple exterior columns have experienced damage over time, exposing rebar
  - Exposed wood in multiple locations where fascia is unfinished.
- 
- Proposed Repairs:
    - Consult with a structural engineer to repair columns.
    - Replace damaged portion of wall, patch cracks in brick masonry with matching brick.

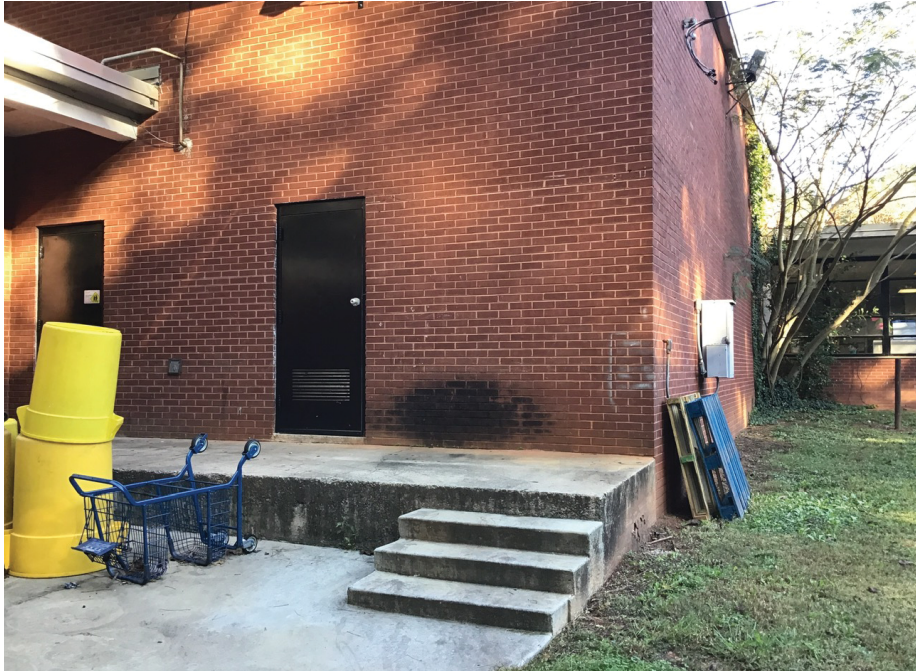
- Exterior brick has some defects typical of a building of its age. There are multiple locations where brick has been patched with excess mortar.
- Multiple exterior columns have experienced damage over time, exposing rebar
- Exposed wood in multiple locations where fascia is unfinished.
- Proposed Repairs:
  - Consult with a structural engineer to repair columns.
  - Replace damaged portion of wall, patch cracks in brick masonry with matching brick.

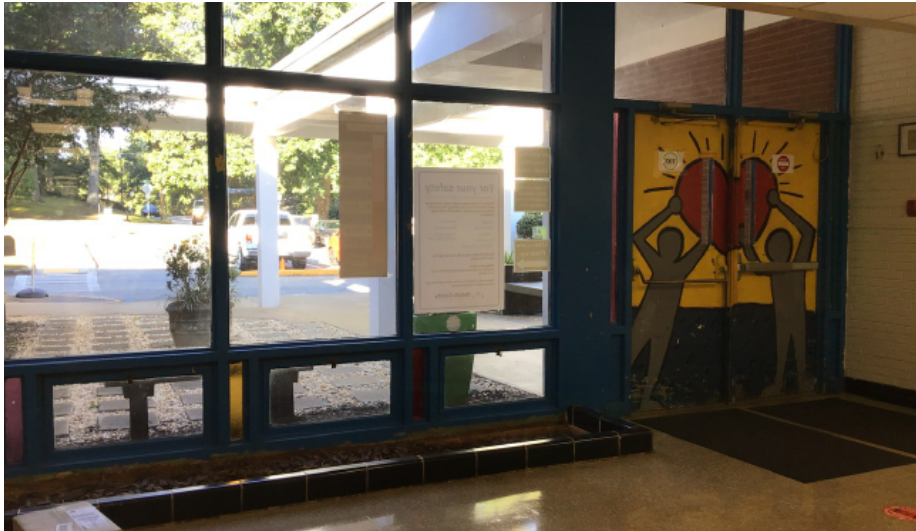
- Existing door hardware should be replaced to meet ADA requirements
- Water damage on ceiling tiles throughout building
- Flooring is terrazo, VCT, and quarry tile throughout. Floor finishes appear to be in fair condition.
- Light fixtures vary between fluorescent pendants and lay in fluorescent fixtures.

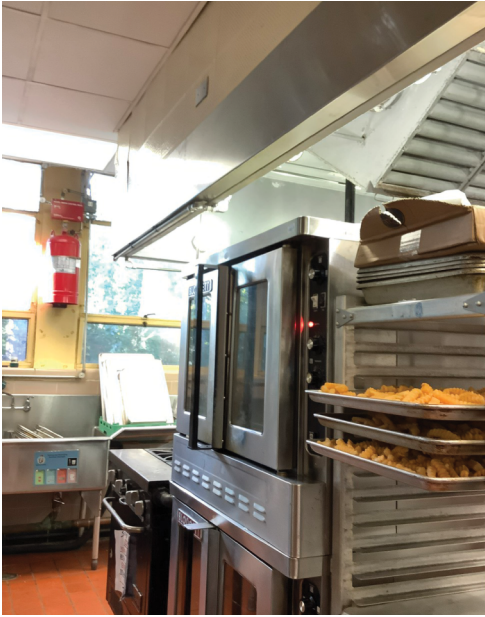
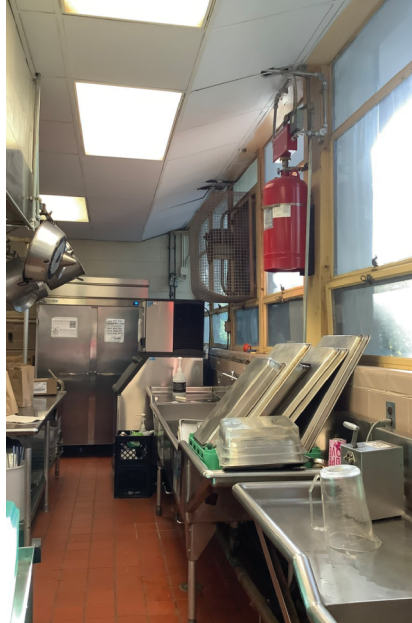
- The existing kitchen is in fair condition. According to the kitchen manager, all equipment is in working order. The kitchen contains equipment that is no longer used. This could result in a resizing of the vent hood.
- Proposed Repairs:
  - Reference mechanical assessment

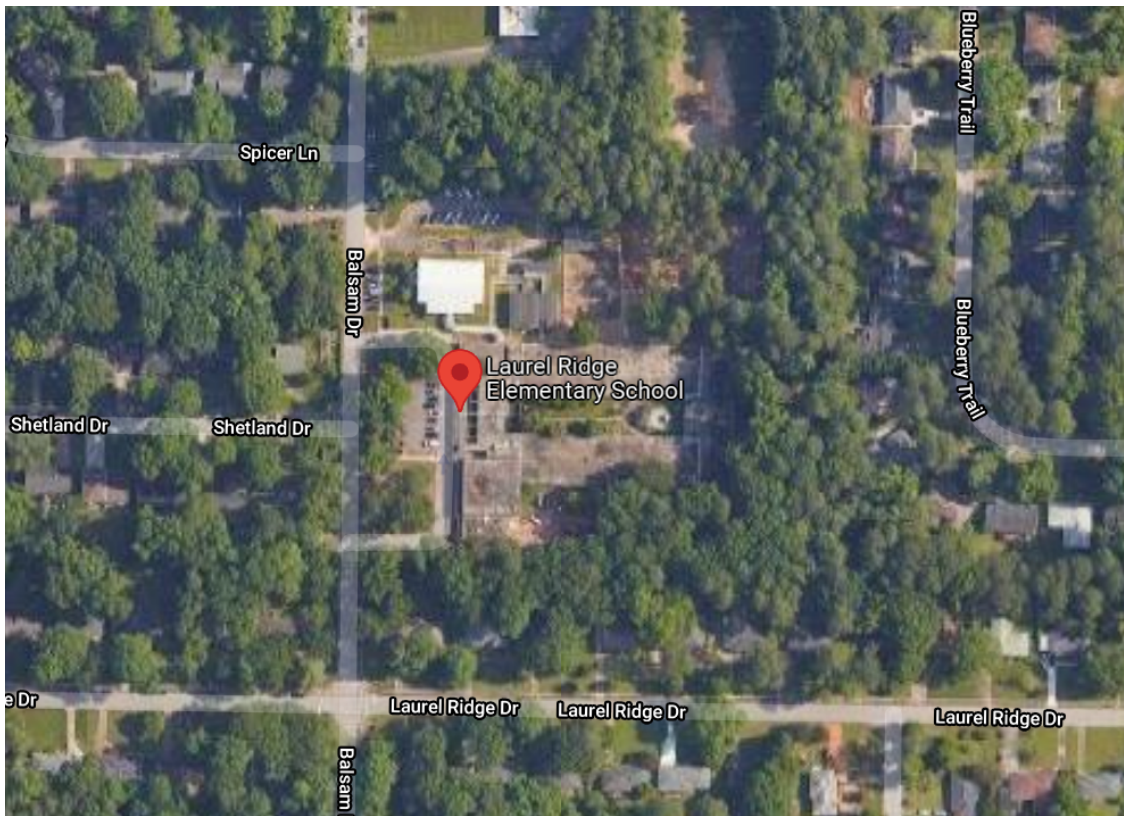
- c. Design and install a fire suppression system for the entire school. A fire hydrant directly in front of the building may provide an entry point for the sprinkler riser and installation of the riser in the mechanical room near this location. The fire line location would need to be confirmed and possible branch point installed near the southern portion of the site.
- d. Support the addition of a security vestibule. HVAC air distribution may need to be reworked if new walls create obstructions to current airflow patterns and spaces.
- e. If ADA requirements need to be addressed, supportive plumbing redesign may be necessary. Specifically, if toilet rooms need to meet ADA standards, adjustments to plumbing fixture locations will require plumbing design. Additionally, drinking fountains may be addressed.

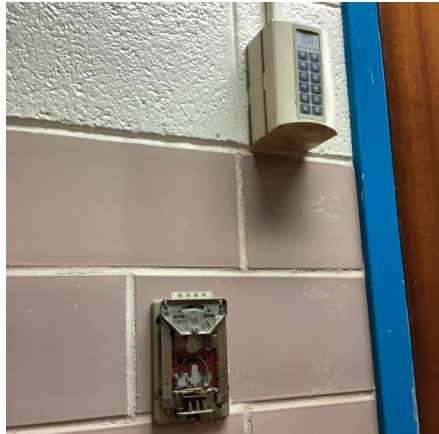
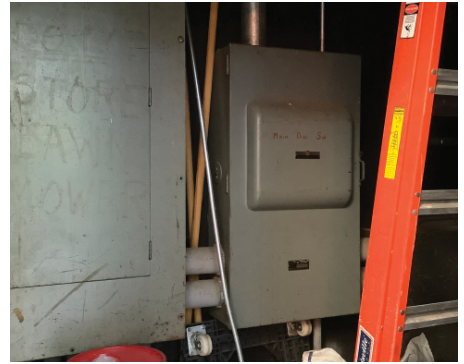
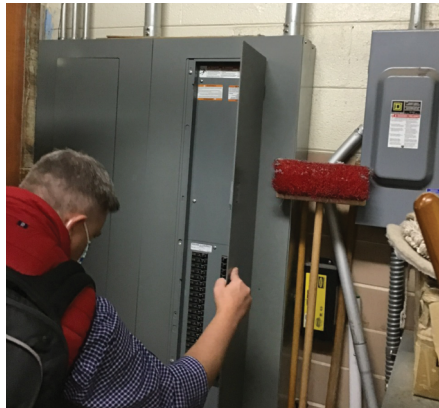
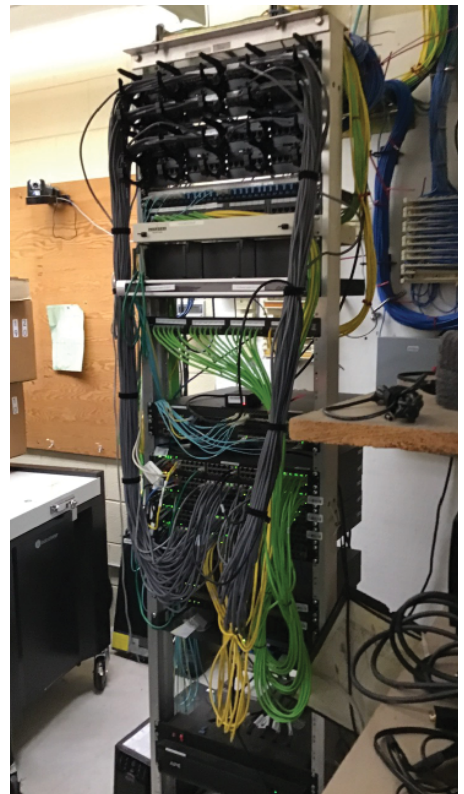
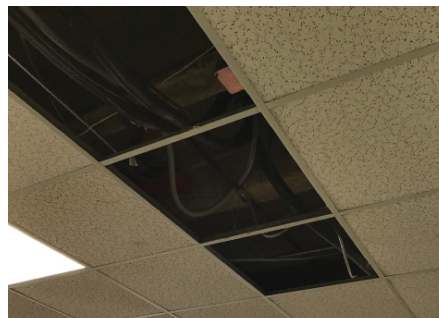
- Power Distribution Systems
  - Existing electrical service is original to building and is in poor condition. Existing main panel labeling is unreadable, but estimated service is rated for 800-1000 Amps at 277/480 Volts, 3-Phase, 4-Wire.
  - Panelboards and transformers throughout building are original to building and in need of replacement.
  - Emergency generator does not exist for this school.
  - Emergency lighting is currently tapped ahead of main and is a code violation.
- Lighting
  - Existing lighting in corridors, media center, cafeteria and administration are older LED retrofit.
  - Existing lighting in all other areas is existing fluorescent.
- Fire Alarm
  - Fire alarm system does not meet current life safety codes and is in need of replacement.

- Power Distribution
  - Upgrade electrical service and provide new panels and circuiting for HVAC system replacement.
  - Provide new emergency generator and separate life safety and non-life safety systems.
- Lighting
  - Provide new LED lighting and controls throughout building to meet IECC. This includes new LED lighting in Gymnasium.

- Fire Alarm System
  - Provide new fire alarm system throughout building per DeKalb County design guidelines.
