PHASE I ENVIRONMENTAL SITE ASSESSMENT & RISK HAZARD ANALYSIS

CLAIRMONT PRESBYTERIAN PROPERTY

2020 CLAIRMONT ROAD
DECATUR, GEORGIA 30033

MARCH 27, 2023

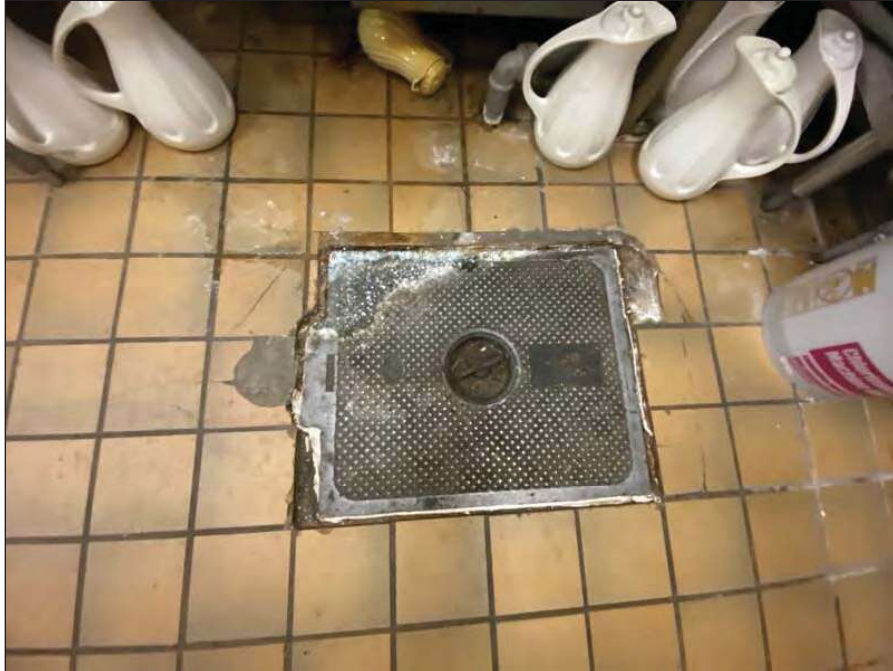
19 - Grease trap in the kitchen

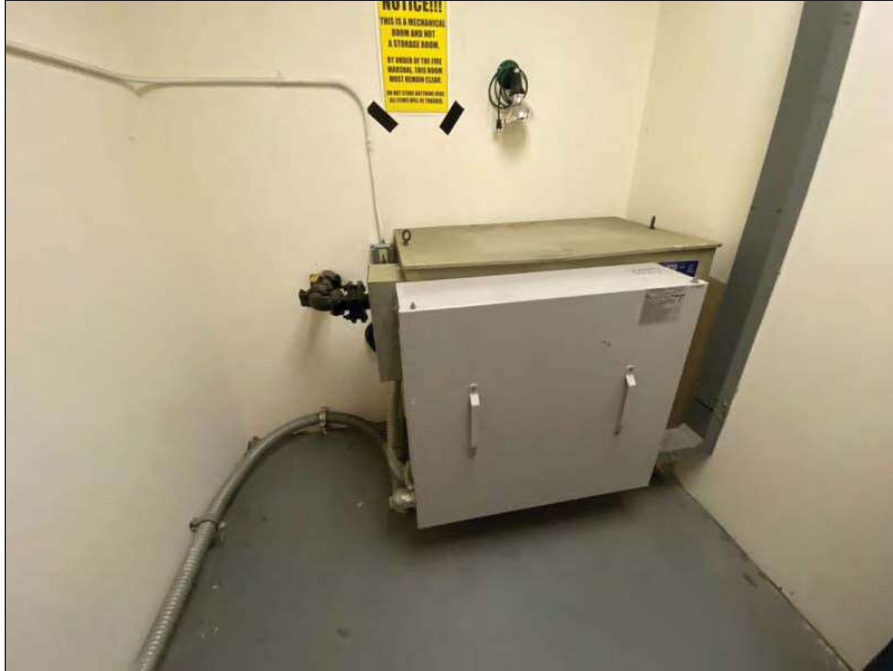
29 - Elevator room with hydraulic fluid reservoir on the second floor
