## **Report of Findings, Recommendations and Probable Cost**

Re: Colusa USD District Office Building Stabilization  
Colusa Unified School District  
Project No.: 2023-003.00

## Report of Findings

Subject: **Colusa USD District Office**  
745 10<sup>th</sup> Street  
Colusa, CA  
Point 2 Job No.2023-011

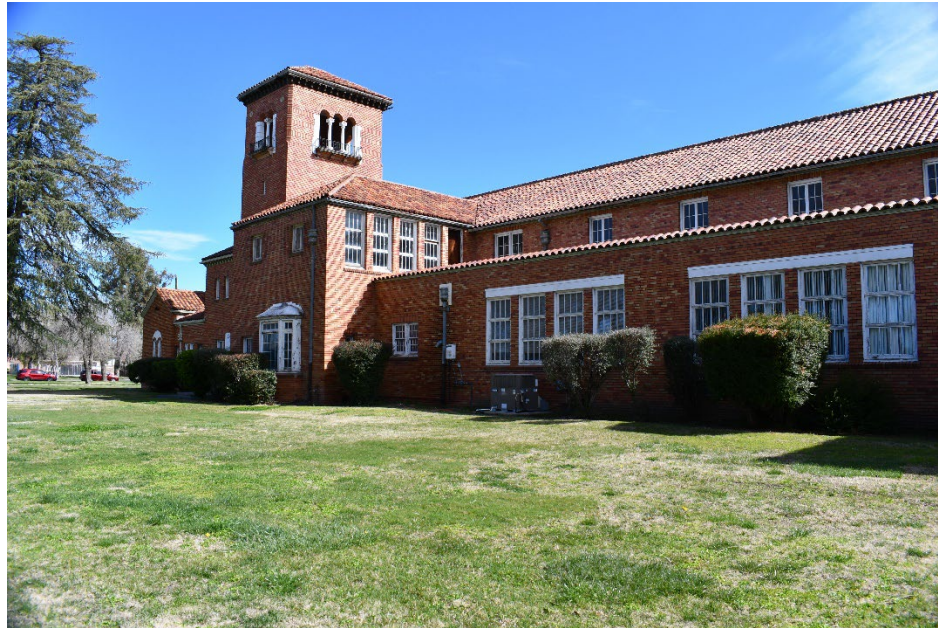
The URM building was a common construction method of the 1920's. The walls are constructed of 2 or 3 layers (wythes) of masonry brick, stacked, with mortar between the bricks in a pattern called "American Bond". The stretcher courses are typical, and they run parallel with the wall. The header courses are bricks turned inward, extend into the thickness of the wall, and are typically located at each 6<sup>th</sup> row. See the photo below:
