PHASE I ENVIRONMENTAL SITE ASSESSMENT & RISK HAZARD ANALYSIS

CLAIRMONT PRESBYTERIAN PROPERTY

2020 CLAIRMONT ROAD
DECATUR, GEORGIA 30033

MARCH 27, 2023

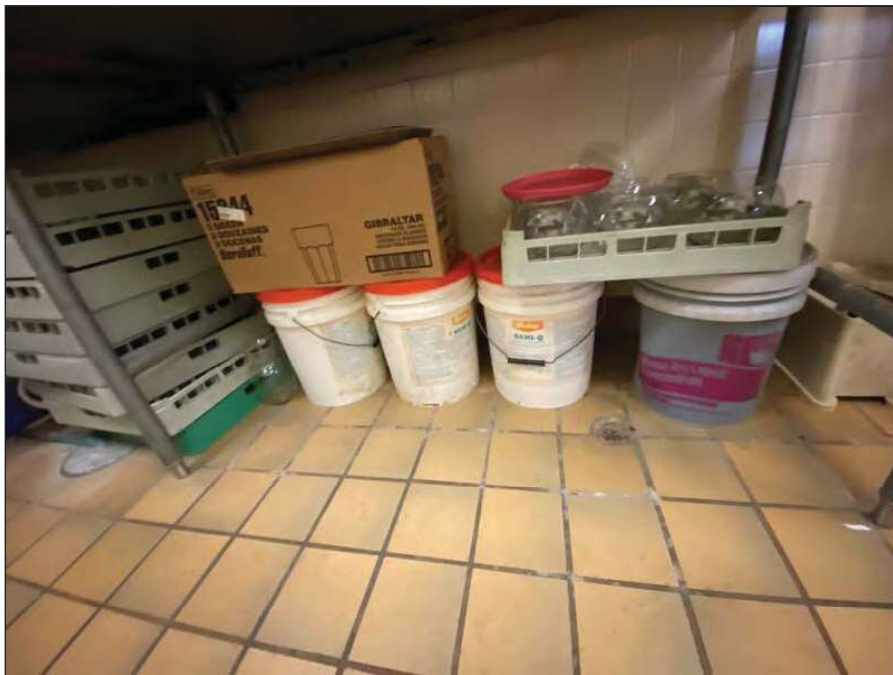
18 - Soaps in the kitchen
